Failure Analysis of 316L Air Cooler Stainless Steel Tube in a Natural Gas Production Field

Keywords: Failure analysis; stainless steel; inclusions; pitting corrosion; fractography

The purpose of this work was undertaken to study an industrial case regarding the failure behavior of 316L SS air chiller tube supplied by a Qatari Gas Company. Macroscopic failure characteristics of the specimens were examined using SEM and XRF techniques.

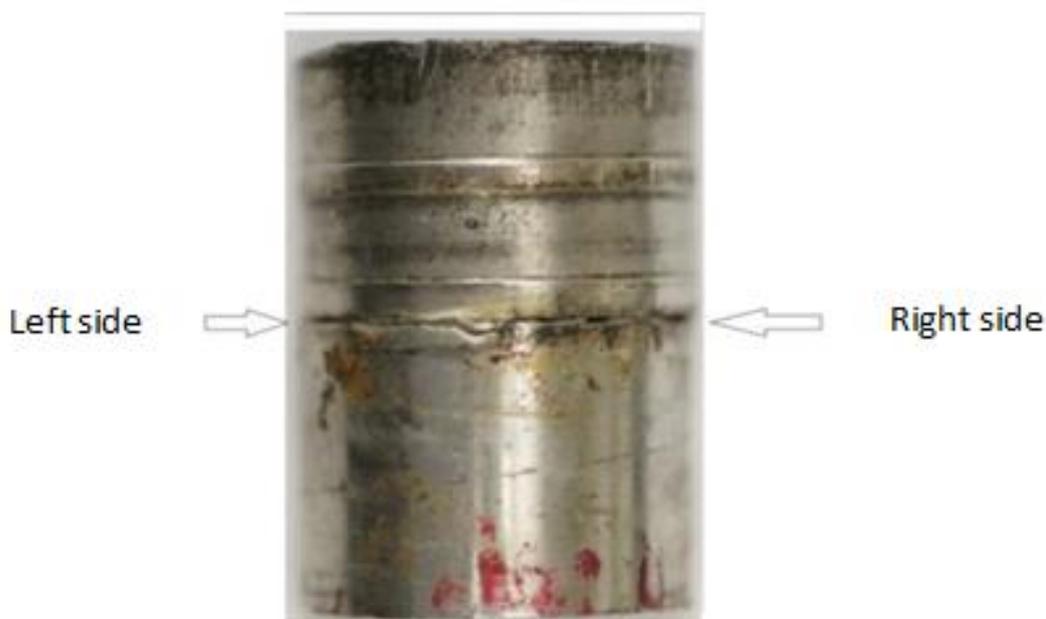
In this work a detail failure analysis of 316L SS air cooler from a Qatari Gas company with a peripheral crack at the edge of the roll expansion close to the clamping area is performed. Figure 1 shows photograph of the as received failed 316L stainless steel tube connected to the cooler pipe.

Figure 1. Overview of the as-received failed tube connected to the cooler pipe. Arrows refer to the inspected regions.

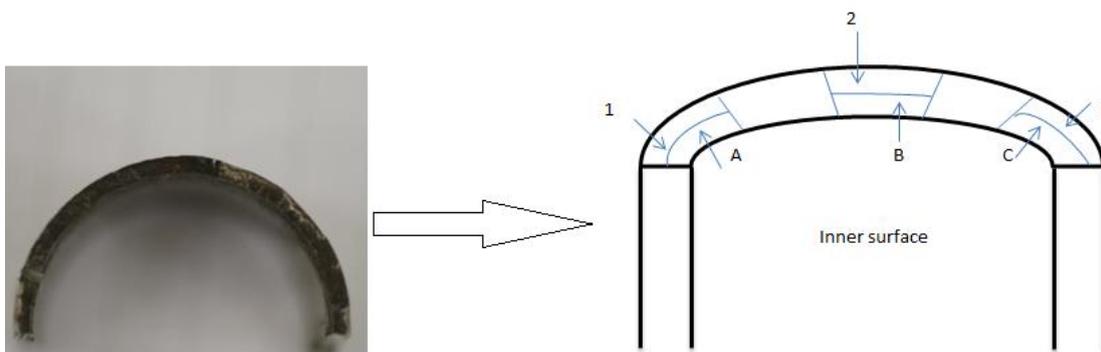
Figure 2. Schematic macrograph for the investigated areas at the fracture surface of 316L SS tube.

At the outer surface of the tube (exactly behind the crack) a horizontal cross section parallel to the crack propagation plane was done without touching the crack surface, as shown in Figure 2. The test locations are indicated by arrows as shown in Figure 2. In other words, the fracture surface has been divided into six sections, the three alphabets sections are closed to the inner surface exposed to the gas (A, B and C) and the other three numerical sections are closed to the outer surface. The length of each inspected section is 10 mm.

In Figure 2, regions A, B and C show the SEM images taken from the inner surface which was in contact with the processed gas and regions 1, 2 and 3 show the SEM images of the outer surface. Fry's Reagent Etching techniques per ASTM standard E. 407 as No. 79 revealed the microstructure.

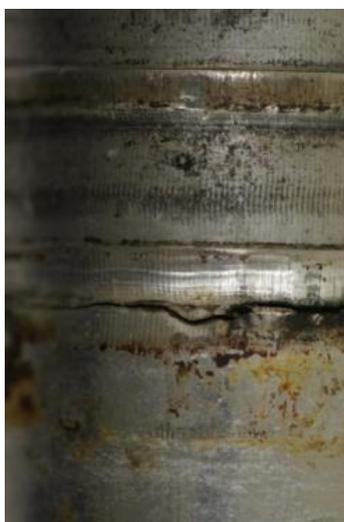
Figure 3. Photograph image for the crack region of 316L SS tube.

Visual examination of the cracked tube section was performed by naked eye and a digital camera before and after cutting. Digital imaging of the fracture surface clearly revealed the crack was localized at the center of tube and adjacent to the clamping area, as shown in Figure 3 .

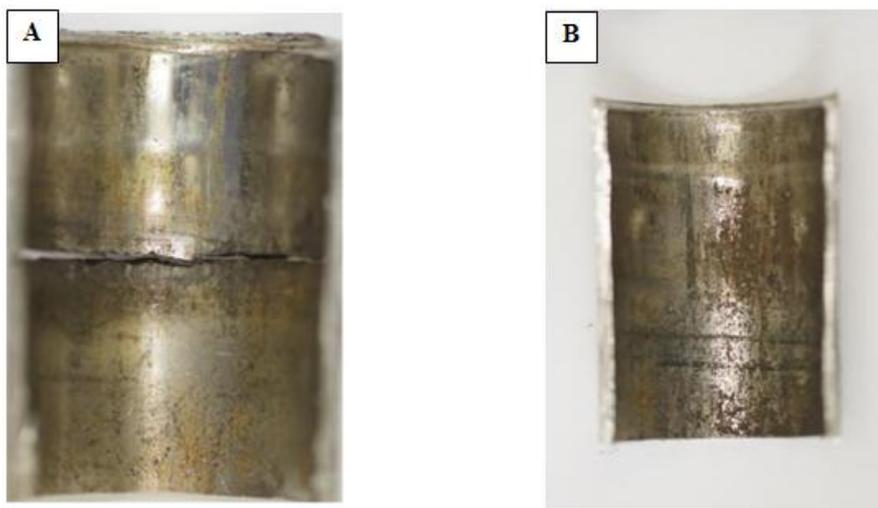
Figure 4. [A and B]. Show the inner cross section of 316L SS tube after cutting.

The sectioned sample showed accumulation of corrosion products at the inner surface which was even denser at the outer side, as illustrated in Figure 4 [A and B]. Correspondingly, the fracture surface at the central region showed a deep dark color (pointed out in Figure 5), which was more intense and closed to the inner surface, as depicted in Figure 2 [A, B and C]. However, the black tint diminished in magnitude towards the ends of the crack area, see the regions 1, 2 and 3 in Figure 2. A release of the pronounced internal stresses was noticed during the cutting of the tube e.g. sudden brittle failure occurred and the part fell into several pieces although the cutting was done ca. 1cm apart from the failure.

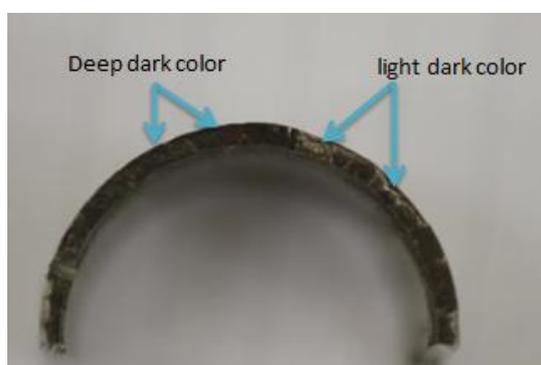
Figure 5. Overview of the fracture surface of 316L SS tube showing heavy oxidized regions (deep dark color) and less oxidized places (light color).

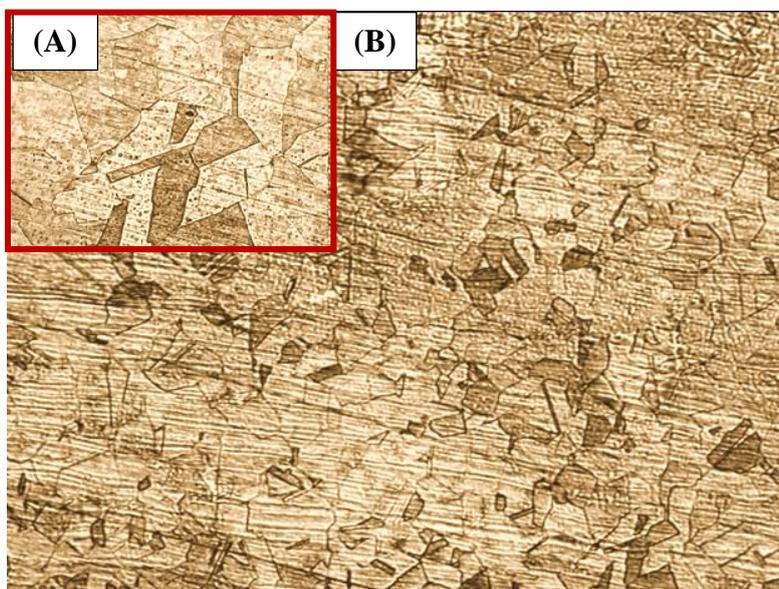
Figure 6. Optical microstructure of 316L SS air cooler tube using Fry's reagent at (A) 50X and (B) 10X magnifications.

Figure 6 shows the microstructure of 316L stainless steel. The average size of the austenitic grains (austenitic isles in a continuous matrix of ferrite) is about 30 μm which is reasonable in case of 316L stainless steel. It may be observed that different types of corrosion induced by Cl^- resulted in failure of the tub. The first type is chloride induced fatigue cracking corrosion due to internal cyclic stress, resulted in ductile fracture. The second type is chloride induced stress cracking corrosion under constant external stress (due to clamping around air cooler tube circumference). Chloride ions accumulate locally at the regions at stress concentration and induce the initiation of a crack. The combined effects of these corrosion types led to the final failure of 316L SS.

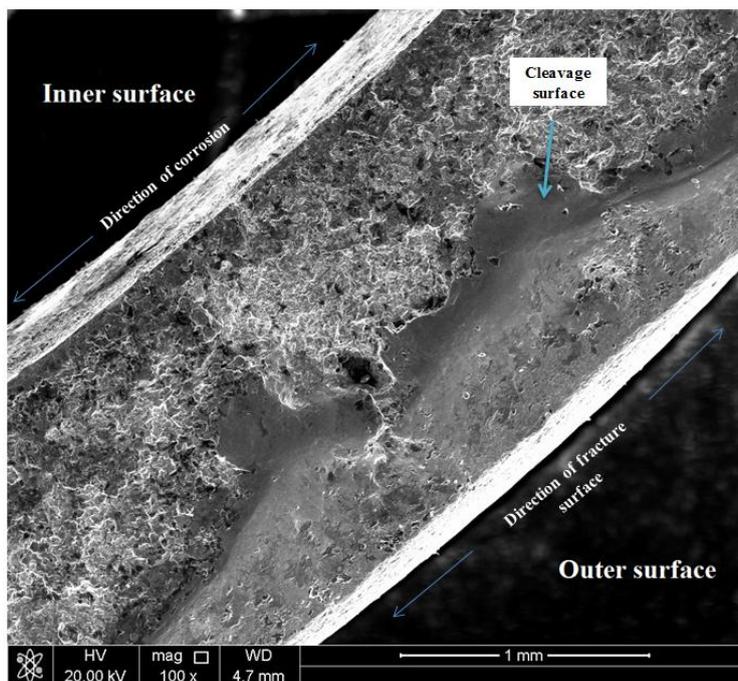
Figure 7 illustrates that the actual corrosion event initiated at the inner surface and was followed by subsequent cleavage occurring at the outer surface which led to the ultimate failure of stainless steel tube.

Figure 7. SEM micrograph at low magnification showing the cracking corrosion of inner surface and cleavage fracture at outer surface.

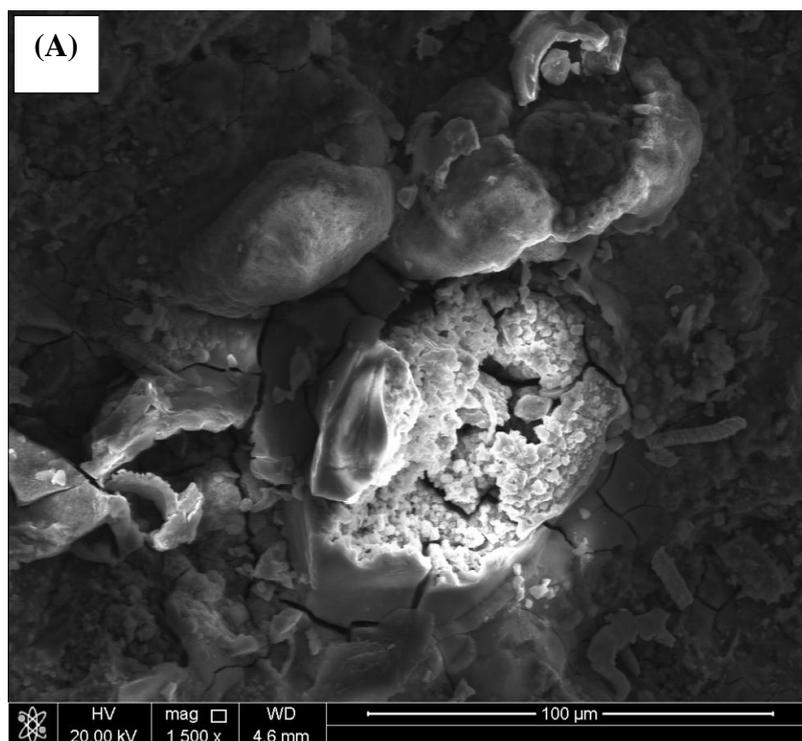
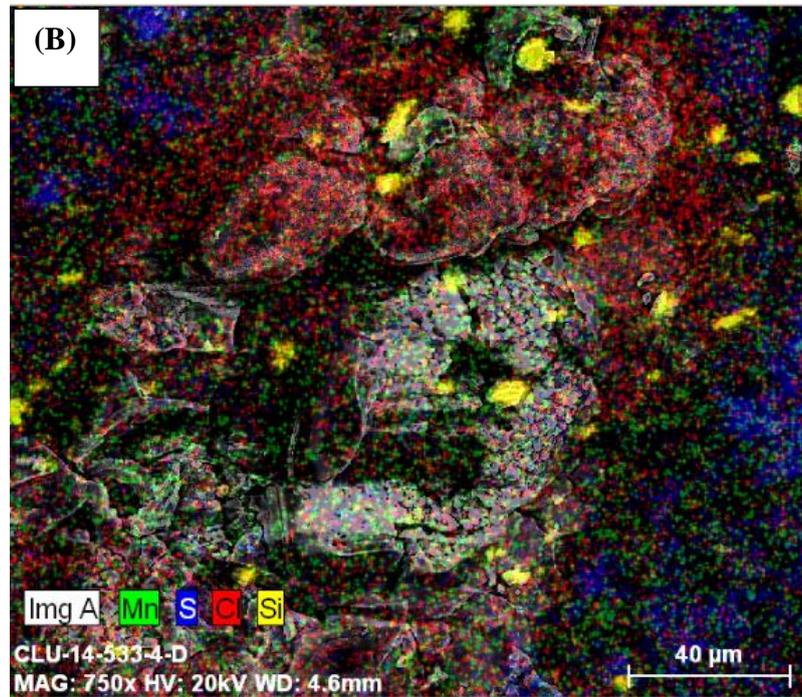
The first corrosion type occurred as result of interaction of Cl^- ions with manganese sulfide (MnS) inclusions, which acts as active sites for initiation of corrosion pits, see Figure 8 (A and B). Dissolution of inclusions were noticed and proposed to be the first step for pit formation [15, 16]. This proposed mechanism originated from the presence of Mn, where it segregates sulfur as MnS instead of

Figure 8. (A) The initiation of pits formation due to MnS inclusion on the inner surface of 316L stainless steel and (B) the corresponding EDX mapping image.

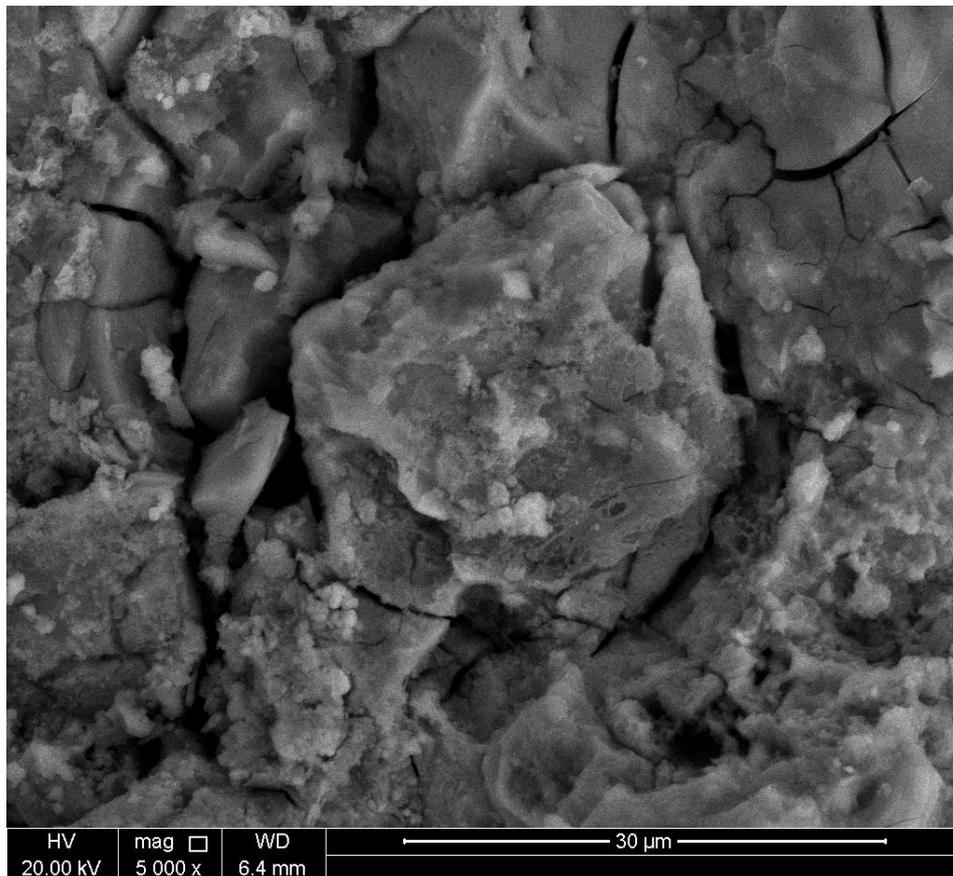
Figure 9. Typical SEM micrograph of the corrosion- fatigue fracture on the outer surface of 316L stainless steel tube.

Intergranular corrosion fatigue cracks, as illustrated in Figure 9, are presumably as a result of cyclic stresses. Figure 10 shows the formation of microcracks at the inclusion sites where the pits were formed and their subsequent propagation from the base of pits. This observation is in agreement with the most common mechanism of crack initiation and propagation due to corrosion fatigue as suggested by Butler and Isom [20].

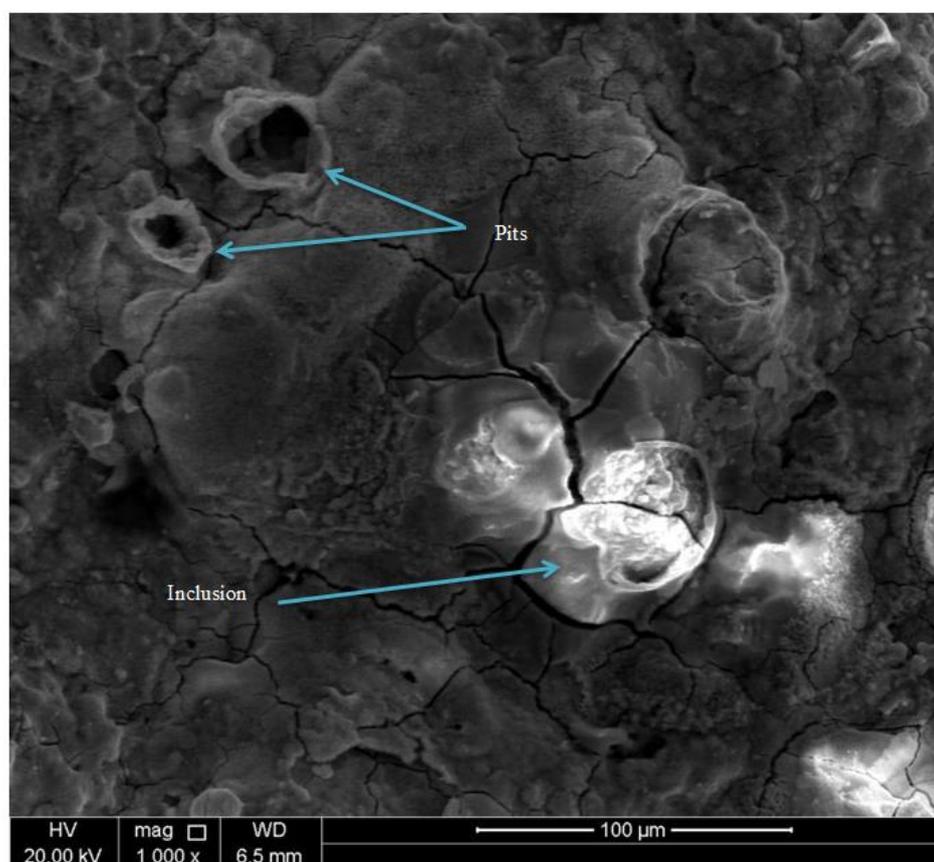
Different regimes have been suggested to clarify the corrosion fatigue behavior [21, 22]. Bayoumi [23], indicated that the endurance of chloride induced fatigue corrosion arises through incorporation of both environmental factor and applied cyclic stresses. Many researchers have reported pitting as an important element in corrosion and thereby in corrosion fatigue cracking of materials containing second phase particles [24] and consequently, resulted in the formation of micro-cracks (at/around the location of an inclusion), as an evident in Fig. 10.

Figure 10. SEM micrograph showing the formation of stress cracking corrosion around of pits on outer surface of 316L SS air cooler tube.

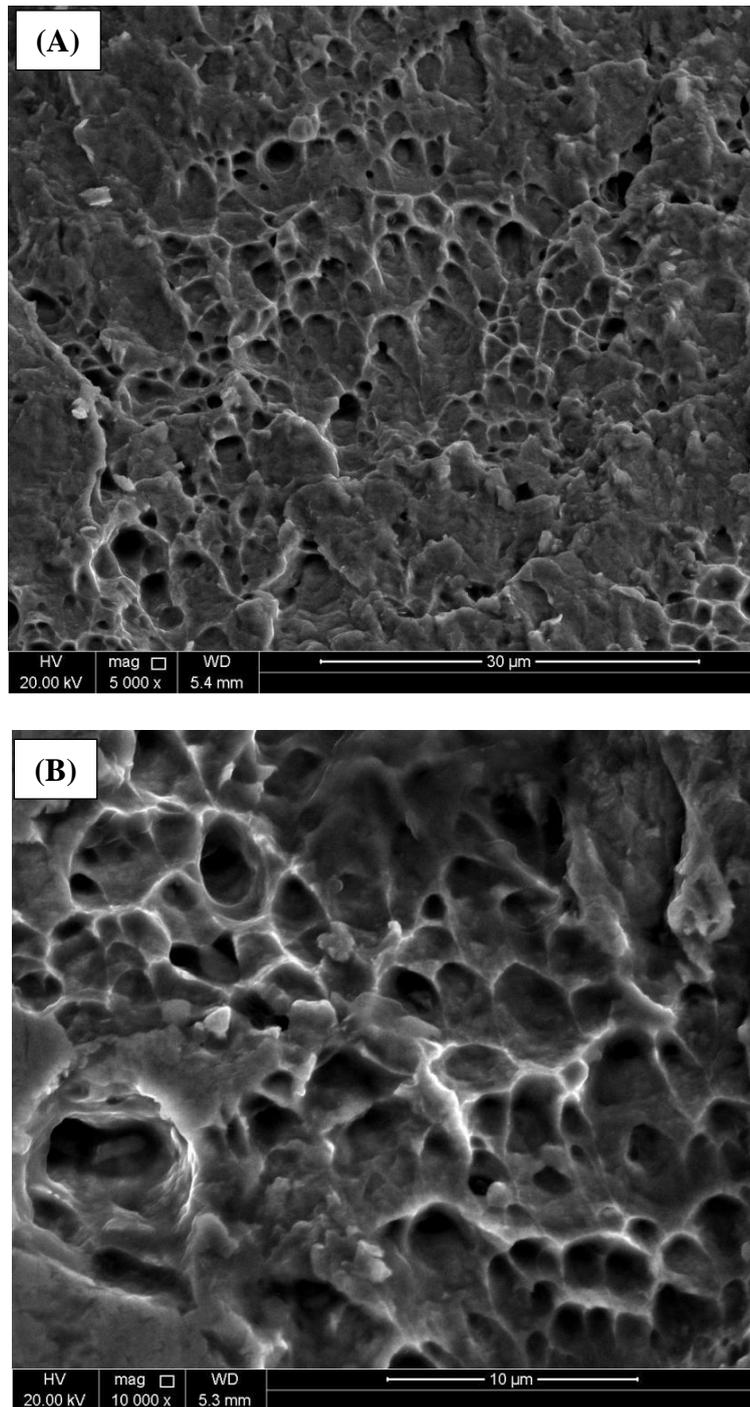
Figure 11 [A and B]. Fractography of the ductile fracture on the outer surface of 316L stainless steel at different magnifications.

Figure 11 (A & B) illustrates how the formation of microcracks facilitated the eventual ductile fracture which in a good agreement with the results obtained Sudhakar [25].

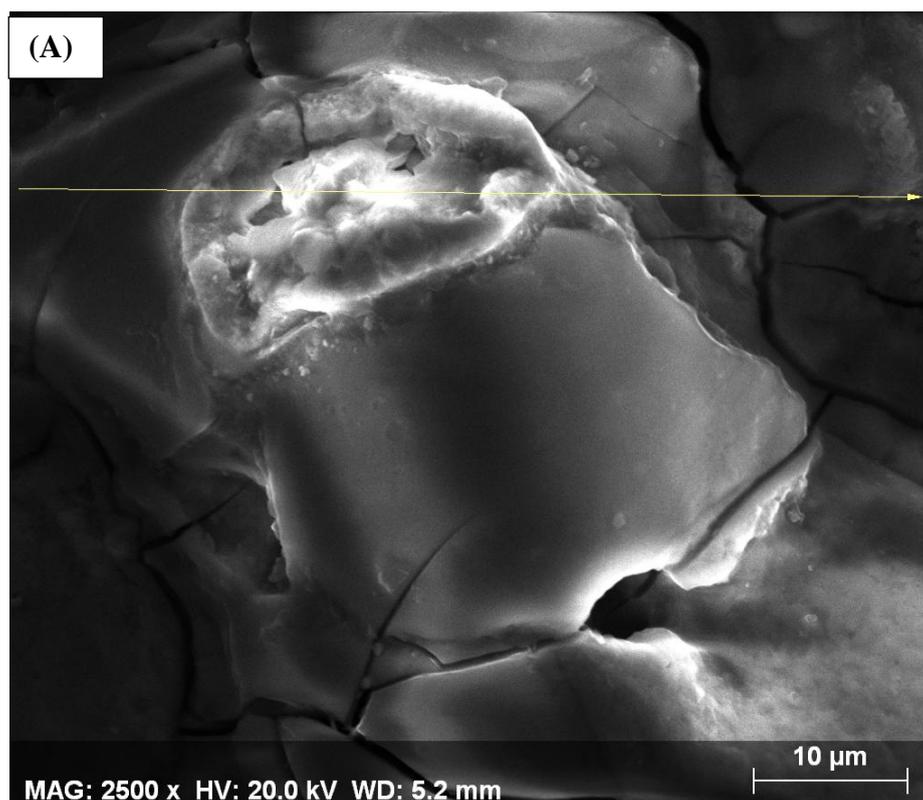
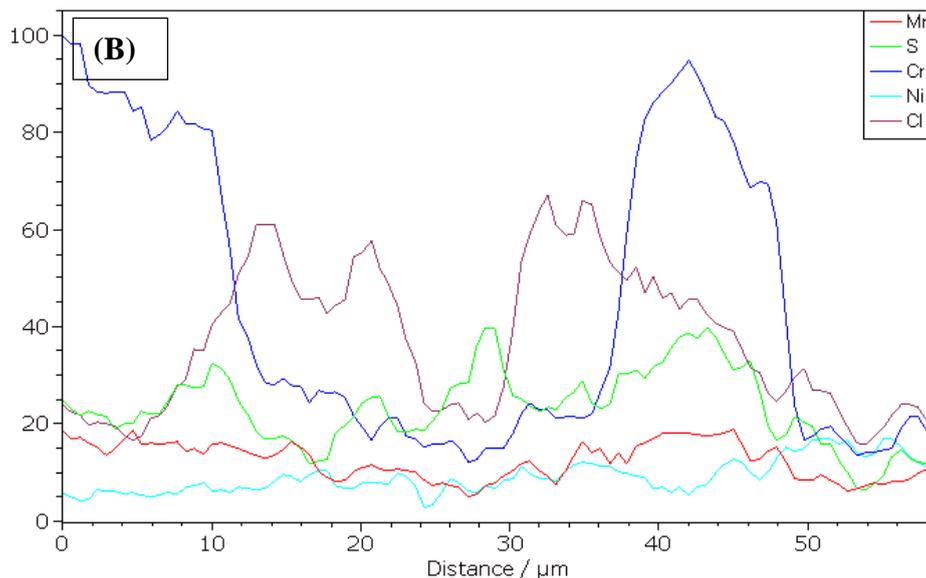
The SEM line scans were carried out across the inclusion/steel – interface, in order to detect the composition at the inclusion. It was observed an increment of Cr signal intensity and a decrease of Cl and S signal intensity at the steel/inclusion-interface. Fig 12 indicates depletion of Cr and

accumulation of S and Cl as the scanning approached from the inclusions to the inclusion/steel interface.

The present results are in accordance with the observations which detect Cr-depletion around inclusions [26]. The signal intensity of Cr around inclusion remains strong compared to Mn signal. This strong peak of Cr however indicates to the formation of either chromium carbide or chromium sulfide. The formation of these phases is thermodynamically possible only at relatively high temperature, e.g., chromium carbide and chromium sulfide are formed at 550 - 950 and 1400 °C, respectively. These high temperatures were not applicable during the operation and welding processes. Therefore, the formation of both chromium carbide or sulfides is out of the scenario.

Figure 12. SEM image of an inclusion of 316L stainless steel (A) and a corresponding SEM line scan (yellow line). (B) Gives the energy-dispersive X-ray analysis of the inclusion.

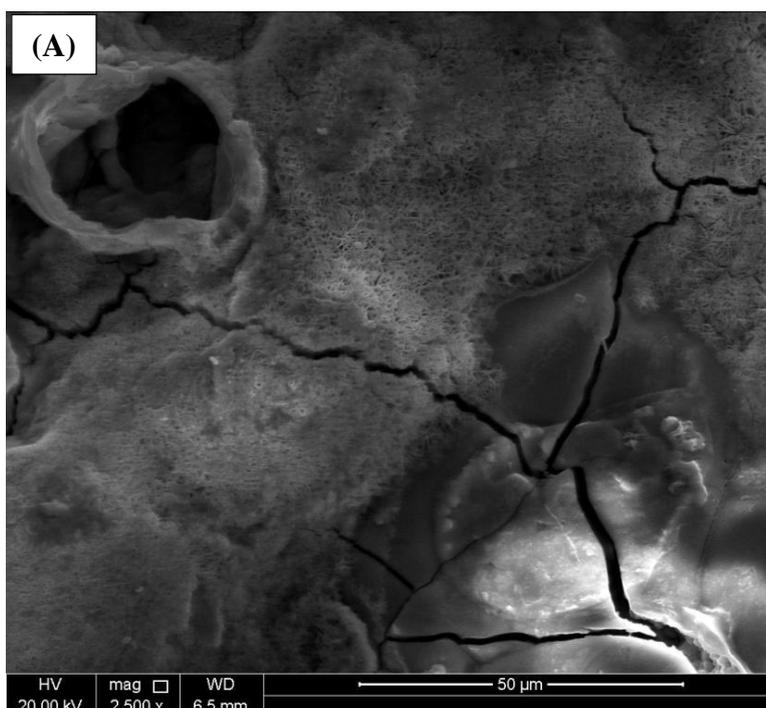
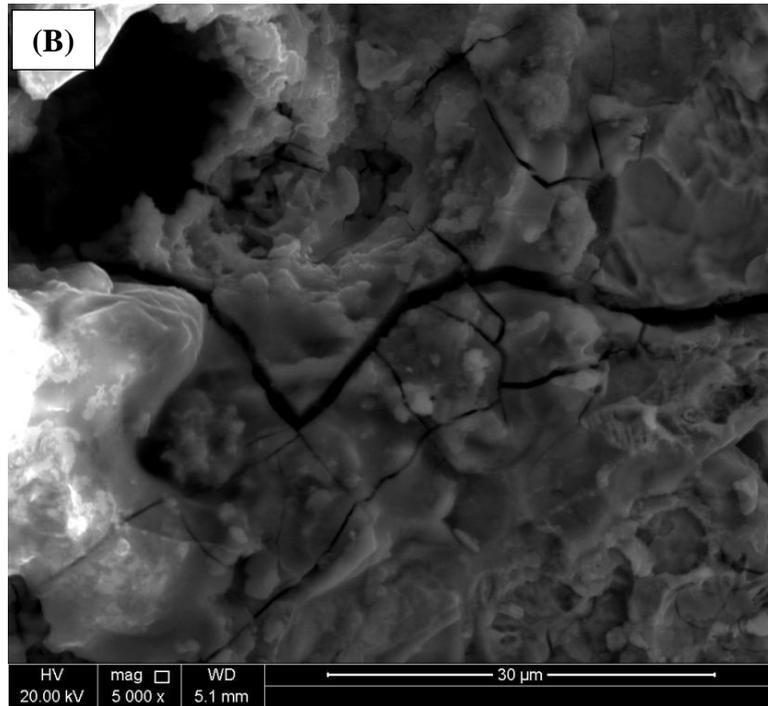
Combination of Figure 12 and Figure 13 demonstrate that the crack initiates from the active pit sites at which the Cl⁻ concentration is high which is an indicative of CLSCC as was outlined by Yin et al. [27]. Rate of dissolution of MnS inclusion as the origin of pit and corresponding crack growth rate at pits was observed to be faster than the overall corrosion rate, which is in a good agreement of Fantechi's results [28]. Moreover, Elsariti and Ftirman [29] indicated the possibility and propensity of pitting and Stress Corrosion Cracking behavior of austenitic stainless steel at the room temperature as well as elevated temperature. All these evidences indicate that CLSCC is the most probable mechanism responsible for the failure event of the air cooler tube where some local small pits were formed on the internal surface of tube and became the stress concentrations sources. The constant internal stress of clamping contributes to the propagation of CLSCC, as shown in Figure 14.

Figure 13[A and B]. SEM images illustrate the formation of pits which acted as active site for initiation of chloride stress cracking corrosion on the outer surface of 316L stainless steel.

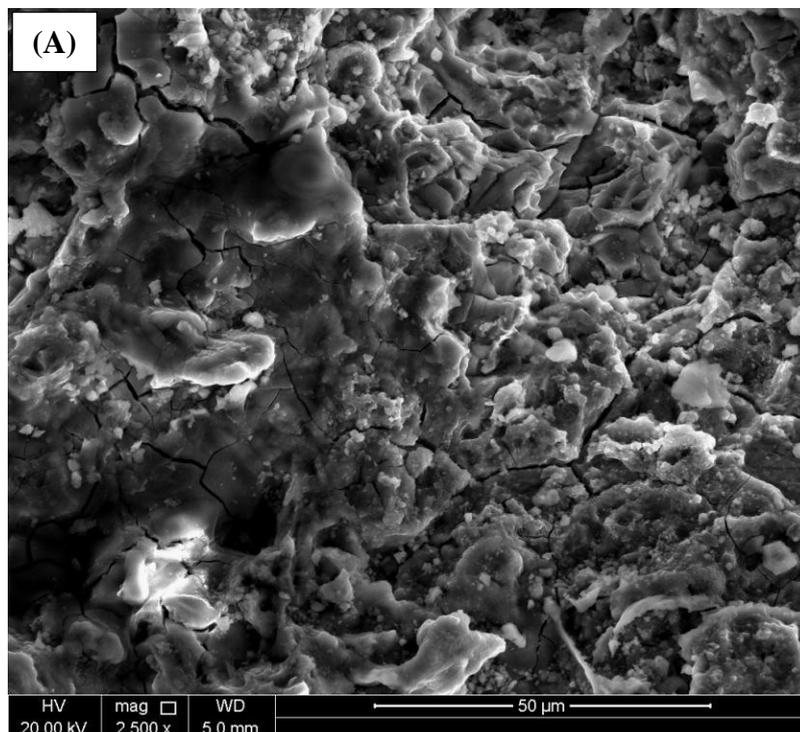
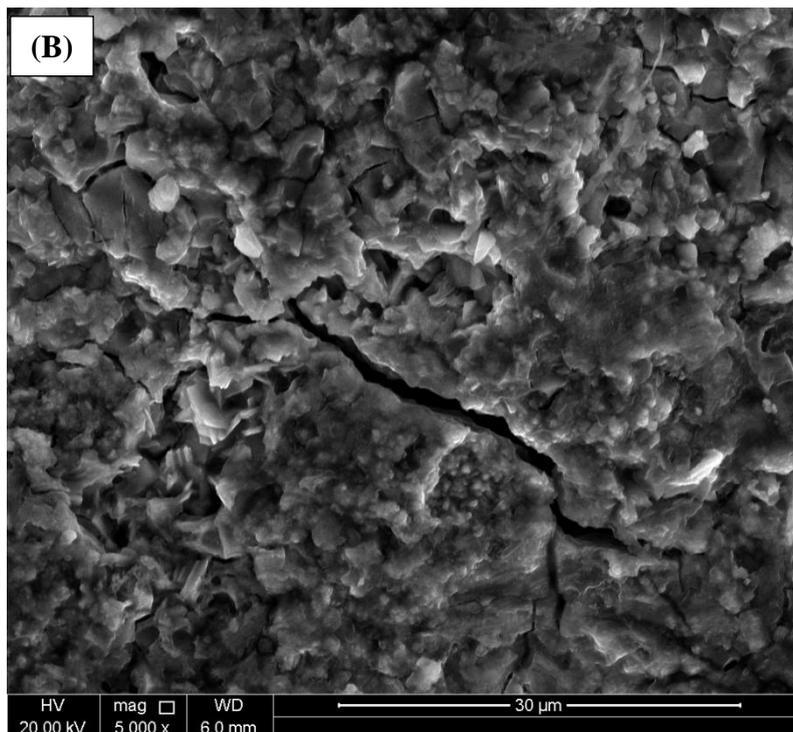
Figure 14 [A and B]. SEM images showing the formation of intensive IGC due to chloride stress cracking corrosion on inner fracture surface of 316L SS air cooler tube.

The formed pits act as stress concentrators which at the end lead to SCC. Consequently, the used 316L stainless steel must be replaced with higher quality one that is free of Cu to lower the pitting susceptibility of the alloy. It was reported that low alloying percentage of Cu increases the corrosion resistance of 316 SS in presence of chloride and H_2S but its effect is completely reversed when H_2S is absent where the corrosion rate increased dramatically [30 & 31].

- Dissolution of the MnS inclusions induced the pit initiation process, with the contribution of released compounds from the inclusions.
- It is recommended to use higher grade of 316L SS that is free of Cu since the gas stream in the air chiller is free of H₂S. The latter, in presence of Cu, forms a CuS which increases the protection of the chromium oxide layer of 316L SS.
- Also, the removal of chlorides from the gas stream can be an option to lengthen the life time of the chiller 316L SS tubes since it will decrease the pitting corrosion rate.
