Evaluation of the Weld on In-service Gas Pipeline

The study evaluated the condition of steel gas pipeline at the site of weld after more than 45 years of service. The deformation cycle of welding and particularly superposition of the thermal and deformation cycle, results in phase transformation and precipitation processes in the thermally affected region. The deformation cycle has a pronounced effect on ageing of the welded joint and the associated increase in its hardness and reduction in notch toughness. The hardness of the weld was measured according to Vickers HV0.05. The highest values of hardness were measured for the weld metal, namely 293 HV0.05. The values of mechanical properties of steel after more than 45 years of service of the pipeline corresponded to values defined by the respective standard. Transition temperature T_T according to Charpy test was equal to -8.5 °C. From the point of view of technical practice, with regard to pipe service properties, it is important that the construction material is loaded at temperatures above the transition temperature T_T . Transcrystalline brittle failure was observed on the specimens that have been broken at T_T temperature.

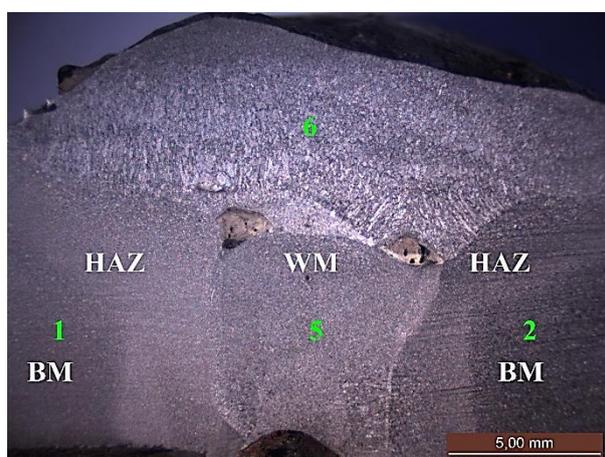
Figure 2. Weld on the pipeline steel with HV0.05 hardness measurement in points 1,2,5,6

Site of measurement	HV0.05 microhardness
1	201
2	192
3	270
4	203
5	219
6	293

The highest values of hardness were measured for the weld metal, namely 293 HV0.05. The lowest values of hardness were measured in the region of the welded material with ferritic – pearlitic structure, namely 192 HV0.05. Results of measurements of mechanical properties of the steel gas pipeline are presented in Table 3 and compared with values set by EN 10028/2-92 [19]. The values of yield point and tensile strength for both orientations of sampling after more than 45 years of service of the pipeline corresponded to values defined by the respective standard.

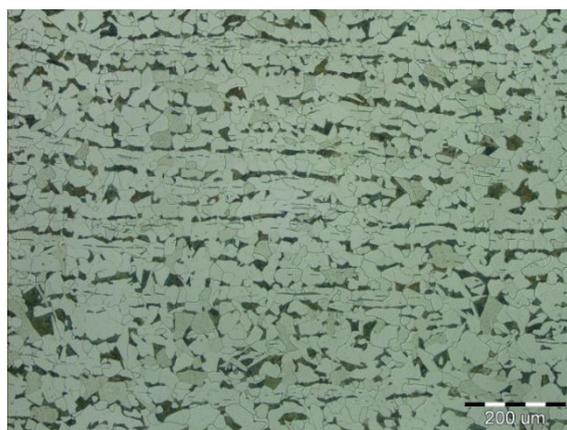
The structure of P295GH steel (basic material – BM) is documented in Figure 3 and Figure 4. The microstructure of steel parallel to the longitudinal axis of the pipeline was ferrite – pearlite and showed a pronounced line-like structure in ferrite and pearlite, see Figure 3.

Figure 3. Microstructure of steel parallel to the longitudinal axis of the pipeline, etch. Nital

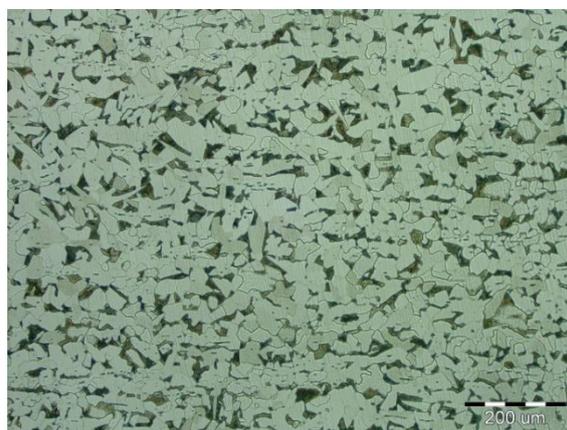
Figure 4. Microstructure of steel transversal to pipeline axis, etch. Nital

Sulphidic inclusions were observed in the microstructure. The microstructure of steel oriented transversally to pipeline axis, see Figure 4, was similar to steel parallel to the direction of rolling except for the inclusions which were considerably shorter. The occurrence of inclusions in non-etched steel is illustrated in Figure 5 and Figure 6. The microstructure of the weld metal (WM), Figure 7,

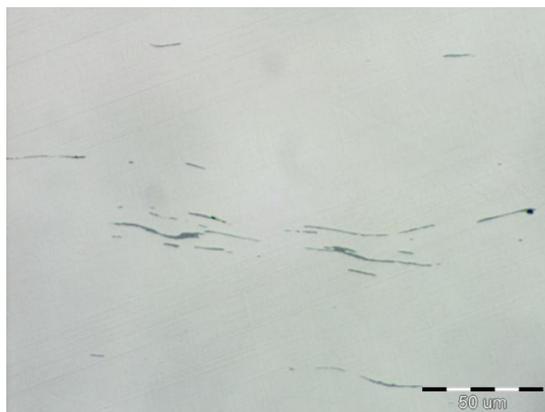
Figure 5. Occurrence of inclusions elongated in the direction of rolling, non-etched

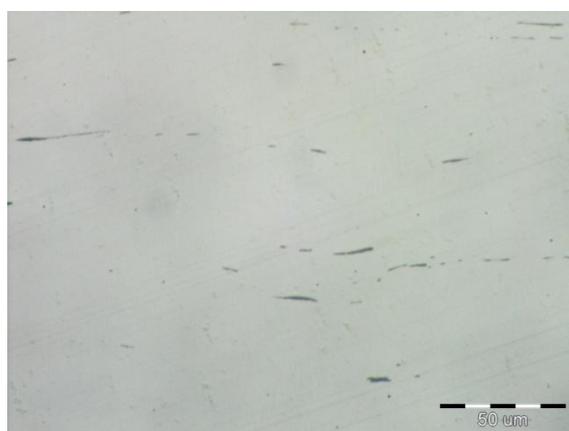
Figure 6. Occurrence of inclusions oriented perpendicularly to rolling, non-etched

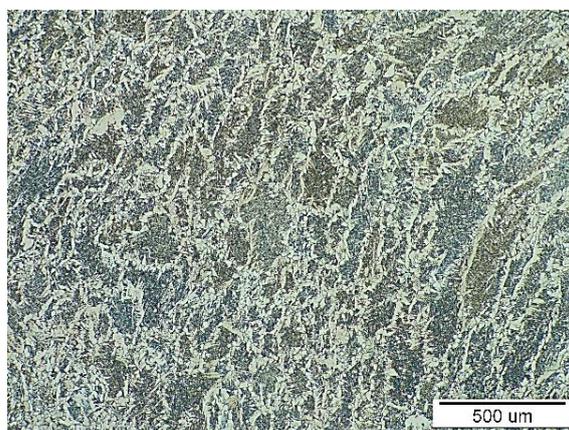
consisted of coarse acicular ferrite with Widmanstätten pattern and pro-eutectoid ferrite. The microstructure of heat affected zone (HAZ), Figure 8, was composed of acicular ferrite and polyhedral ferrite.

Figure 7. Microstructure of weld metal, etch. Nital

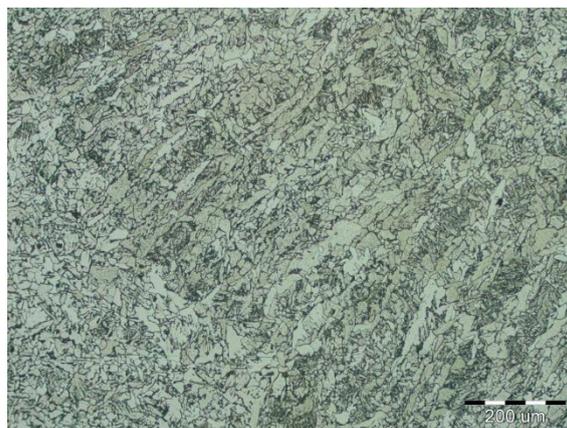
Figure 8. Microstructure of thermally affected region, etch. Nital

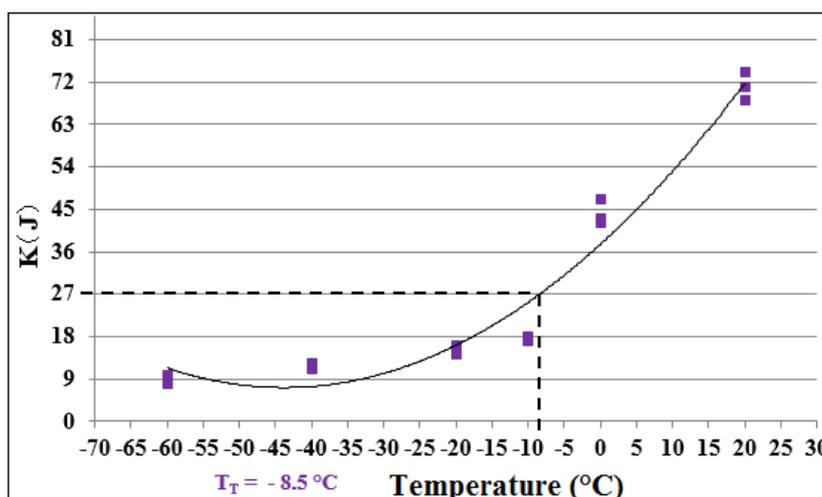
determination of transition temperature T_T [18]. Figure 9 shows the thermal relationship for the impact energy and the obtained transition temperature, which in our case was equal to $T_T = -8.5^\circ\text{C}$. From the point of view of technical practice, with regard to pipe service properties, it is important that the construction material is loaded at temperatures above the transition temperature T_T .

Figure 9. Thermal relationship for the impact energy K and the transition temperature obtained from the curve; $T_T = -8.5^\circ\text{C}$ at $K = 27$ J

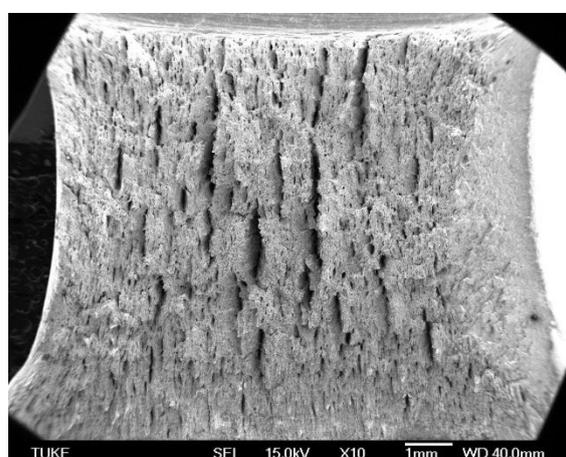
Figure 10. Fracture surface of a specimen fractured at temperature $+20^\circ\text{C}$, SEM

surfaces, we selected specimens fractured at temperatures close to the determined transition temperature. The macroscopic examination of specimen surface presented in Figure 10 showed that transcrystalline plastic failure with pitted morphology was predominantly involved.

The fracture surface in Figure 10 is rough with ridges and specimen edges show signs of plastic deformation. Pronounced lines of elongated pits oriented parallel to the surface of the steel pipe are visible in fracture morphology. Details of these elongated pits initiated by rolled inclusions present in the steel are shown in Figures 11 and 12. The size of the pits which developed by plastic failure of the respective specimen and were initiated by inclusion particles in respective specimens differs. In large pits one can observe relatively large inclusion particles (Figure 12). EDX analysis of such particle, as documented in Figure 13, showed presence of S and Mn and eventually of Fe. This involves either sulphide MnS, or complex sulphide MnFeS particles.

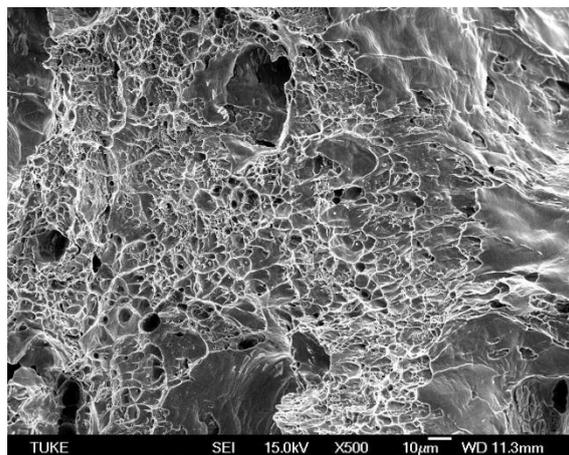
Figure 11. Transcrystalline plastic failure with pitted morphology, SEM

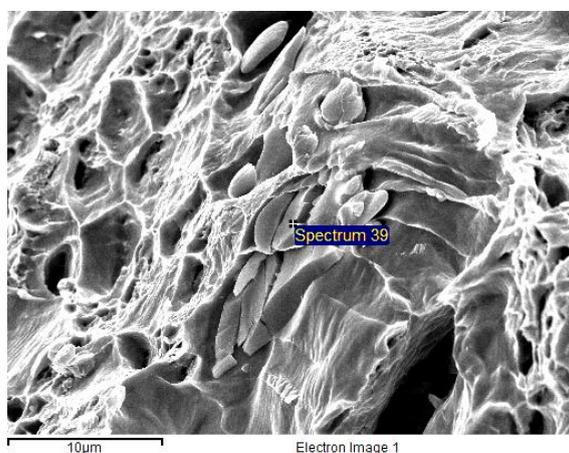
Figure 12. Inclusions in fracture pits, SEM

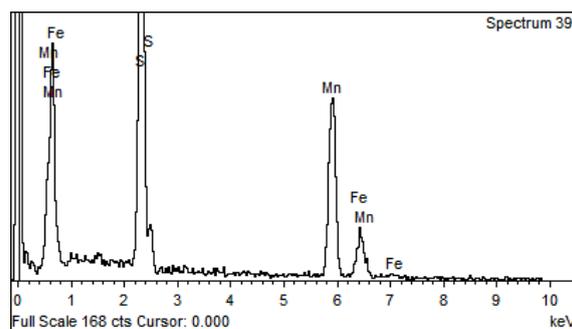
Figure 13. EDX analysis of inclusion depicted in Figure 12, SEM

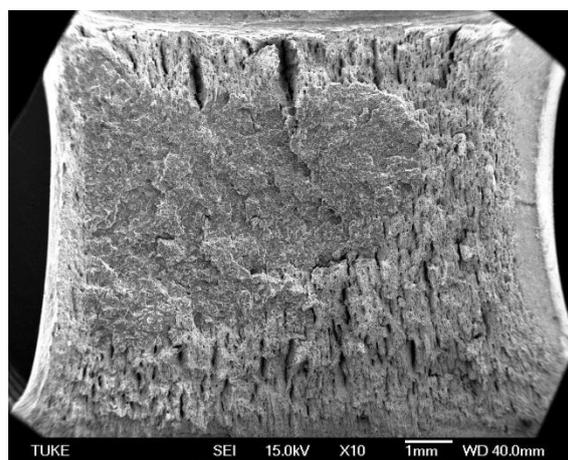
The fracture surface of a specimen documented in Figure 14 shows the mostly presence of cleavage facets of transcrystalline brittle failure. The fracture surface is less rough and specimen edges do not show considerable deformation. Pronounced lines of elongated pits oriented parallel to steel surface are visible in fracture morphology.

Figure 14. Fracture surface of a specimen fractured at 0 °C, SEM

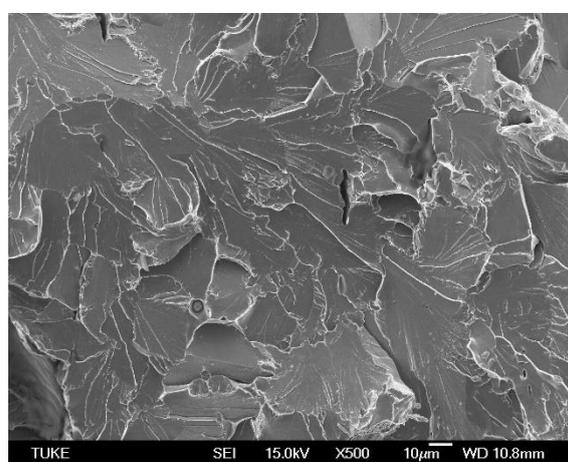
Figure 15. Transcrystalline cleavage failure of the specimen, SEM

transcrystalline brittle failure of fracture surface depicted in Figure 14 are documented in Figures 15 and 16. The morphology consists of transcrystalline cleavage facets locally separated by elevated levels (see detail in Figure 16). Among cleavage facets one can also observe regions of intercrystalline brittle separation of grains. The presence of intercrystalline facets provides the proof of the intercrystalline brittleness of ferrite induced as a rule by segregation of atoms of contaminants, such as P and S.

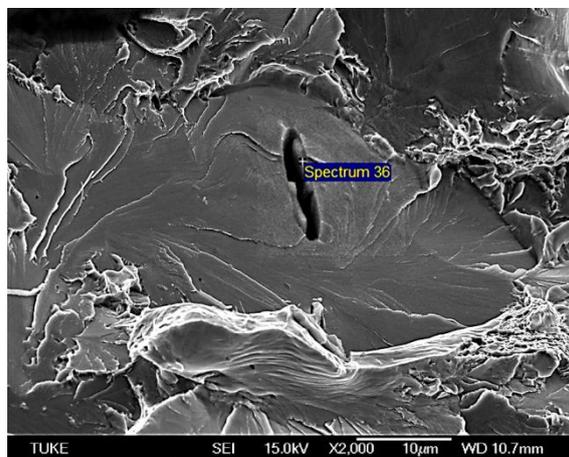
Figure 16. Inclusions in a cleavage facet, SEM

This assumption is confirmed by the presence of inclusion particles (sulphides) close to this region with intercrystalline facets (marked inclusion in Figure 16). EDX analysis of this particle, with its spectrum presented in Figure 17, confirms the presence of sulphide particles in the structure of steel.

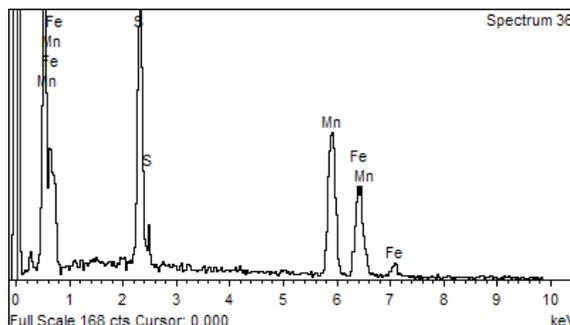
Figure 17. EDX analysis of inclusion depicted in Figure 16.

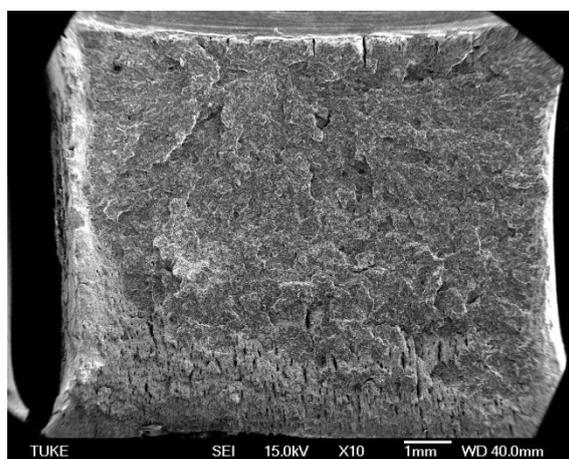
Figure 18. Fracture surface of a specimen fractured at -10 °C, SEM

The majority of the fracture surface of the specimen fractured at $-10\text{ }^{\circ}\text{C}$, as shown in Figure 18, consisted of facets of transcrystalline brittle failure. The fracture surface is relatively flat and specimen edges are less deformed than those of specimens depicted in Figures 10 and 14. In the lower part of the specimen one can see a region of transcrystalline plastic failure, which takes up a small proportion of the area of fracture surface. It consisted of transcrystalline cleavage facets separated by elevated levels of varying size.

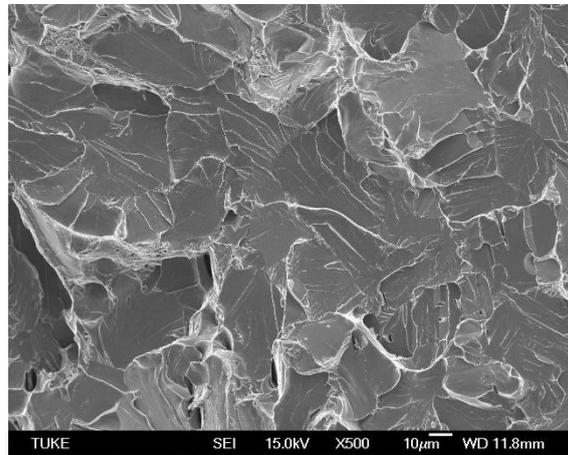
Figure 19. Transcrystalline brittle failure of the specimen, SEM

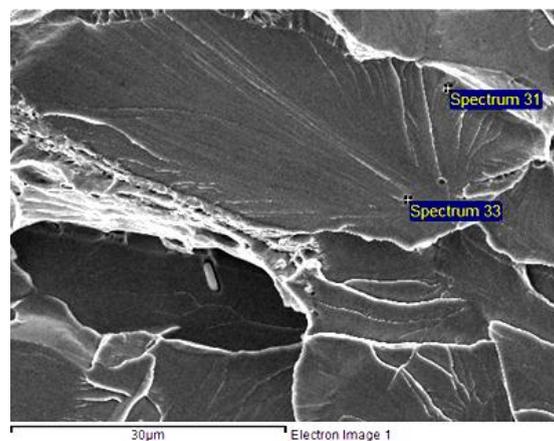
Figure 20. Detail of the region of intercrystalline brittle failure on fracture surface, SEM

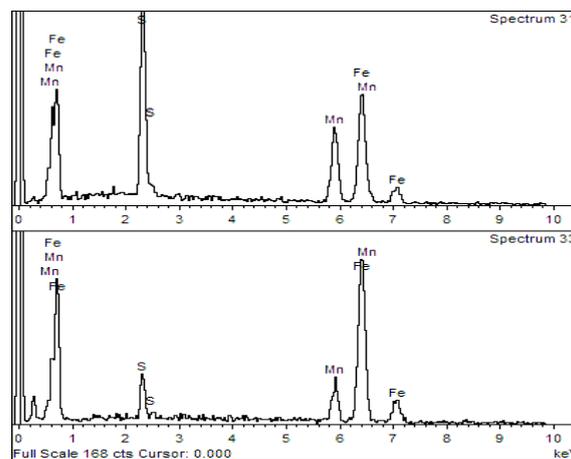
Figure 21. EDX analysis of inclusions, SEM
