Corrosion failure analysis of duplex stainless steel in marine environment

Serious crevice corrosion was detected at wear ring and pump casing of an S32760 duplex stainless steel fire pump assembled on an offshore platform, which resulted in broken of the wear ring. The failure mechanism of the cracked wear ring was analyzed, and results showed that the chemical composition of the wear ring corresponds to the standard S32760. However, metallographic test results showed that the wear ring has many harmful σ -phases and inclusions in the matrix, which led to the decrease of corrosion resistance of the material and induced crevice corrosion at the bolt joint and the wear ring. Besides, Chloride, sulfide, sodium and potassium have been found at corrosion products and pump casing fragments through energy dispersive X-ray spectrometry. Thus, to extend the service life of the fire pump, better sealing measures are needed to prevent crevice corrosion.

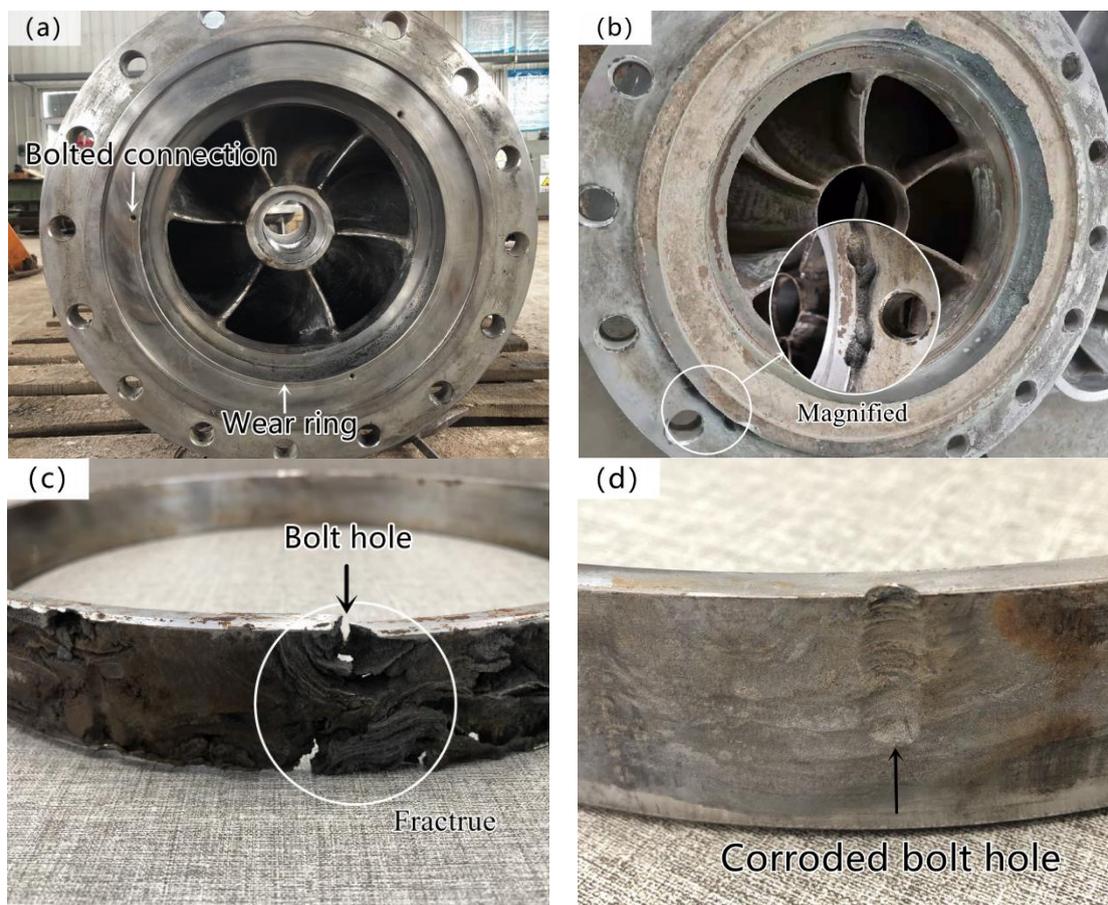
Fig. 1 shows the corrosion condition of the pump casing and the wear ring, and no obvious plastic deformation can be observed on them. As shown in Fig. 1 (a), the wear ring is assembled with the pump body by clearance fit, and the function of bolts is to prevent relatively sliding. A deep etch groove with a length of 100 mm is found at the flange (Fig. 1 (b)). More than half of the circumference of the wear ring has been corroded with varying degrees, and the largest corrosion depth reaches to 5 mm. The corroded wear ring cracks at the position of the corroded bolt hole as shown in Fig. 1 (c). An initial corrosion morphology of another bolt hole also can be found in Fig. 1 (d).

Figure 1. Pictures of the failed parts: (a) Intact pump casing with wear ring; (b) Corroded pump casing; (c) Corroded and cracked wear ring; (d) Corroded bolt hole on the ring.

According to the macroscopic inspection, all the corrosion positions of this fire pump occur in crevices, such as the crevice caused by clearance fit of wear ring and pump casing or the bolt crevice. Based on the EDS results, corrosion products contain a large amount of chloride indicating that the failure mechanism of the fire pump is crevice corrosion in the marine environment [25-27].

The condition for crevice corrosion is that corrosive medium enters and stays in the crevice, thus the crevice width is usually between 0.025-0.1 mm. Besides, it is proved that when the crevice width is 0.1-0.15 mm, crevice corrosion sensitivity is the highest and the corrosion rate is the most serious [31]. It is easy to form crevices with different widths at the flange, wear ring and bolt attributing to non-uniform stress and the difference of surface conditions in the assembling process.

Thus, to extend the service life of the fire pump, better sealing measures are needed to prevent crevice corrosion.

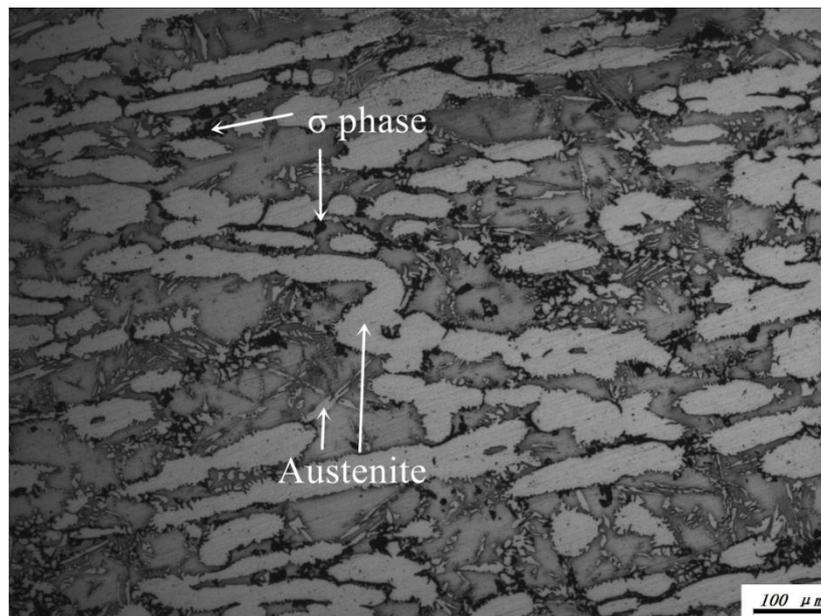
Fig. 2 shows the microstructure of the failed wear ring. It is found that the austenite phase presents two forms: the “island” austenite stretched along the rolling direction and thin strip austenite. And ferrite is located in the matrix around austenite. The proportion of austenite and ferrite is close to 1:1. Some sigma phase is found at the grain boundary of austenite and ferrite. As shown in **Fig. 3**, some inclusions of Al_2O_3 and $m\text{CaO}\cdot n\text{Al}_2\text{O}_3$ can be found in the polished metallographic specimen.

Figure 2. Microstructure of the failed wear ring.

Although the chemical compositions of the failed wear ring correspond to the standard S32760 (Table 1), the matrix of the wear ring contains many harmful σ -phases according to the metallographic testing results. The stainless steel would occur compositional segregation caused by the σ -phases inducing that chromium and molybdenum at grain boundary are depleted, which is easy to cause intergranular corrosion resistance and pitting corrosion [28, 29]. The existence of inclusions destroys the continuity of matrix structure and causes uneven chemical composition, which leads to selective corrosion [30]. Inclusions and σ -phase precipitates are potential sensitive corrosion areas.

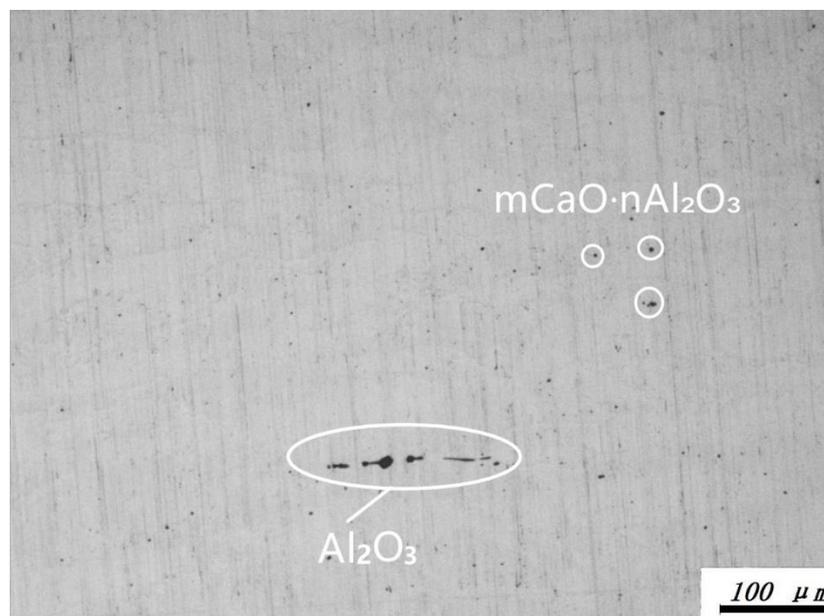
Figure 3. Inclusions of the failed wear ring.

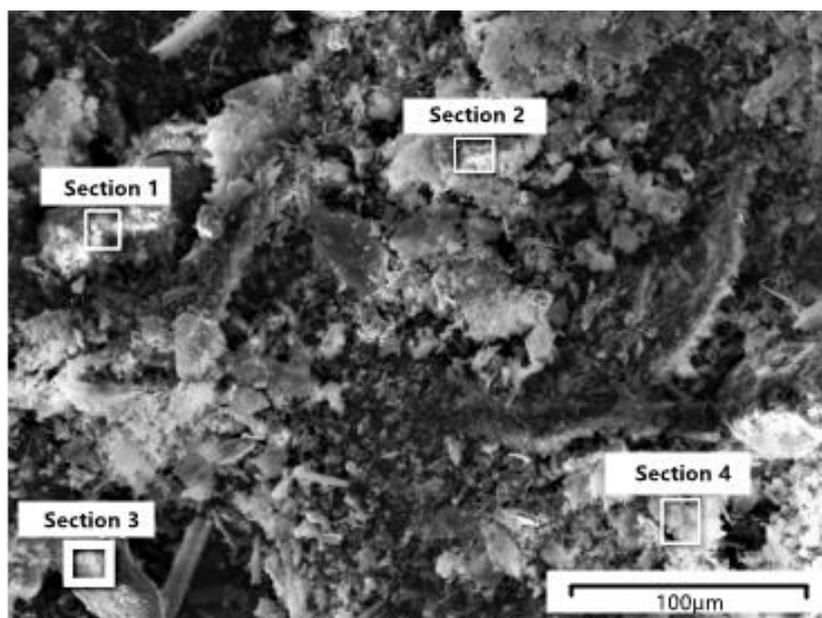
The chemical compositions of corrosion products and pump casing fragments near the crevice side were tested by EDS (Figs. 4 and 5). As listed in Tables 2 and 3, the results show that all the corrosion products obtained from both the failed wear ring and pump casing contain chloride, which increases the possibilities of pitting corrosion and crevice corrosion of stainless steel. And the chlorine reaggregated in the crevice is a typical feature of crevice corrosion [24].

Figure 4. EDS testing sections of corrosion products.

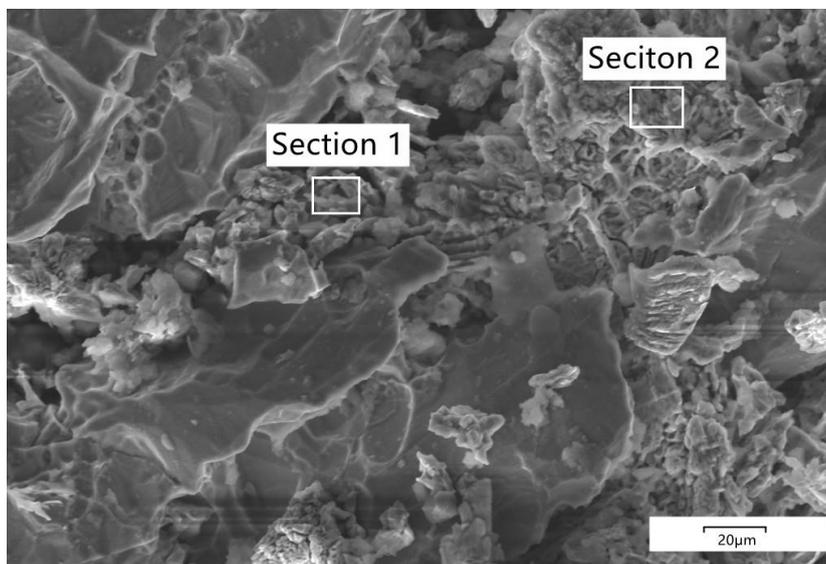
Figure 5. EDS testing sections of pump casing fragments.**Table 2.** Chemical compositions of corrosion products by EDS (wt.%).

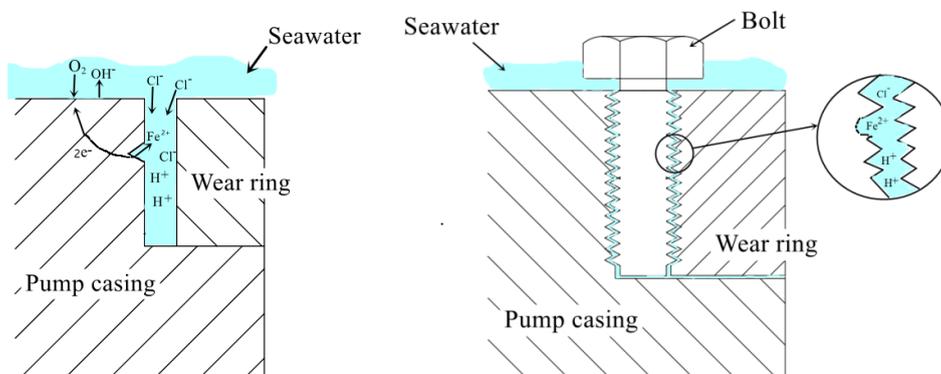
Fig. 6 shows procedures of crevice corrosion of the fire pump. At first, the reaction rate of the cathode in the crevice is the same as that of the anode. However, with the development of corrosion, the corrosion current density of the anode is greater than that of the cathode due to oxygen consumption in the crevice. Then, because of the increase of ferric ion (Fe^{2+}) in the crevice, chloride ion (Cl^-) is transferred to the inside crevice for maintaining charge balance. Thus, the hydrolysis

tendency of Fe^{2+} will be enhanced due to the increase of Cl^- in the crevice, which leads to the decrease of pH value in the crevice increasing corrosion rate and resulting in the wear ring crack.

Figure 6. Schematic diagram of crevice corrosion.
