Novel Method for Preventing Macro-Cell Chloride Induced Corrosion in the Simulated Repaired Reinforced Concrete Patch and Its Electrochemical Verification

Muhammad Wasim¹ and Raja Rizwan Hussain^{2,*}

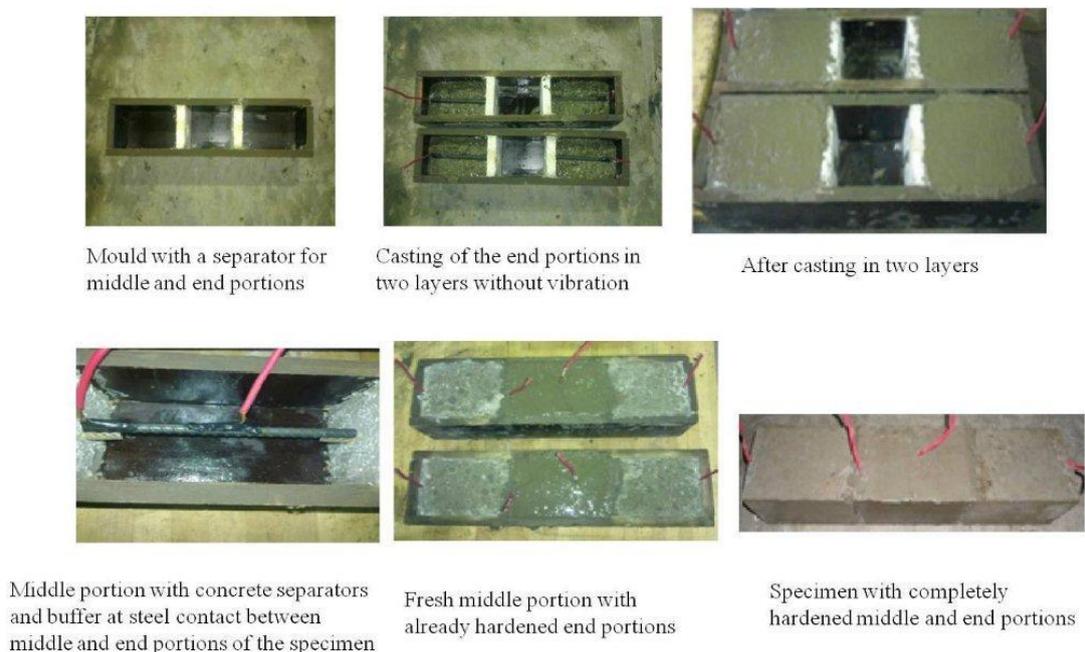
Figure 3. Experimental methodology for avoiding re-corrosion in repaired portion of chloride contaminated concrete.

Now in this research the same methodology is followed for experimentation using the specimens having same dimensions and chloride content as above, but to avoid the formation of macro cell due to the separation of anode and cathode; a buffer is put at the contact steel area of the middle and the end portions of the specimens. The schematic diagram of the buffer (plastic) at contact between the middle and the end portions steel of the specimens is shown in fig. 2. Further fig. 3 is a comprehensive illustration of the stepwise experimental methodology implied for casting the specimens in this research.

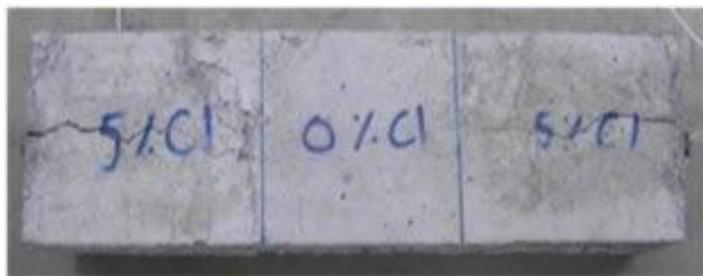
(With buffer)

(Without buffer)

Figure 6(a-b). Comparison of cracks propagation in specimens with and without buffer at the contact steel area between middle and uncontaminated portions.

3) There is no appearance of crack formation after one year in the specimen having 5% chloride content at the end as compared to the previous studied specimen without buffer at contact steel between end and middle portions fig 6a and fig. 6b. Previously it was found that there was cracking at the two ends of the 5% chloride content specimen that propagated towards the centre no chloride contaminated (control) portion showing much higher corrosion rate (due to macro-cell formation) than normally corroded (due to micro-cell formation) reinforced concrete for a chloride concentration of 5% [22]. The very high chloride induced corrosion potential of -0.62 Volts at the two extreme ends of that high chloride contaminated specimen was actually due to the macro-cell formation (anodic in nature) which also induced a macro-cell corrosion potential (cathodic in nature) of -0.55 Volts in the middle no chloride portion. Fig. 6 shows the comparison of crack propagation in specimens having 5% chloride contamination at the end with and without buffer after one year.
