Technical Report

Electrochemical Behavior of Reinforced Concrete and Its Relation With the Environment of Xalapa, Veracruz

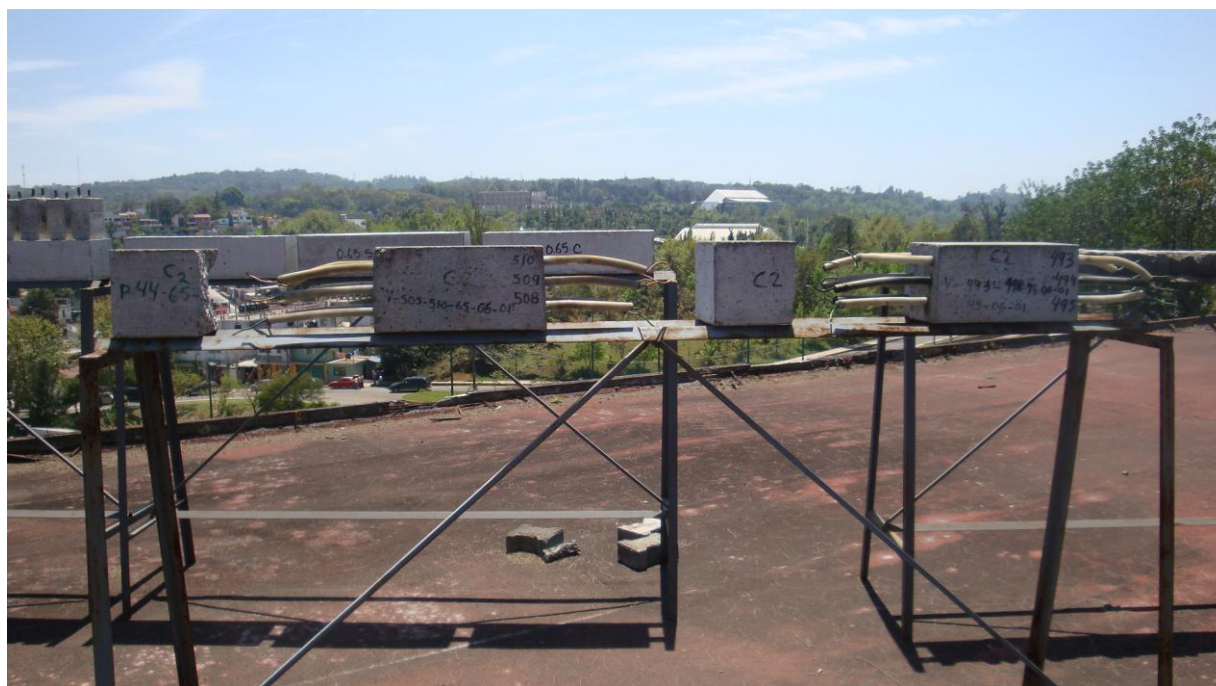
Figure 2. Natural test station, facing the prevailing winds

For each station there were manufactured 12 concrete beams of 15 x 15 x 30 cm, from which 6 of them are made of simple concrete and the other 6 are made of reinforced concrete with 6 rods of #3 1018 steel (9.5 mm diameter). The rods were placed inside the beams in 3 different concrete coating thicknesses 15, 20 and 30 mm., figure 1 shows a sketch of the geometry of the beams in the project, figure 2 shows a photograph of the natural test station of the DURACON Project in the city of Xalapa, Veracruz.

The beams were placed on metallic bases, with a side facing the prevailing winds (exposed side) and the other side facing the non prevailing winds (protected side). The reinforced concrete beams are employed to perform the assessment of electrochemical parameters (E_{corr} , i_{corr} and ρ).
