## **Corrosion of Beach Concrete Housing in the Yucatan Peninsula**

*E. I. Moreno, R. Solís-Carcaño, R. Márquez-Novelo*

Universidad Autónoma de Yucatán, Mérida, Yucatán, México

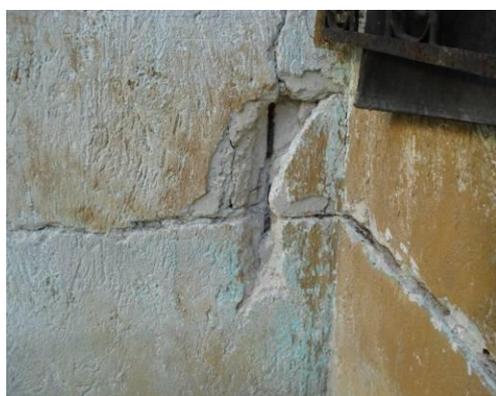
The general inspection showed common damage in the concrete elements of the houses; either by reinforcing corrosion or by sulphate attack. The reinforcing steel for seismic protection was corroded. Figure 4 presents some examples of the observed damage. Except for isolated cases, houses from Chetumal have no apparent damage.

Damage in wall, Cancun (CA).

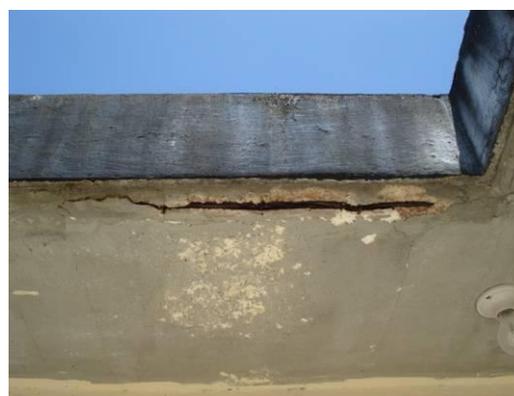
Damage in outside ceiling, Chetumal (CT).

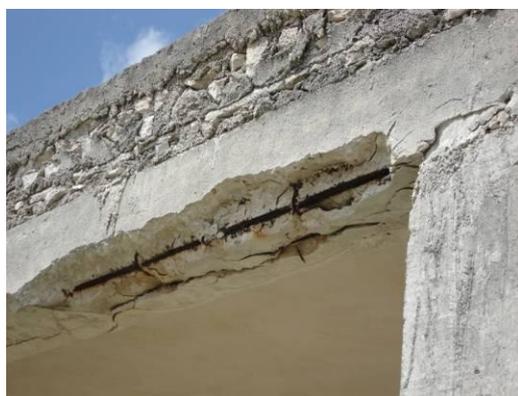
Damage in beam, Dzilam Bravo (DB).

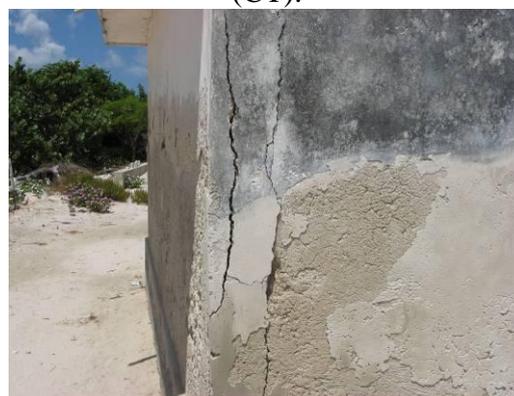
Damage in wall, Chabihau (CB).
