Evaluation of the Weld on In-service Gas Pipeline

The study evaluated the condition of steel gas pipeline at the site of weld after more than 45 years of service. The deformation cycle of welding and particularly superposition of the thermal and deformation cycle, results in phase transformation and precipitation processes in the thermally affected region. The deformation cycle has a pronounced effect on ageing of the welded joint and the associated increase in its hardness and reduction in notch toughness. The hardness of the weld was measured according to Vickers HV0.05. The highest values of hardness were measured for the weld metal, namely 293 HV0.05. The values of mechanical properties of steel after more than 45 years of service of the pipeline corresponded to values defined by the respective standard. Transition temperature T_T according to Charpy test was equal to -8.5 °C. From the point of view of technical practice, with regard to pipe service properties, it is important that the construction material is loaded at temperatures above the transition temperature T_T . Transcrystalline brittle failure was observed on the specimens that have been broken at T_T temperature.

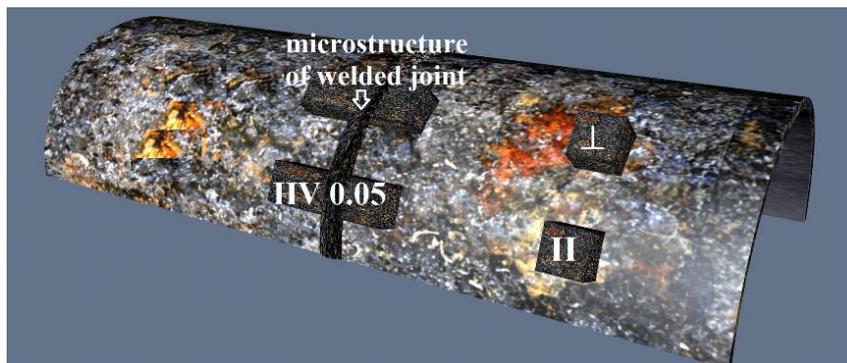
Figure 1. Sampling points

The weld on the steel P295 GH gas pipeline after more than 45 years in service was evaluated by means of a light microscope OLYMPUS VANOX-T. The metallographic analysis was used as a tool to help to identify uniform structure of steel pipeline. The sampling points are illustrated in Figure 1. The strength properties and plasticity of the steel gas pipeline were evaluated by means of a tensile test according to EN ISO 6892-1 at ambient temperature $T = 20 \pm 3 \text{ }^\circ\text{C}$, employing a tensile test machine ZWICK 1387 at loading $0 \div 200 \text{ kN}$ and speed $1 \text{ mm}\cdot\text{min}^{-1}$ [13]. Mechanical properties (yield point $R_{p0.2}$, tensile strength R_m and ductility A_5) of P295 GH steel were determined on circular section specimens of dimensions $d_0 = 5 \text{ mm}$ and $L_0 = 10 \text{ mm}$, removed from the gas pipe in a direction parallel to the longitudinal axis of the pipe, and in direction transversal to the pipe axis. Microhardness
