Flow Assisted Corrosion of API 5L X-70 in Sour Brine induced by Pipe Flow Changes in a Jet Impingement Chamber

Keywords: Flow assisted corrosion, jet impingement, API 5L X-70 steel.

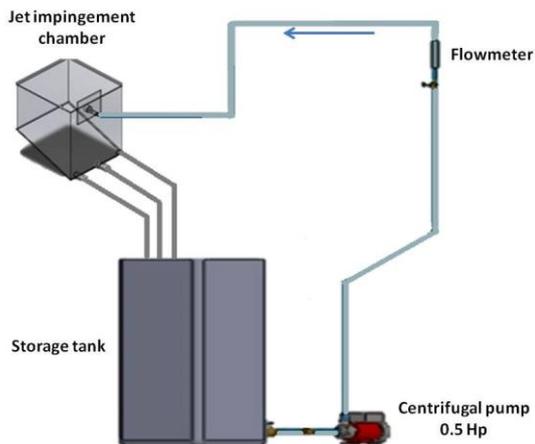
Figure 1. Schematic diagram of the experimental setup.

The experimental equipment used in this investigation is shown in Figure 1, it consists of a test chamber in clear acrylic 5 mm thick. This was made to recirculate a medium consisting of brine prepared according to the NACE standard 1D-196 [9], which was stored in a polyethylene tank with capacity of 100 L. Flow rate was controlled by the adjustment of a rotameter device. The impingement chamber exit consisted of three hoses, which are connected to assist the drain located in the middle of the tank. The equipment pieces used in the present research are shown in more detail below.

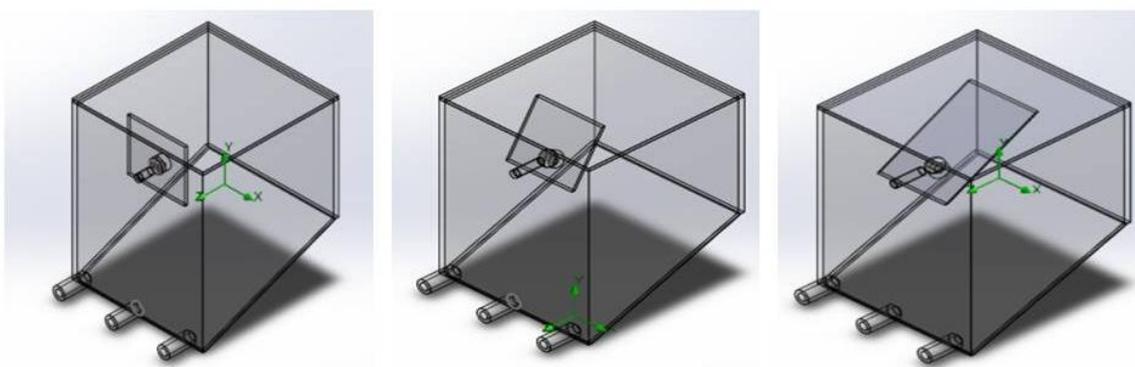
Figure 2. Geometry generated by Solidworks software for the 3 impingement angles on use.

To carry out the experiment, the geometry of the jet impingement chamber or strike plate chamber, was developed by using Solid Works software program (Fig. 2). The test chamber, whose design is shown in Figure 3, consisted of an empty space of 14-liter capacity with a tilted plate at the bottom for rapid fluid drainage.

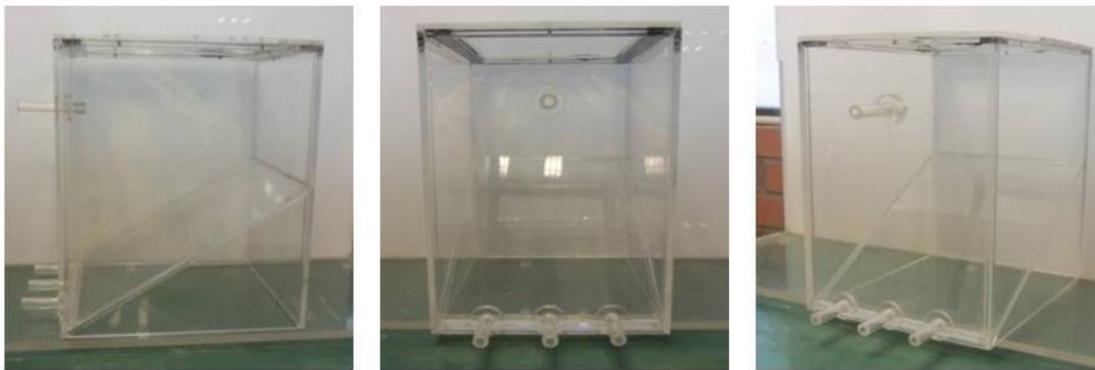
Figure 3. Test chamber in acrylic material.

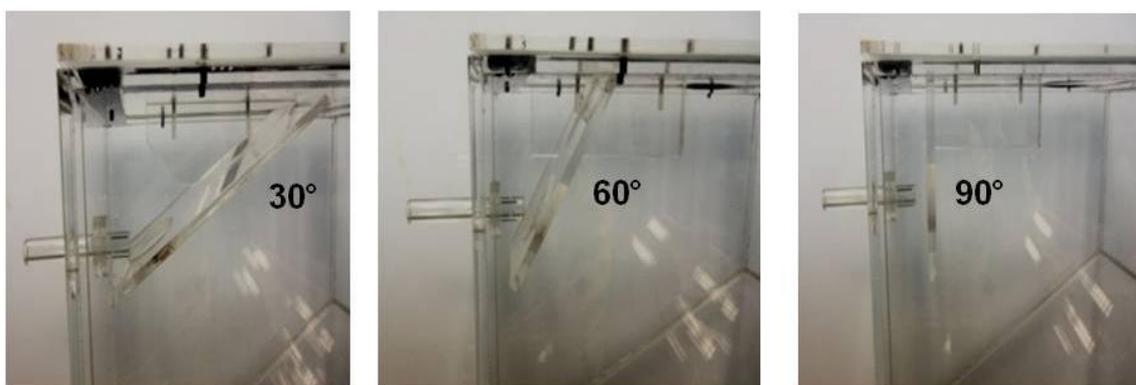
Figure 4 shows the inlet and outlet connections as well as the movable plate. It displays the assembly of the striking plate in the test chamber where metallic coupons were placed at impingement angles of 30° , 60° and 90° ; these were selected from evaluations carried out on short and long size elbows from fluid mechanics information. Fluid is fed opposite to the entrance and into the front plate at the middle section to be recirculated from the storage tank to the chamber and from there to the metallic coupon surfaces.

Figure 4. Shock plates positioned at different impingement angles of inclination (a) 30° , (b) 60° and (c) 90° .

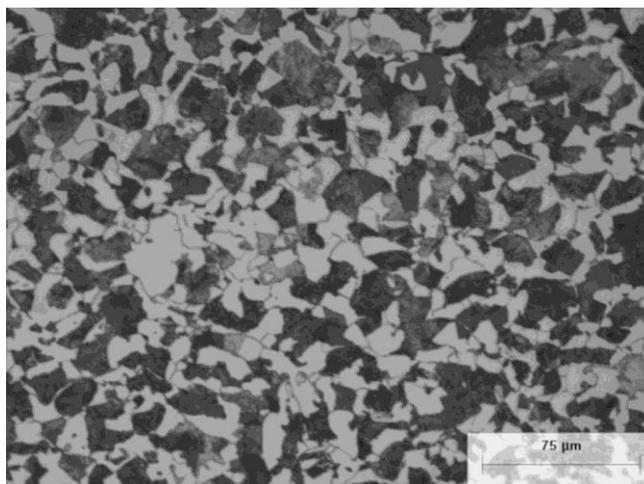
Microstructure of steel API 5L X-70 was developed by nital etching and it is shown in Figure 5; a dactillar pearlite (dark contrast) along with colonies distributed over a ferrite matrix (light contrast) is observed in a uniform distribution, which is in agreement with carbon steel microstructures obtained by others researchers [11-13].

Figure 5. Microstructure of API 5L X-70 steel etched in 5% nital (500X).

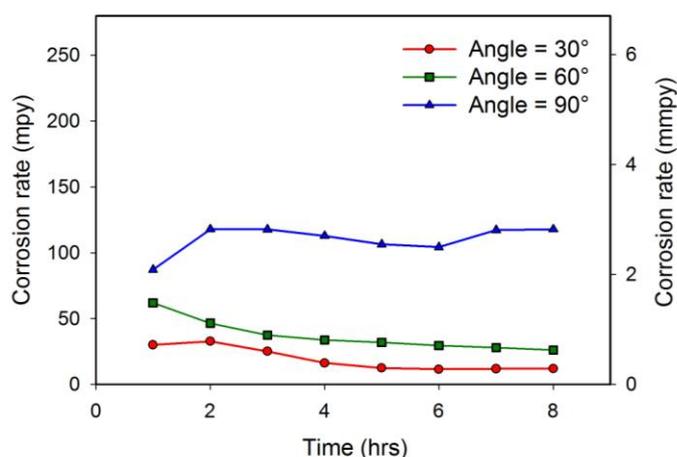
Figure 6. Corrosion rate time dependent after immersion of X-70 in sour brine with kerosene at a flow rate of 8 L/min for impingement angles of 30, 60 and 90°.

Figure 6 shows the corrosion rate as a function of time for the different angles used in this work. At 30° and 60°, the corrosion rate decreased with time though in the case of flow impingement at 90°, the corrosion rate increased above those for 30° and 60°. In the latter, the decrease in corrosion rate was attributed to the persistence of corrosion products, which is more likely because stress seems to be lower. In contrast, at 90° the increase in corrosion rate is derived from the detachment of corrosion products formed due to the flow assisted action in combination with a high impact angle (90°).

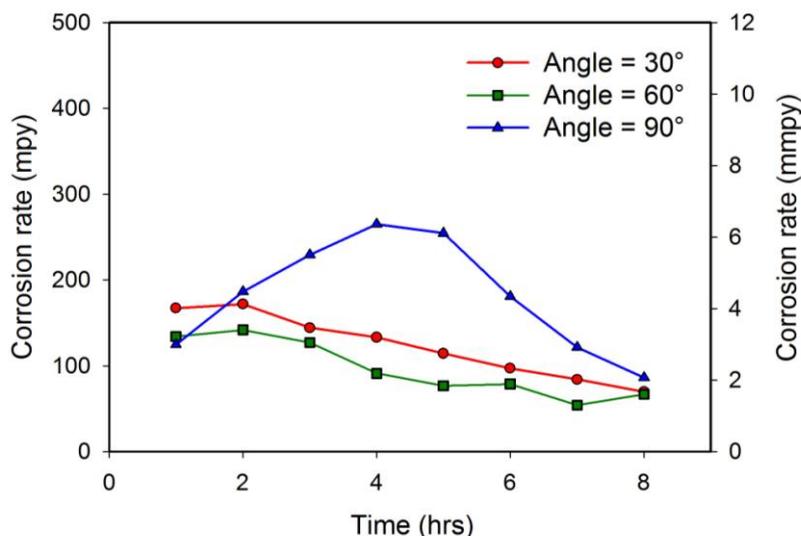
Figure 7. Corrosion rate time dependent after immersion of X-70 in sour brine with kerosene at a flow rate of 18 L/min for impingement angles of 30, 60 and 90°.

In Figure 7, the change in corrosion rate as a function of experimental time for a flow of 18 L/min (2.36 m/s) at 30°, 60° and 90° is observed. Corrosion rate tends to decrease as time is increased; the lowest corrosion rates occurred at an angle of 60°, apparently because the corrosion products formed may seem to be more stable and less soluble. On working at an angle of 90°, the corrosion rate shows a parabolic behavior; where a marked increment in corrosion rate is accompanied by its continuous decrease with time, this decay in corrosion rate was attributed to the continuous formation of corrosion products. At an angle of 90°, the highest initial and final corrosion rates are displayed with 8 L/min, while at 18 L/min only the highest final corrosion rate (Table 2); it appears that the normal stresses developed turns to be higher than those shear stresses formed at lower angles (60-30°), though this matter requires further experimental work. The final corrosion rates might show the apparent higher resistance of corrosion products formed at lower angles (60-30°) due to inherent crystalline phase compositions.

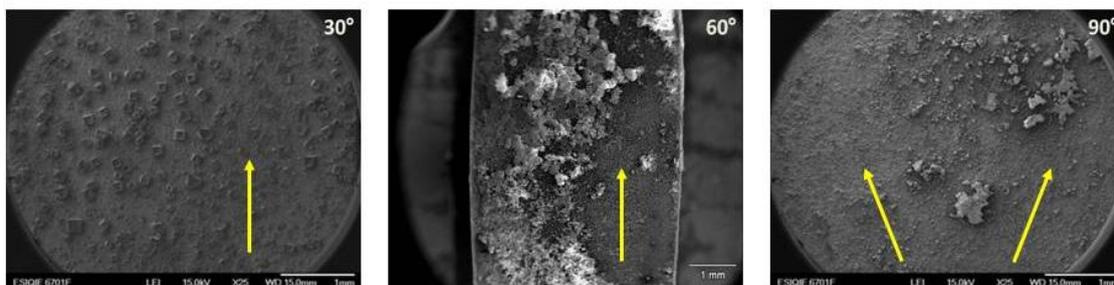
Figure 8. Micrographs of removal of corrosion products at the impingement angles indicated and a flow rate of 8 L/min.

Figure 8 shows the metallic surfaces after testing at the impingement angles indicated. The three surfaces displayed a partial removal of the corrosion products, which provided different patterns as a result of flow and contact angle; removal is presented in a lesser degree on the coupon surface of 30° although it increased as the angle did. The impact direction of flow is indicated by the yellow arrow in each image. The lower removal of corrosion products at 30° is attributed to the presence of NaCl crystals deposited on the surface that may act as a barrier to fluid motion [14], and also to the lower surface resistance to the fluid movement compared to higher inclinations (60, 90°).

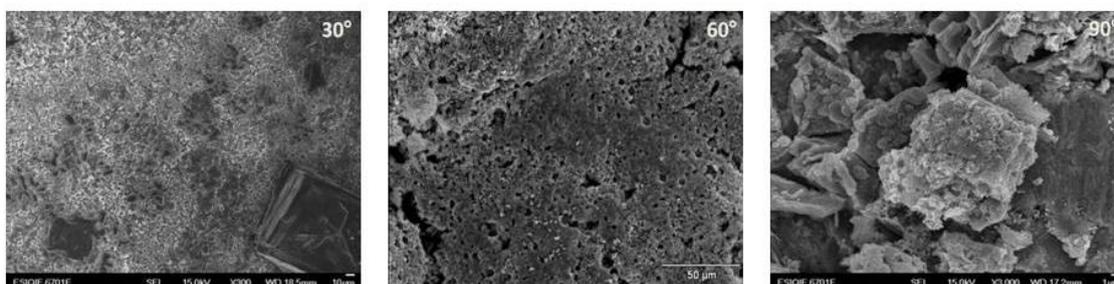
Figure 9. Micrographs of corrosion products deposited on the metallic coupons at the impingement angles indicated and a flow rate of 8 L/min

Figure 9 shows the corrosion products formed on testing, which can be classified as toothed type as it does have an angular shape. On the surfaces, it was observed a first layer called mackinawite and subsequently the growth of other layers consisting of a mixture of oxides and sulfides, and in some cases the presence of sulfate was observed. The relative higher content of corrosion products on the coupon placed at 90° and less on the coupon at 30° might be ascribed to the effect of flow resistance and aeration provided by flow turbulence; this fact may be consistent with the number of phases detected by XRD in Figure 13.

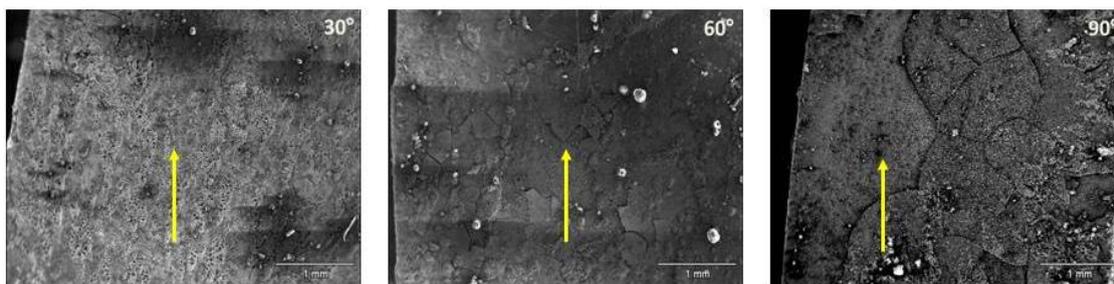
Figure 10. Micrographs of corrosion products deposited on the metallic coupons at the impingement angles indicated and a flow rate of 18 L/min

Figure 10 shows the surfaces of the coupons after conducting the test at a flow rate of 18 L/min (2.36 m/s). It is noticed that flow rate contributed to corrosion product removal and induced cracking in the precursor layer of the formed products. The degree of detachment increased with increasing the angle from 30 to 90°. The flow direction is indicated with arrows in yellow color.

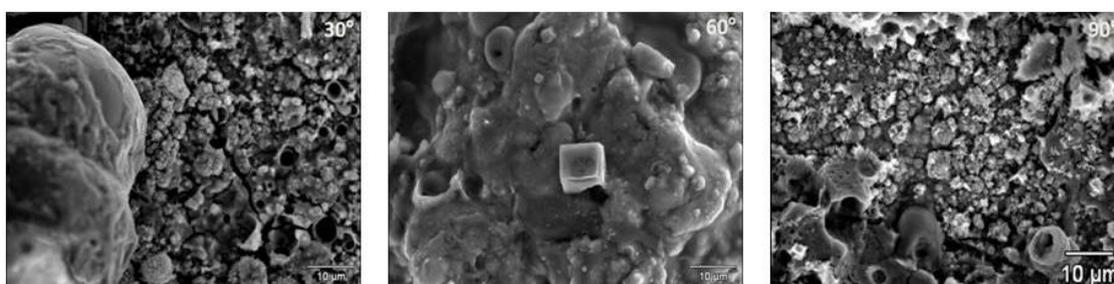
Figure 11. Micrographs of corrosion products deposited on the metallic coupons at the impingement angles indicated and a flow rate of 18 L/min

Corrosion products in Figure 11 are classified within the toothed type in a porous surface, which is more evident for coupons at 30° and 90°; while on the surface of the coupon placed at 60° a relative greater amount of deposits is observed. The corrosion products formed displayed an increase in the density of agglomerates as the impact angle was increased from 30 to 90°. In the three surfaces, the growth of corrosion products is observed to be developed in layers, this behavior can be better observed in the coupon at 90°. The removal of corrosion products is not only derived from the flow effect on surface but also from the nature of crystalline layers, which are more or less susceptible to cracking.

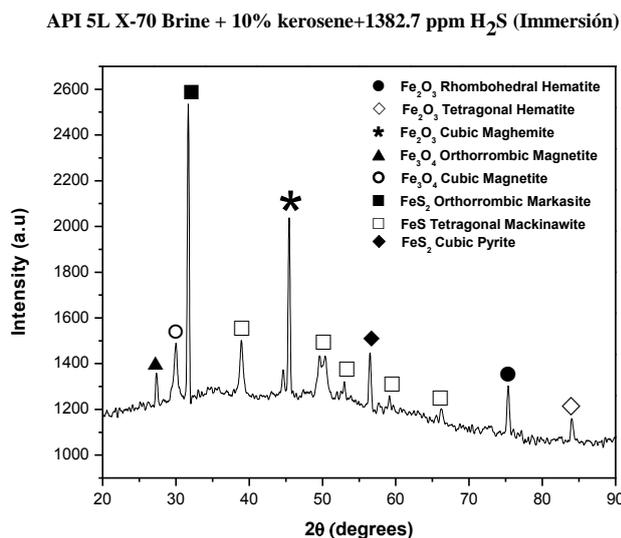
Figure 12. XRD analysis of corrosion products in API 5L X-70 after immersion tests for 24 hours in sour brine.

Figure 12 shows the diffraction pattern in static condition with the feature that sulfides predominated over oxides. The presence of mackinawite (FeS) as a base precursor [15] and the growth of layers of corrosion products is observed. Layers consisted of rhombohedral hematite (Fe₂O₃), tetragonal hematite (Fe₂O₃), cubic maghemite (γ-Fe₂O₃), orthorhombic magnetite (Fe₃O₄), cubic magnetite (Fe₃O₄), orthorhombic marcasite (FeS₂) and cubic pyrite (FeS₂). These products are equivalent to the iron sulfides reported by Ning *et al.* [15], where it is emphasized the importance of polymorphism of crystalline phases on film mechanical properties, which coincided with the identification made by Cervantes *et al.* [16].

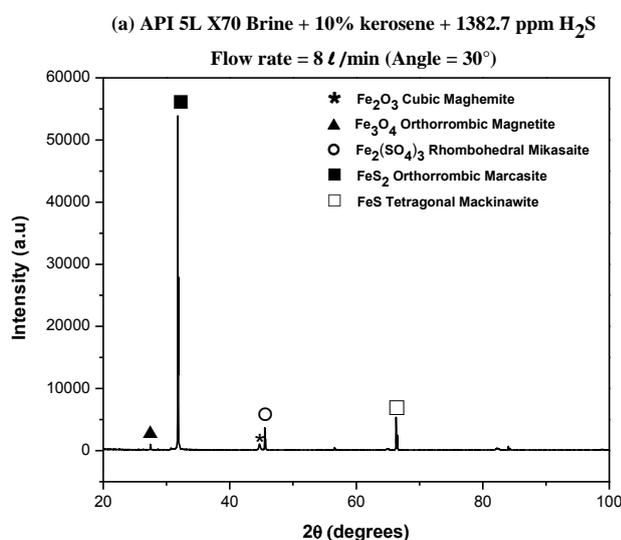
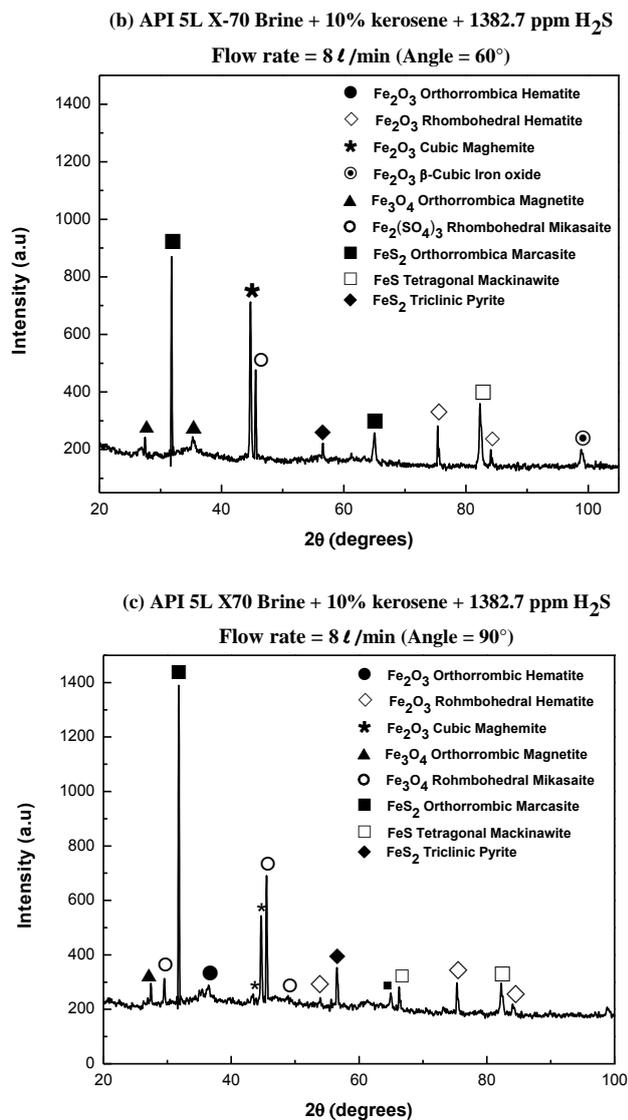
Figure 13. X-ray diffraction analysis (XRD) of corrosion products in API 5L X-70 steel surface in sour brine (a) 30°, (b) 60° and (c) 90° and flow rate of 8 L/min.

Figure 13 shows the diffraction patterns obtained for the coupons under the test conditions at a flow rate of 8 L/min (1.05 m/s) at 30, 60 and 90°, respectively. The phases presented for the three angles are tetragonal mackinawite (FeS), orthorrombic magnetite (Fe₃O₄), cubic maghemite (Fe₂O₃), orthorrombic marcasite (FeS₂) and iron sulfate, known as rhombohedral mikasaite (Fe₂ (SO₄)₃). Qualitatively sulfides predominated over oxides for the three-impingement angles; with the additional feature, that triclinic pyrite (FeS₂) is observed at 60° and 90°. Orthorrombic marcasite (FeS₂) was the predominant phase appearing on the surfaces subjected to the three impingement angles. This face appeared where the corrosion products grew and it is assumed that aided in the mitigation of corrosion [17].

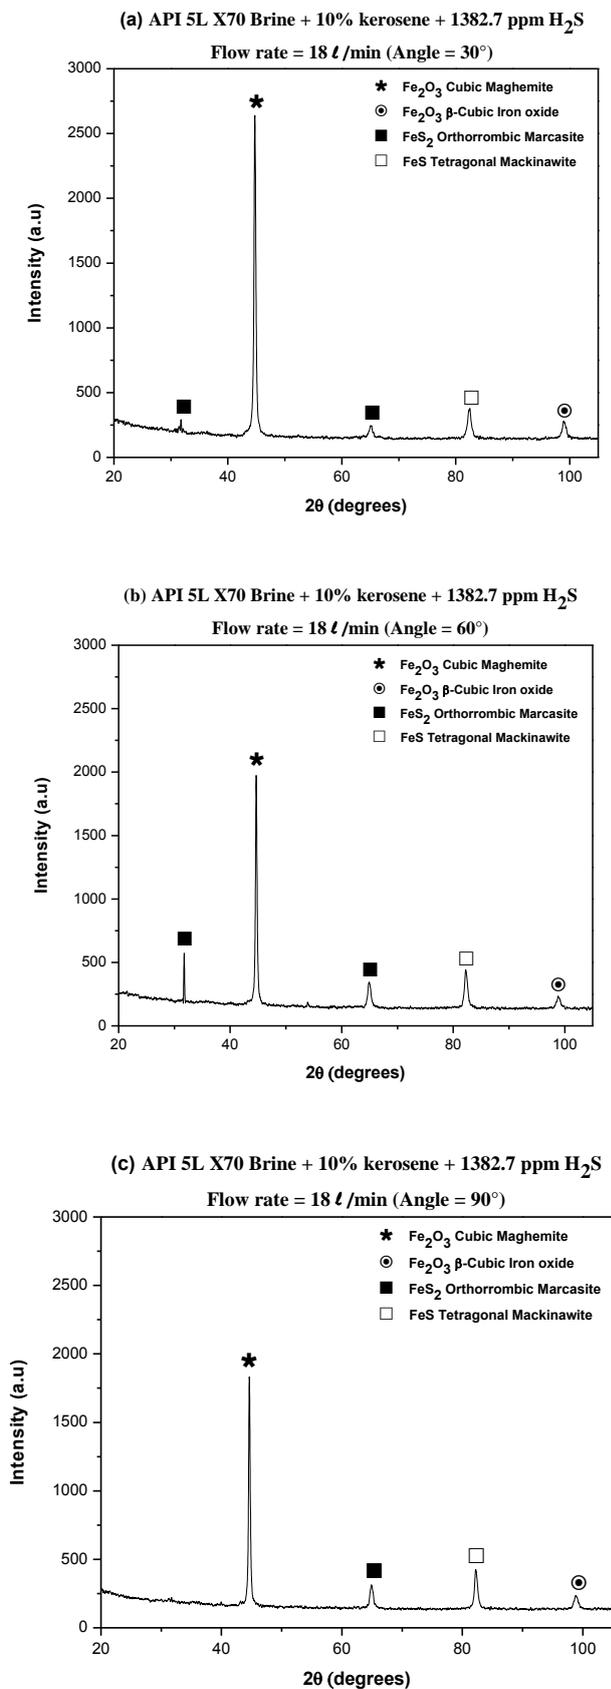
Figure 14. X-ray diffraction analysis (XRD) of corrosion products in API 5L X-70 steel surface in sour brine at (a) 30°, (b) 60° and (c) 90° and a flow rate of 18 L/min.

The phases that appeared in the diffraction patterns at a flow rate of 18 L/min are basically the same for the three angles of impingement: tetragonal mackinawite (FeS), cubic maghemite (Fe₂O₃), orthorhombic marcasite (FeS₂) and β -cubic iron oxide (Fe₂O₃). The presence of marcasite might explain the low corrosion rates at the angles of inclination of 30°-90°, as it is known as a stable corrosion product that contributed to decrease corrosion rate because the adherence of crystal lattice on steel surface [17]. The cubic maghemite shows a decrease in its peak as the angle increased, just as it did the iron oxide-cubic β , while marcasite displayed two peaks (30°, 60°) but only one at 90°. In this case, the corrosion products formed are the same, with the feature that now oxides predominated over sulfides; it appears that the high flow rate allowed only the formation of a lower number of phases though of high stability as fluid rate did not provide sufficient time for chemical reaction to occur.
