# Corrosion Behavior of Hot-dip Galvanized Advanced High Strength Steel Sheet in a Simulated Marine Atmospheric Environment

This paper describes a study of the corrosion behavior and mechanism of 1000MPa grade hot-dip galvanized steel in a simulated marine atmospheric environment with neutral salt spray tests at different times. Subsequent weight loss measurements, electrochemical measurements, confocal scanning laser microscopy (CSLM), scanning electron microscopy (SEM) coupled with energy dispersive spectroscopy (EDS) and X-ray diffraction (XRD) were used. The results demonstrated that with neutral salt spray (NSS) time elapsing, the corrosion appearance evolved from pitting corrosion to severe uniform corrosion. At the initial time, flocculent corrosion products were predominant and were mainly made up of Zn(OH)<sub>2</sub> and ZnO. Then, the corrosion products became compact, and at this period, the corrosion rate was at a lower level, indicating that the compact products prevented the diffusion of reactive ions and were protective for the matrix. Cl<sup>-</sup> could combine with the zinc oxides and accelerate the dissolution of the protective products; ZnCl<sub>2</sub> and Z

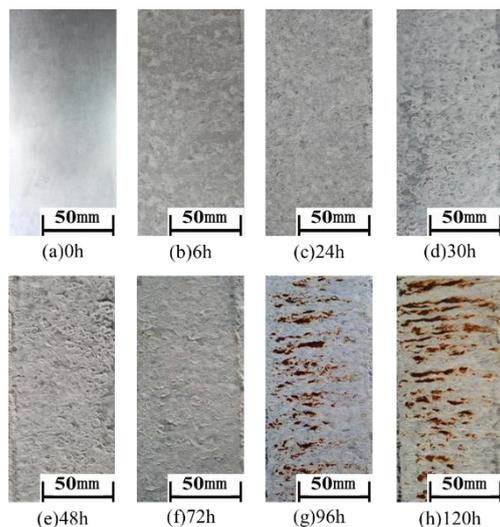
Fig. 1 shows the macro-corrosion morphology of the specimens after NSS and after various times. Before salt spray, the surface of the specimen is intact and bright. After 6h of NSS, the zinc coating is slightly corroded; some white spots develop, and the metallic luster disappears. With time passing, the degree of corrosion becomes increasingly more severe. Particularly, white corrosion products cover almost the whole surface at 48h and 72h, demonstrating uniform corrosion of the zinc coating. Red rust

can be observed at 96h, where zinc failed to protect the matrix from corrosion. At 120h, the entire matrix is exposed and heavily corroded.

**Figure 1.** Macro-corrosion morphology of the specimens after NSS and after various times (a) 0h; (b) 6h; (c) 24h; (d) 30h; (e) 48h; (f) 72h; (g) 96h; (h) 120h.

Fig. 7 shows the morphology and element distribution of the corrosion products of galvanized steel after NSS. Before NSS, the surface is intact, with few coating defects and no corrosion products; Zn is evenly distributed. After 6h NSS, flocculent and loose corrosion products are created and are verified to be zinc oxides by EDS mapping. When the NSS time reaches 24h, masses of corrosion products appear, where Cl is enriched and O is depleted. According to Ohtsuka [29], the destructive effect of Cl<sup>-</sup> on zinc oxides causes less severe flocculent corrosion products. In the first 30h, the corrosion products are loose and not protective, accounting for the increase in corrosion rate in Fig. 2. At 48h, compact corrosion products such as plate strips form and are adherent to clusters on the surface or within the crevice; O and Zn are distributed uniformly, and no Fe is detected. The compact corrosion products prevent the attack of corrosive media and lead to the plateau of the corrosion rate. With the time elapsing, the zinc coating is continuously destroyed, clusters gradually diminish, and the plate strips are pitted with cracks and subsidence holes. Especially at 96h, clusters are rare; the remaining corrosion products are further corroded and exert a gap-shape, in which a large amount of Cl is detected. It can be inferred that the damage of the plate strips is related to Cl<sup>-</sup>. At 120h, the existence of Fe demonstrates the comprehensive damage of the zinc coating and the corrosion of the matrix. The transformation of the corrosion products corresponds with the variation in macro morphology (Fig. 1), corrosion rate (Fig. 2) and electrochemical curves.

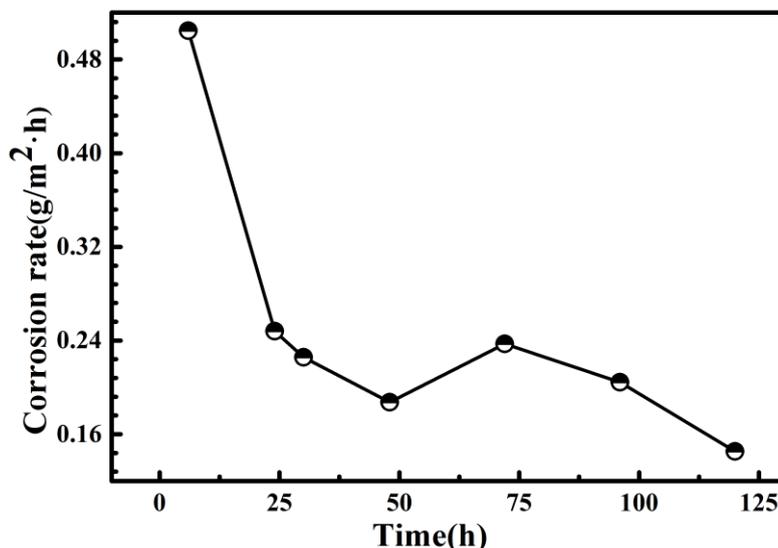
**Figure 2.** Corrosion rate of the specimens during NSS after various times.

Fig. 2 illustrates the corrosion rate of the specimens during NSS after various times, showing first an increase and then a decrease. Combined with the corrosion morphology, at the first 30h, zinc is corroded at a high corrosion rate due to the direct contact between the zinc coatings and the corrosive medium, and as time passes, the degree of corrosion of the zinc coating becomes increasingly greater. This stage is called the initial corrosion stage of galvanized steel reported in the literature [26]. At 48h, compact and protective corrosion products form, in which the corrosion rate is the lowest; at 72h, there is a minor increase in the corrosion rate, which may be attributed to the consumption of the protective corrosion products. Then, the matrix begins to be exposed, the corrosion rate of which is lower and may account for the subsequent descending curve. The variation in the corrosion rate is considered to be

related to the types of corrosion products, especially the compactness and adhesive property [27], which is discussed further in 3.3.

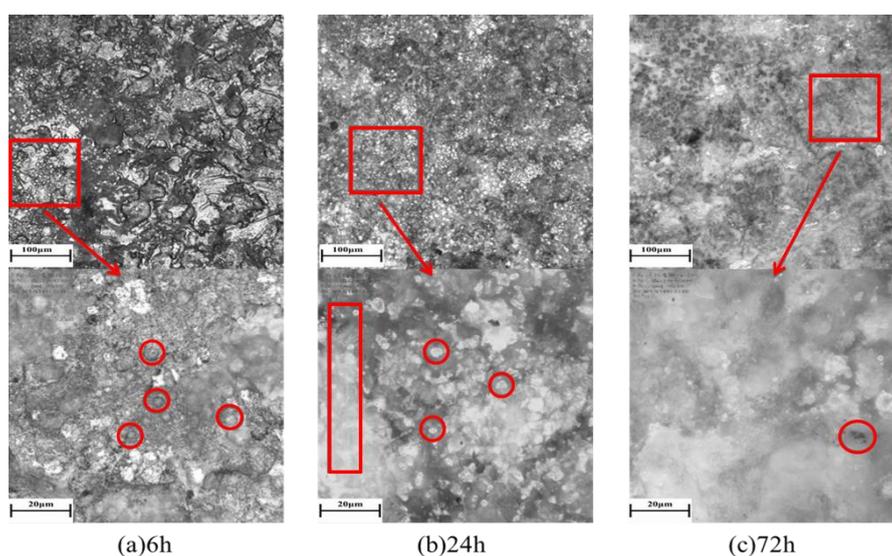
For assessing the corrosion form, the specimens for NSS tests after rust removal were observed with CSLM (Fig. 3), which illustrates the initiation and development of corrosion with NSS time passing. In the initial period, the zinc coating is corroded, and the corrosion appearance is mainly pitting corrosion with the pit diameter ranging from 1.5 $\mu$ m to 2.5 $\mu$ m. With the passage of time, the pits multiply rapidly and grow in depth instead of in the radial direction, and this outcome is in agreement with results reported in the literature [27]; the pits gradually become confluent and eventually transform to present severe uniform corrosion.

**Figure 3.** Corrosion morphology of galvanized steel after rust removal (a) 6h; (b) 24h; (c) 72h.

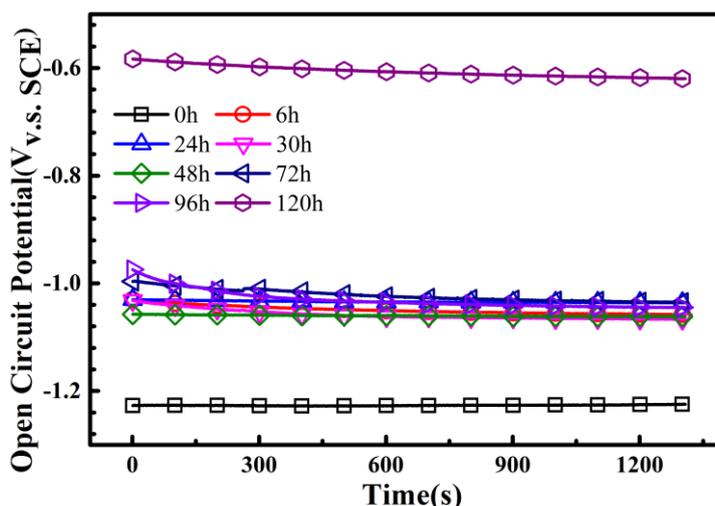
**Figure 4.** OCP of galvanized steel after the NSS test and after various times.

Fig. 4 shows the OCP of galvanized steel after NSS testing over a range of various times. The results show that after salt spray, the OCP shifted positively and significantly; this outcome is attributed to the damage of the zinc coating and thus the galvanic corrosion between zinc and the steel matrix. In addition, the OCP varies slightly (approximately -1.05V) in the first 96h and then exerts an obvious positive shift to approximately -0.6V after 120h NSS, reaching the corrosion potential of steel materials in 3.5% NaCl solution. Therefore, it can be inferred that most of the zinc coating is totally destroyed, and the exposed steel matrix suffers from severe chloride-induced corrosion, which corresponds well with the corrosion morphology observation and can be verified with the XRD results.

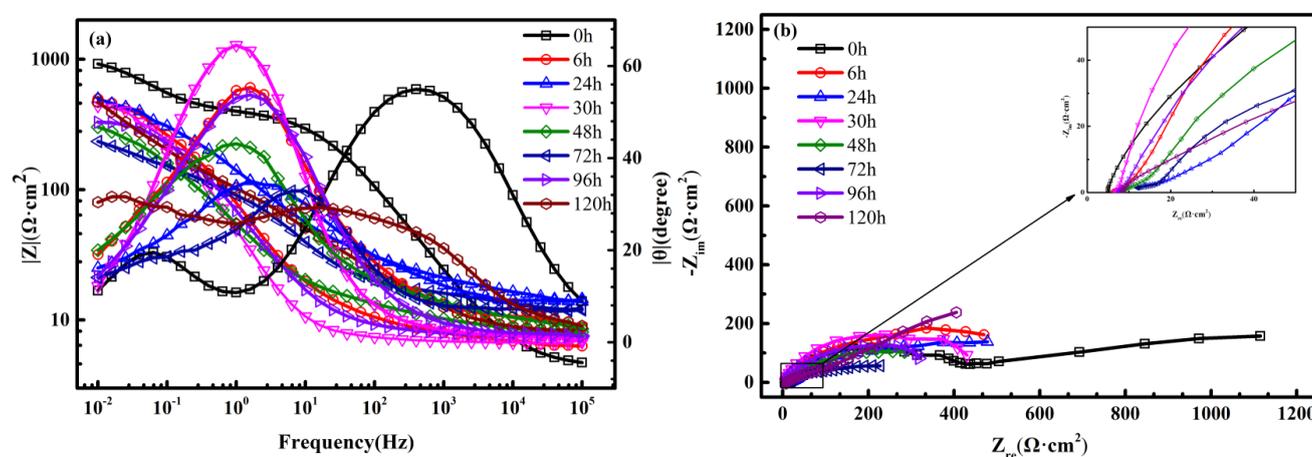
As is known, the EIS technique has been extensively used to characterize surface coatings in a semiquantitative way [4,28]. The EIS diagrams of galvanized steel are displayed in Fig. 5. It can be seen that the EIS diagram demonstrates characteristics of two time constants. It can be inferred that a complicated mass transport mechanism participates in the corrosion process [7]. In the EIS diagram, the high-frequency part is related to charge transfer, associated with the effect of an electric double-layer, while the low-frequency part characterizes a finite thickness diffusion process, mainly depending on the properties of the corrosion products. After the first 30h, the corrosion process was controlled by the active dissolution of zinc, while at 48-72h, the emergence of the diffusive tail at low frequency indicates the mixed control of diffusion and active dissolution. Finally, at 96-120h, the corrosion process is controlled by the active dissolution of the matrix. Combined with the macro-corrosion morphology in 3.1, it can be inferred that at 48-72h, the intact corrosion products of zinc prevented the diffusion of reactive ions; while at 96-120h, the matrix was exposed and corroded. Similar results also appear in Liu’s work [28], demonstrating that with the passage of immersion time, the low-frequency arc in the Nyquist diagram shrinks; this shrinkage results from the complete blockage of the pores in the outer coarse layer by the accumulation of the corrosion products. Further, as immersion time increases, the maximum phase angle at high frequency increases, indicating that the corrosion products become more compact.

Figure 5. EIS diagram of galvanized steel after the NSS test after various times: (a) Bode; (b) Nyquist.

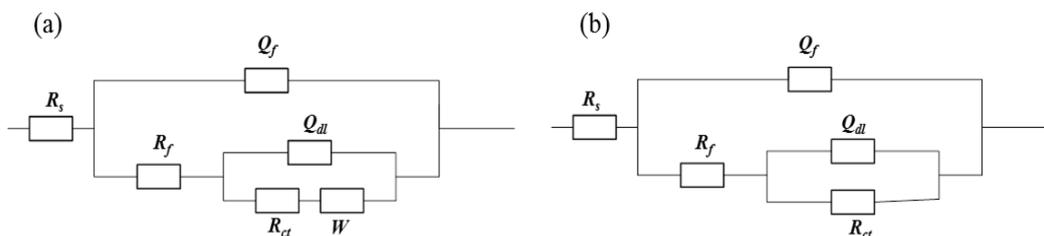
The software of ZSimpWin was used to fit the EIS plots, and two models of  $R_s(Q_f(R_f(Q_{dl}R_{ct})))$  and  $R_s(Q_f(R_f(Q_{dl}(R_{ct}W))))$  were applied to analyze the variation in corrosion progress, as shown in Fig. 6. The fitted values are shown in Table 3.

**Figure 6.** Equivalent circuit diagram: (a)  $R_s(Q_f(R_f(Q_{dl}R_{ct})))$  model; (b)  $R_s(Q_f(R_f(Q_{dl}(R_{ct}W))))$  model.

$R_s$  is the solution resistance from the reference electrode to the working electrode;  $R_{ct}$  and  $Q_{dl}$  are the constant phase elements (CPE) of the charge transfer resistance and the angle element of the electric double-layer capacitor between the solution and the matrix;  $R_f$  and  $Q_f$  stand for the resistance and CPE between the solution and the zinc coatings. A Warburg impedance,  $W$ , was used to fit the plateau of the phase angle at low frequency. In general, the capacitor of the electric double layer cannot be considered as the ideal capacitive element because of the roughness of the electrode surface, the impedance of which is always concerned with the angular frequency of the pumping signals and conveyed in the following form:

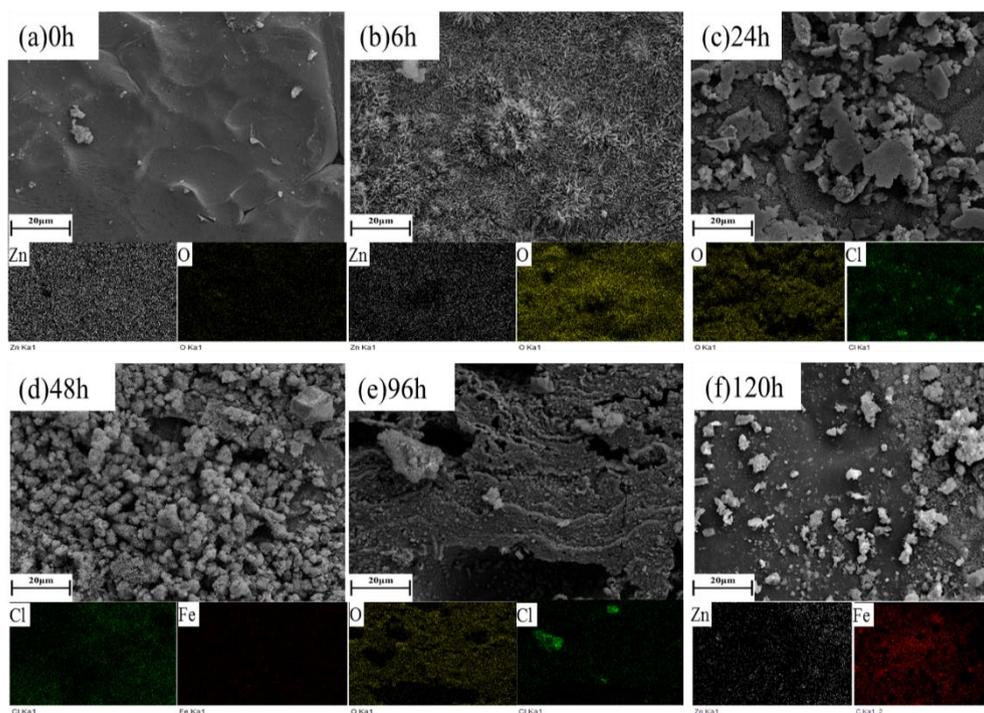
**Figure 7.** Corrosion morphology and element distribution of the corrosion products of the galvanized steel after NSS (a) 0h; (b) 6h; (c) 24h; (d) 48h; (e) 96h; (f) 120h.

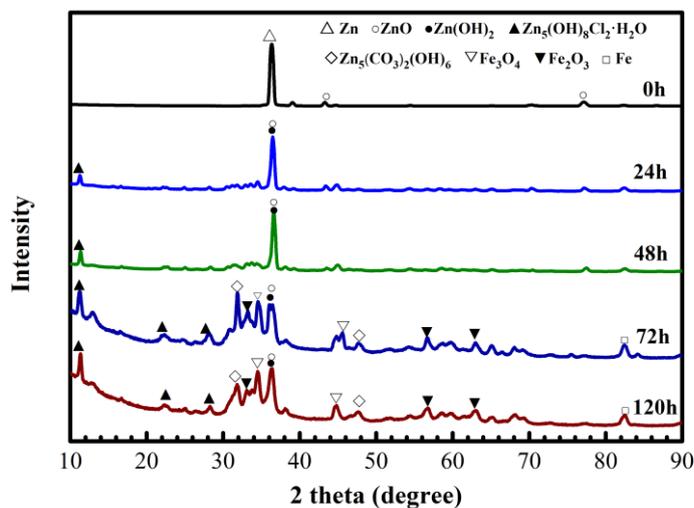
**Figure 8.** XRD diagram of the corrosion products of the galvanized steel after NSS.

For understanding the chemical composition of corrosion products, XRD analysis was conducted. From Fig. 8, at the initial NSS time, amorphous Zn(OH)<sub>2</sub> appears, transforms to β-Zn(OH)<sub>2</sub> and then changes into ZnO rapidly from dehydration. At 48h, Zn<sub>5</sub>(OH)<sub>8</sub>Cl<sub>2</sub>·H<sub>2</sub>O comes into being as a result of the combination of Cl<sup>-</sup> and zinc oxides; furthermore, Zn<sub>5</sub>(CO<sub>3</sub>)<sub>2</sub>(OH)<sub>6</sub> is observed. When NSS time reaches 120h, a substantial amount of Fe<sub>2</sub>O<sub>3</sub> is detected.

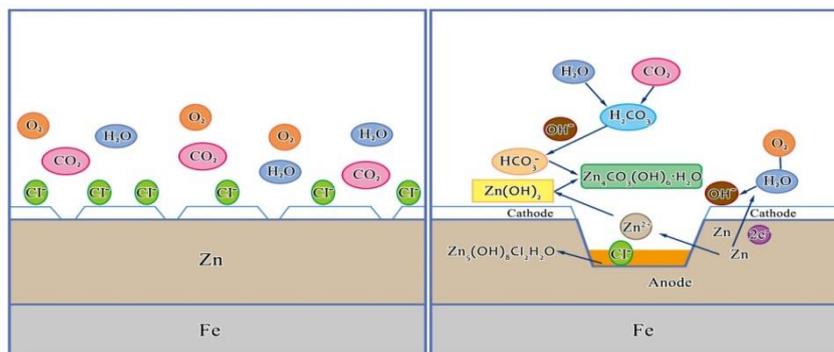
**Figure 9.** Schematic diagram of the corrosion mechanism of the specimens during NSS.

On the basis of Santos's work [10], the corrosion mechanism during NSS can be summarized in Fig. 9, and the chemical reactions are shown as follows:

At 48h and 72h, an increasing amount of Zn<sub>5</sub>(OH)<sub>8</sub>Cl<sub>2</sub> · H<sub>2</sub>O forms and accumulates in the bottom part of the pits, and it is considered to be able to repel aggressive ions and mitigate further corrosion processes [30].

Zinc hydroxide carbonate was detected after 72h immersion and was generally considered to be present in the outer layer of the corrosion products [31]. The formation of the carbonate was considered to depend on the absorption of atmospheric carbon dioxide into the surface electrolyte and the formation of carbonate and bicarbonate, as (8)~(10) shows [28]. The carbonate was quite porous and had a low

ability to hinder the transport of oxygen and water to the metal surface, facilitating further propagation of the localized corrosion attack.

Eventually, the zinc coating is consumed and cannot provide sacrificial anodic protection; the matrix is exposed and corroded, manifesting as red rust (at 120h):
