Electrochemical Behavior of Cast Iron in the Presence of Bacteria in Water Distribution Systems

Electrochemical behavior and corrosion of cast iron were investigated in the presence of sulfate-reducing bacteria and iron bacteria (SRB) and iron bacteria isolated from water distribution system using electrochemical techniques, scanning electron microscopy (SEM) and energy dispersive spectrometer (EDS) analysis. The results of corrosion potentials showed that corrosion occurred on the surface of specimens were decelerated by the presence of SRB and iron bacteria, SRB presented the higher corrosion rate than iron bacteria. SEM morphologies indicated that cast iron revealed no signs of pitting corrosion in sterile water whereas pitting holes were observed in other mediums. Passive films attached on the specimens that immersed in the combination of SRB and iron bacteria were maintained partly leading to a lower corrosion rate.

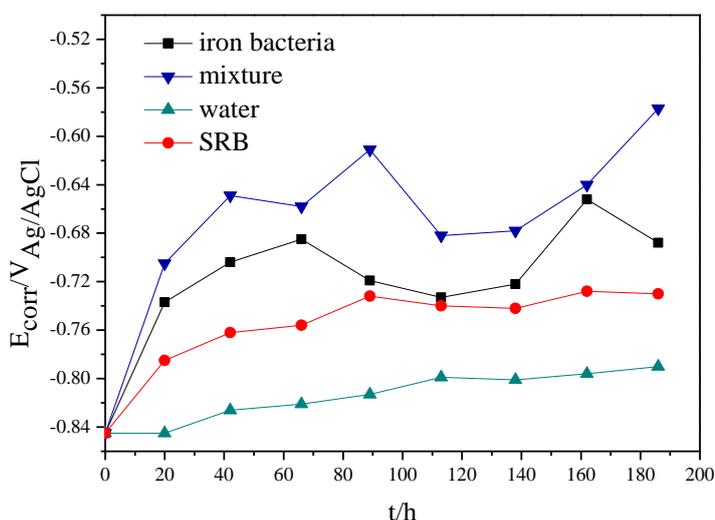
Figure 1. E_{corr} (vs Ag/AgCl)~t curves of samples immersed in different solutions.

Figure 1 shows the potential distributions with exposure time for cast iron coupons in sterile water, SRB, iron bacteria and the combination of SRB and iron bacteria. It indicates that the presence of SRB and iron bacteria influences the corrosion process occurred on the iron coupon surfaces. An iron electrode was activated by cathode reduction of the initial surface oxide showing an initial potential of -0.845V . No significant changes of E_{corr} are observed in sterile water and the curve gradually ascends. There was no obvious corrosion appeared on the electrode surface indicating the specimen was in a passive state in sterile water [24]. The corrosion potential increased gradually after exposure indicating the passivation of cast iron coupons [10]. E_{corr} of coupons immersed in iron

bacteria ranged from -0.785V to -0.728V whereas in SRB solutions, it varied between -0.733V and -0.652V versus Ag/AgCl. It demonstrated that iron bacteria produced the lowest corrosion rate since the metabolism of iron bacteria is low [25]. The potential drop was more pronounced in the presence of SRB indicating an activation of the initially passive films. In the later period, the activated specimen repassivated and passive films formed again so that E_{corr} shifted to positive direction [24]. The higher corrosion rate of SRB is attributable to the aggressive corrosion with iron specimens under anaerobic circumstance in which SRB are ubiquitous in water distribution system, and they generate hydrogen sulfide which can react with iron coupons [26]. In solutions with SRB and iron bacteria, corrosion potentials were distributed above the other curves indicating the repassivation occurred more rapidly and the high stability of passive layers accounted for the higher potentials [10]. Moreover, potential decreases were observed in SRB medium and the combination of SRB and iron bacterial. The potential decrease is mainly attributed to the dissolution of nature oxide films. There are two factors influencing the variation of potential: the formation of biofilms and the dissolution of oxide films. The potential decrease when the forming rate of biofilms is faster than those of dissolving oxide films.

The corrosion process of cast iron in water distribution system was affected by the presence of SRB and iron bacteria, and SRB demonstrated the high corrosion rate than iron bacteria. At the beginning of the experiment, E_{corr} inclined clearly due to the formation of passive layer or biofilms. During the later period, E_{corr} dropped quickly ascribed to the biofilms or corrosion scales which were brushed off from the substrate. E_{corr} of the combination of SRB and iron bacteria was higher than that of SRB and iron bacteria indicating the corrosion of cast iron was decelerated due to the diversity of bacteria.

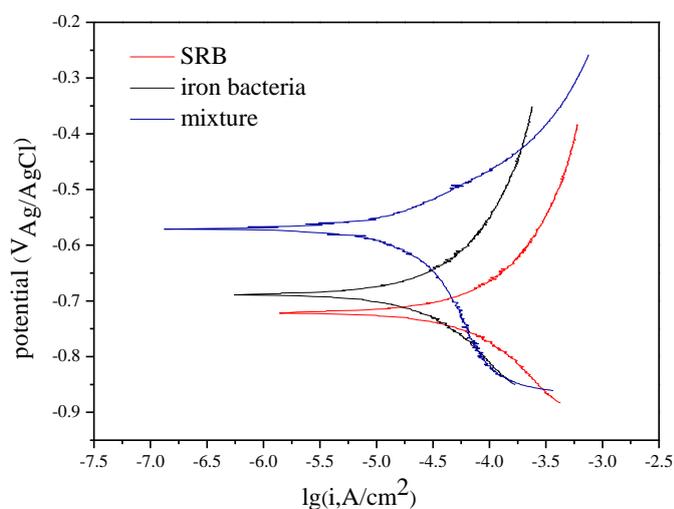
Figure 2. Potential dynamic curves for cast iron coupons in different mediums after 195h exposure.

Figure 2 shows the polarization curves of cast iron after exposure to different solutions for 195 h. It illustrates that the shapes of potentialdynamic polarization curve are not essentially different in three biological solutions indicating that the mechanisms of anode and cathode process are not modified in essential [22].

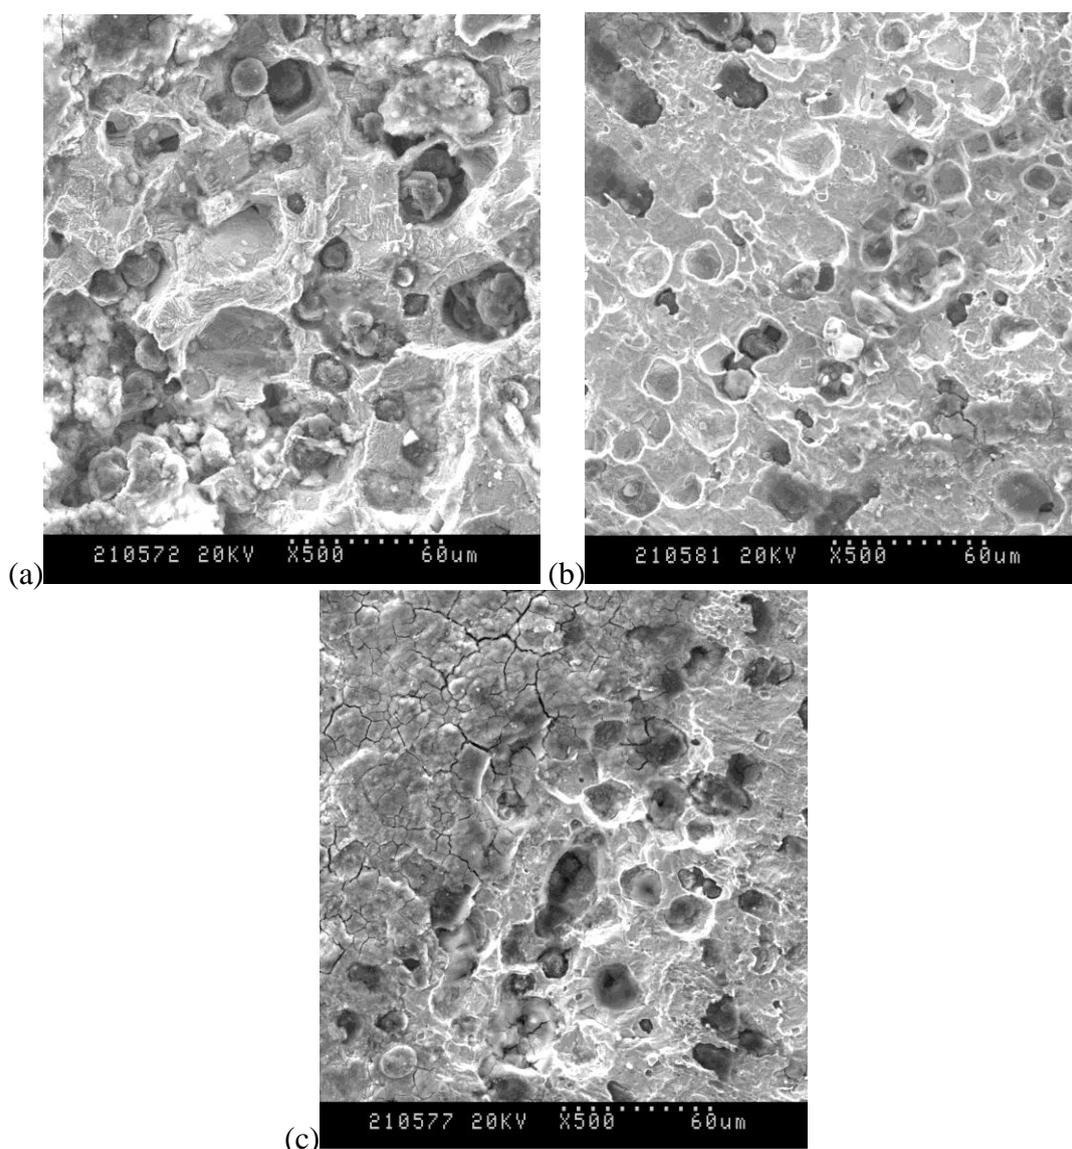
Figure 3 shows the micrograph appearance of cast iron samples after exposure to different solutions. SEM observation confirmed the formation of biofilms on the surface of coupons immersed in pure SRB solution. The biofilms formed in the medium of SRB were relatively loose and porous, with a pitting structure that was destructive in corrosion process. The deposits contained spongy and needle-shaped aggregates. Iron oxides can be dissolved reductively by biogenic hydrogen sulfide and iron sulfides consequently produced [8, 28]. EDS analysis (Figure 4) shows the higher concentration of sulfur (3.08 wt %) and iron (95.13 wt %). The proliferation and metabolism of SRB result in the generation of iron sulfide which has poor protective properties changing the thickness and density of passive layers [28]. After 7 days, the numerous annular damages showed up on the inner surface as sites of localized corrosion and became distributed over the whole surface indicating pitting initiated.

Figure 3. SEM images showing biofilms formed on cast iron surfaces after 170 h exposure, with the presence of SRB (a), iron bacteria (b) and the combination of SRB and iron bacteria (c).

In contrast, the pitting hole was not clearly observed after exposure to iron bacteria medium. The surface was covered with deposits which had a layered structure, EDS analysis indicated high concentration of iron (97.19 wt%) and there were small quantities of silicon, manganese and sulfur at 2.26, 0.31 and 0.10 wt% respectively. SEM revealed that the presence of floccules (ferric oxide) with a heterogeneous distribution of different compounds attached to cast iron surface. The upper layer of deposits contained spherical granules in which iron was the predominant species according to EDS analysis [23]. Small cracks were observed although pitting holes were not distinct. However, the initiation of cracks related to pits which resulted from discontinuities in the biofilm. The structure of biofilm was non-uniform, consisting of biological (e.g. iron bacteria) and non-biological substances (e.g. corrosion products). Electrochemical cells arising therefrom brought about pitting [13].

The morphologies of specimens indicated the formation of biofilms on working surfaces in the presence of microorganisms. Iron coupons revealed no signs of pitting attack in the sterile medium whereas micrometer-scale pitting corrosion appeared in biological solutions, but the protective layers partially remained when iron specimens were exposed to the combination of SRB and iron bacteria. In accordance with electrochemical results, in the presence of SRB, the highest corrosion rate was obtained, coupons immersed in SRB and iron bacteria combination showed the lowest corrosion rate.

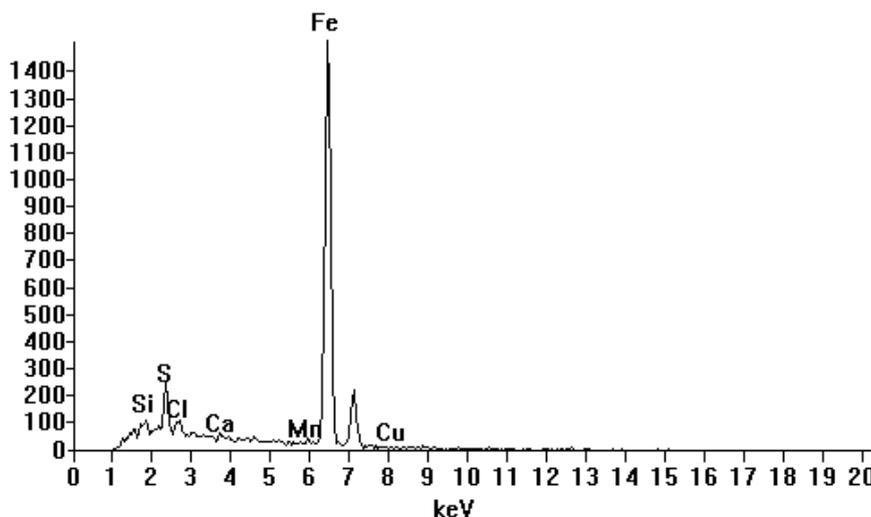
(a)

Figure 4. EDS spectrums of biofilms formed on cast iron surfaces after 170 h exposure, with the presence of SRB (a), iron bacteria (b) and the combination of SRB and iron bacteria (c).
