Investigations on Corrosion Behaviour of Welded Joint in ASTM A355P5 Alloy Steel Pipe

In this paper an investigation on corrosion behaviour of welded joints was performed to facilitate determination the causes of preferential degradation by corrosion of the welded metal (WM) and the heat affected zone (HAZ), in a welded pipeline of grade ASTM A355P5, used in a petrochemical plant as transfer line between a thermal cracking heater and a column which are part of an atmospheric distillation and vacuum (DAV) unit. Mechanical testing, structural and chemical analyses were performed and a heat treatment procedure was applied to reduce the corrosion of WM and HAZ. Besides classical tests and analyses, electrochemical tests were performed in order to study the influence of heat treatment on the welded joints. Measurements were carried out at the open-circuit potential (OCP) on specimens immersed in 3% NaCl solution to observe the change of potential and qualitatively appreciate the dissolution and/or creation of a protective layer on the component surface. It was found that the corrosion of the weld analyzed in this research has resulted due to its dendritic structure (pearlite, ferrite,

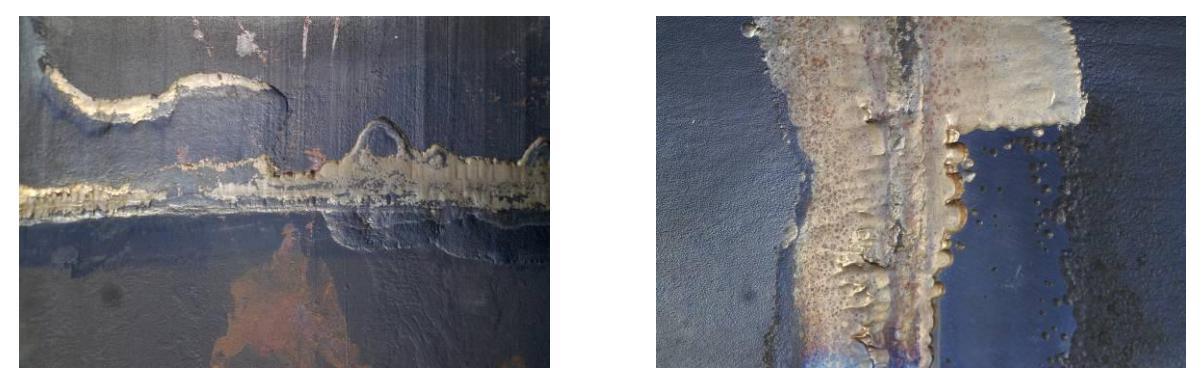
Figure 1. Samples for the experimental program, taken from desalinate oil transfer line between the heater H1 and the column C1.

The experimental study was performed on samples taken from the transfer line $\emptyset 508 \ge 15.09$ mm between the thermal cracking heater H1 and the column C1 of the DAV installation, which generates light products (gasoline, diesel or gas) by atmospheric and vacuum distillation of crude oil. A part of these pipeline welds were affected by preferential corrosion at the weld and HAZ. The pipeline is working under a temperature of 355 °C and pressure of 0.3 MPa and is made of feritic alloy-steel according to ASTM A355P5 - Standard Specification for Seamless Ferritic Alloy-Steel Pipe for High-Temperature Service. Two coupons were taken from the transfer line, each containing both a portion of pipe $\emptyset 508 \ge 15.09$ mm and a portion of the welded joint and a portion of an elbow 90R = 1.5D, $\emptyset 508 \ge 15.09$ mm, placed between the two welds, Figure 1.

a) Coupon containing a portion of the weld no.23b) Coupon containing a portion of the weld no.24 between elbow 90 R=1.5D, Ø508×15.09mm and between elbow 90 R=1.5D, Ø508×15.09mm and pipe Ø508×15.09mm pipe Ø508×15.09mm

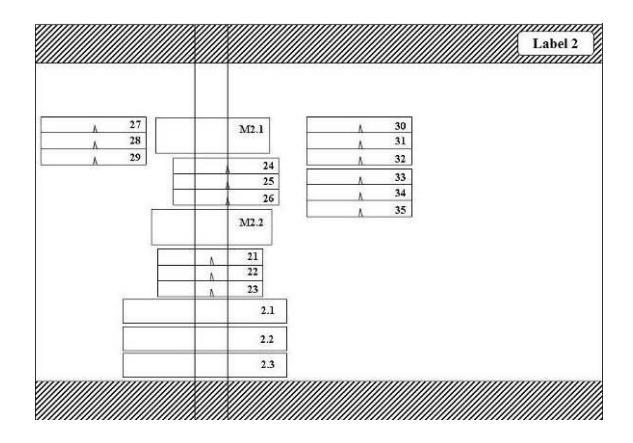
Figure 2. Sampling plan for the specimens.

An extensive experimental investigation has been carried out, including mechanical tests, macro and microstructural examinations, chemical and electrochemical analyses on the specimens extracted from the two coupons, according to the sampling plan presented in Figure 2.

a) Coupon containing a portion of the weld no.23 between elbow 90 R=1.5D, Ø508×15.09mm and pipe Ø508×15.09mm

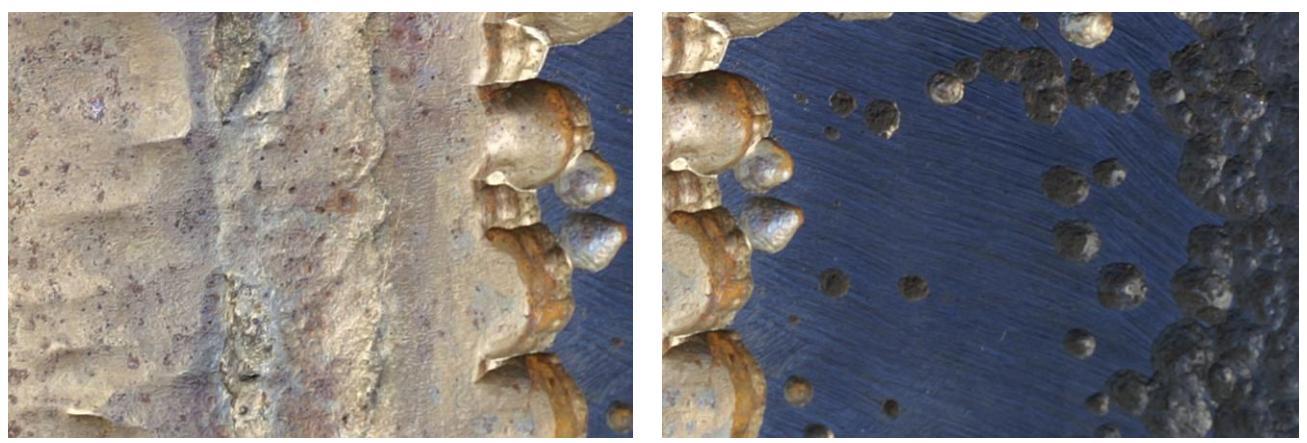
Figure 3. Macroscopic images of WELD no. 24 (inner surface).

The macroscopic analysis has revealed that the inner surface of the component is degraded by selective corrosion phenomenon localized to the welded joint and adjacent areas, Figure 3. The presence of active areas (areas with metallic gloss and colour change by corrosion products), and passivated areas (dark) has been found. It appears that degradation was initiated in the weld (Figure 3a) and has propagated to the BM of the two components. Also, in the BM, pitting degradation has been identified (Figure 3b).

a) Weld no.24 – WM and HAZ areas (detail)

b) Weld no.24 - HAZ and BM areas (detail)

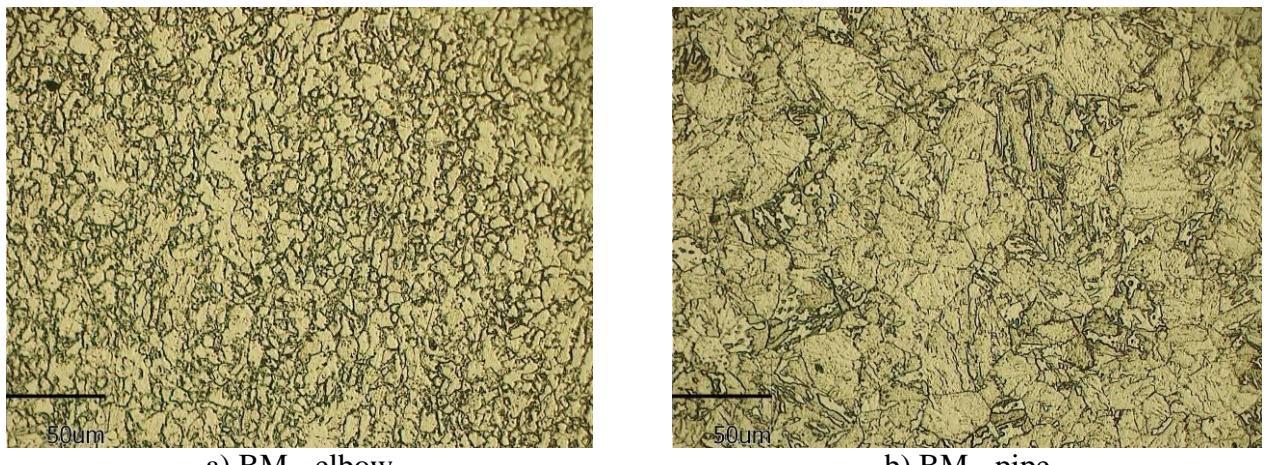
Figure 4. Microscopic images of pipeline's BM.

The elbow BM (Figure 4a) has a ferritic structure with punctiform complex carbides and non-metallic inclusions (oxides, silicates) with a grain size of 8-9. BM of the pipe (Figure 4b) has a ferritic structure with complex carbides with a grain size of 6-7.

a) BM - elbow

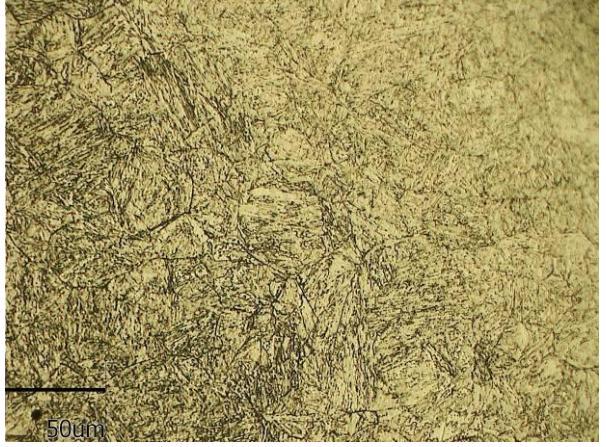
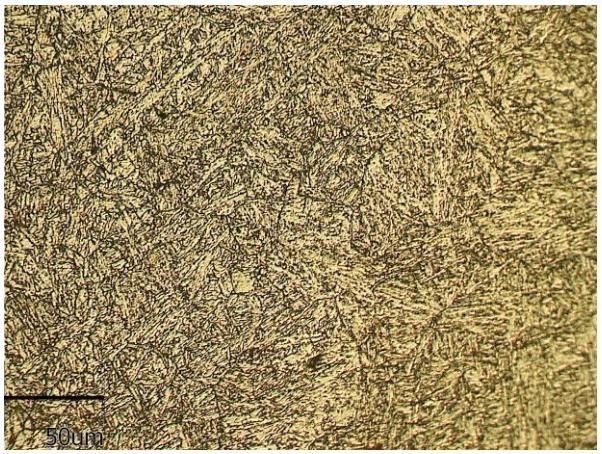
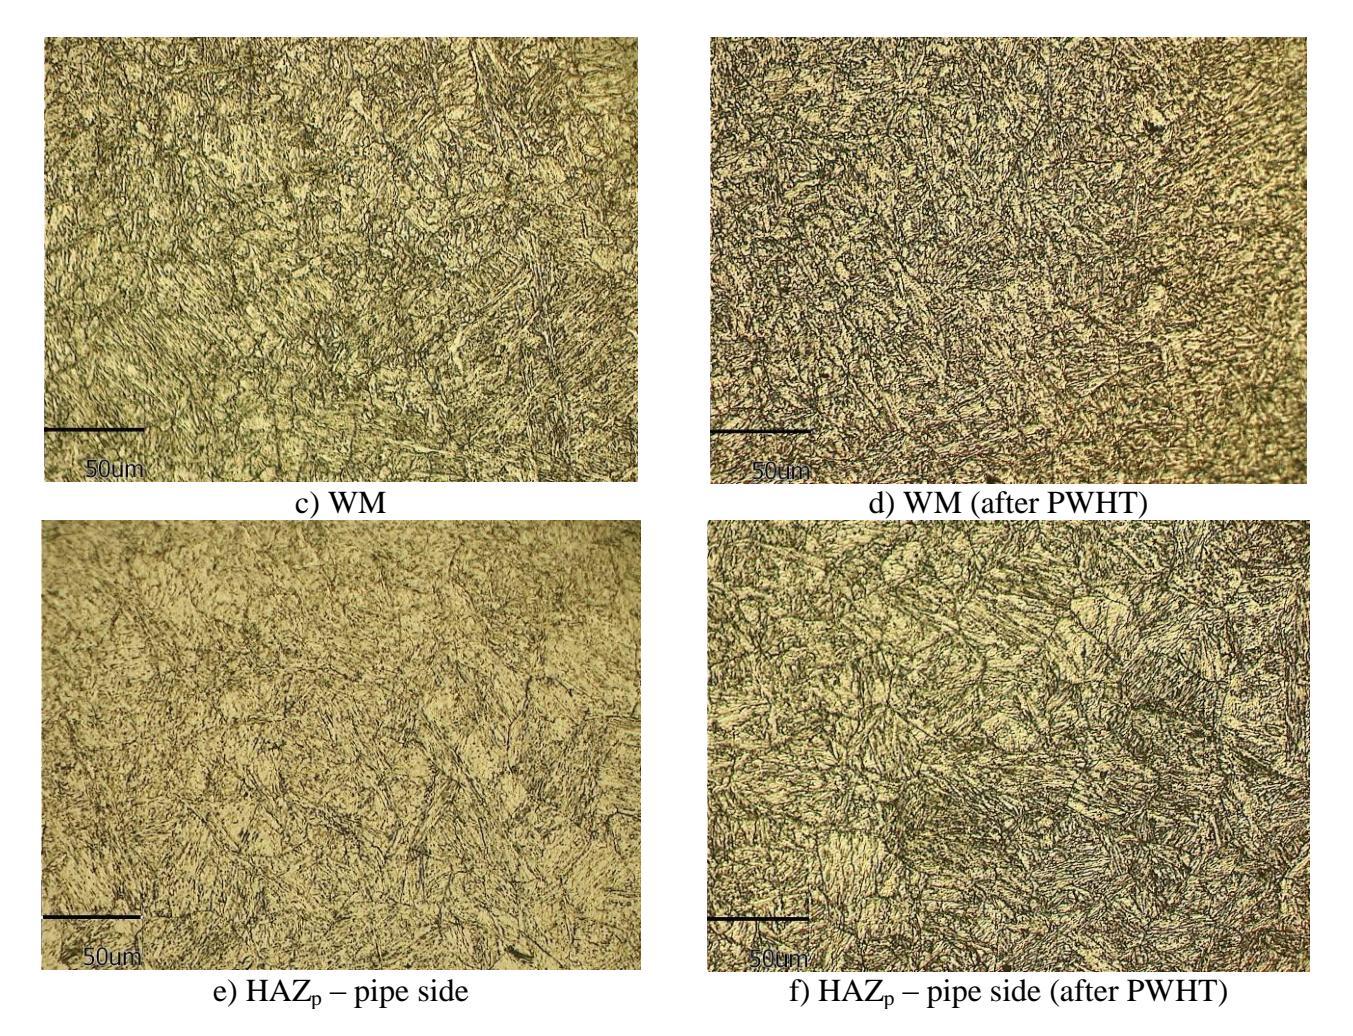
Figure 5. Influence of PWHT at the microstructural level. The indices "e" and "p" signify the elbow or pipe

Evidenced structures are normal for these materials. The microstructures of HAZ and WM zones from pipeline before and after PWHT are presented in Figures 5a -f. It was observed that the structures before PWHT are not homogenous and presents rough seeds with a rather fibrous morphology (Figures 5a, 5c and 5d).

Optical micrographs of HAZ elbow and side show pearlite-ferrite structures with complex carbide and localized areas of bainite and martensite. The micrographs of weld sample show a dendritic structure (pearlite, ferrite, complex carbide, bainite and martensite in localized areas) and revealed in the ferrite part the presence of uniform polygonal ferrite seeds and the formation of some globular carbide particles between the ferrite seeds. This could be connected with precipitation of chromium carbide during the thermal treatment and be a source of inter-granular corrosion. Because the Cr content in the sample was the same as in BM, the corrosion is rather a result of the lack of PWHT (or improper realization on site at the elbow replacement).

a) HAZ_e- elbow side

b) HAZ_e – elbow side (after PWHT)

In order to emphasize the influence of a correctly carried out PWHT, the sample was subjected to heat treatment by heating up to + 725 °C with 60 minutes holding and controlled cooling at a rate of 100 °C/h up to 300 °C, followed by a free cooling in air (Figure 6). After the PWHT more homogenous structures than those before heat treatment have been observed, with an island distribution of martensite in a ferrite matrix (Figure 5f). The HAZ_e and HAZ_p of the elbow and pipe side present a pearlite-ferritic structure, with sorbite areas, and the WM a fine dendritic structure (pearlite, ferrite and sorbite).

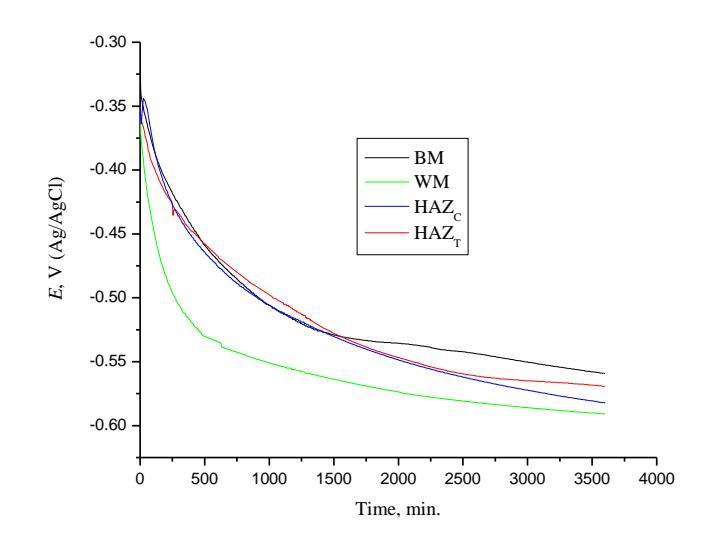
Figure 7. OCP curves for specimens recorded in 3.0% NaCl solution.

The changes of morphologies and mechanical properties induced by welding and heat treatment are reflected in the electrochemical behaviour of the specimens. Corrosion measurements can be used in evaluation of the quality of welding and to appreciate if the weld material and welding process guarantee a service without failures. The variation of OCP potential in time for the specimens immersed in 3% NaCl solution are presented in Figure 7.

The potential of pipelines specimens in chloride solution are shifted toward the negative direction in the first minutes of iron immersion. The potential shift is due to the dissolution of iron as aggressive chloride ions attack the surface. In time the corrosion products formed a layer on the surface and partially protected the iron from further attack.

As a consequence, in time the slight shift in the potential towards the less negative values appears. It was observed that the WM specimen showed a rapid negative shift in the first few minutes and the highest shifts of the potential toward the negative value comparatively with the BM, HAZ_e and HAZ_p specimens. This means that WM is more prone to chloride attach, due to modification of structure of the surface. Figure 8 shows Tafel polarization curves for pipeline specimens BM, WM, HAZ_e , and HAZ_p after 90 min immersion in 3.0 wt % NaCl solutions.

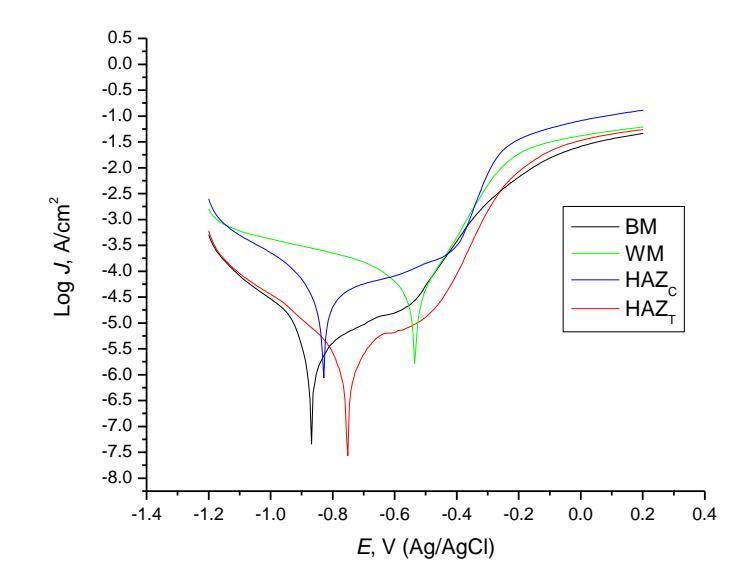
Figure 8. Polarization curves for pipeline samples BM, WM, HAZ_e and HAZ_p after 90 min immersion in 3.0 wt % NaCl solutions.

Parameters obtained from polarization curves presented in Figure 8 are shown in Table 4.

The values obtained for Ecorr and Jcorr indicate their dependence on the structural modification appeared due to the welding process. Post heat treatment improves mechanical properties but could decrease the corrosion resistance. It is reported for low carbon steel that iced-water reduce procedure generates a fine grained recrystallized structure and enhances the mechanical properties and on the other hand, corrosion resistance decreases [19]. All specimens present a pearlite-ferrite structure and the dissimilarity is a result of the difference in the microstructure (different spacing of the cementite lamellae-ferrite, content and size of ferritic phase). The corrosion potentials determined for BM, HAZ_p , WM are more appropriate to -0.860V (to base material), except the HAZ_e specimen which present a nobler corrosion potential of -0.523 V. The nobler corrosion potential value obtained for WM suggests that this zone is more prone to cover with a protective layer, comparatively with BM, HAZ_p and HAZ_e specimens due to the formation of martensitic phase. It is reported that due to the carbon content martensitic phase frequently shift the corrosion potential to a nobler value than the ferritic matrix [14, 20, 22]. Higher hardness obtained for WM and HAZ_e specimens is also a consequence of the formation of a martensite region. The presence of martensite in steel reduces the corrosion resistance as was observed for WM and HAZ_e specimens. The Jcorr determined from Tafel slope show higher corrosion current density for WM specimens and HAZe and lower corrosion current density HAZ_p and BM. The welding induced in the specimens WM and HAZ_e appropriate conditions to brittle fracture of the joint and is the reason for the higher Jcorr value obtained for these specimens. The WM shows a dendritic structure (pearlite, ferrite, complex carbide, bainite and martensite in localized areas) capable in an easier manner to incite an increase of the corrosion current density. The increase of corrosion current density is 16 times higher comparatively with BM. The pearlite-ferrite structure with complex carbide and localized areas of bainite and martensite observed for HAZe structure show a corrosion current 10 times higher comparatively with BM. Also, in case of WM and HAZe the obtained higher corrosion currents and reduced toughness characteristics are the result of residual stress appeared due to martensite transformation (less homogeneous microstructure); and due to the fine needles or lamellas interconnection path between the martensite and ferrite phases (active corrosion area). This significantly affects the ratio between the nobler and active phases responsible for corrosion. Similar observation was reported in the literature [14]. The cathodic β_c constant for BM,

HAZ_p are 0.076 and 0.094V/decade. HAZ_e and WM specimens present higher values and this is a result in variable degradation due to breakdown of the passivating film, behaviour characteristic for alloy materials indicating differential Redox reactions. For HAZ_e and WM the cathodic Tafel slopes (β_c) are found to be greater than those anodic Tafel slopes (β_a) and indicate an overall kinetics under cathodic control due to the increased currents on values of anodic part.

After PWHT, the HAZ_p specimen shows reduced local stress state and this is reflected in the value for Ecorr and Jcorr due to increasing in homogeneity of structure. In result, a decrease of Jcorr of HAZ_p with about 17 times lower comparatively with HAZ_e was obtained. Low value for corrosion rate Rcorr are found for HAZ_p and BM specimens.

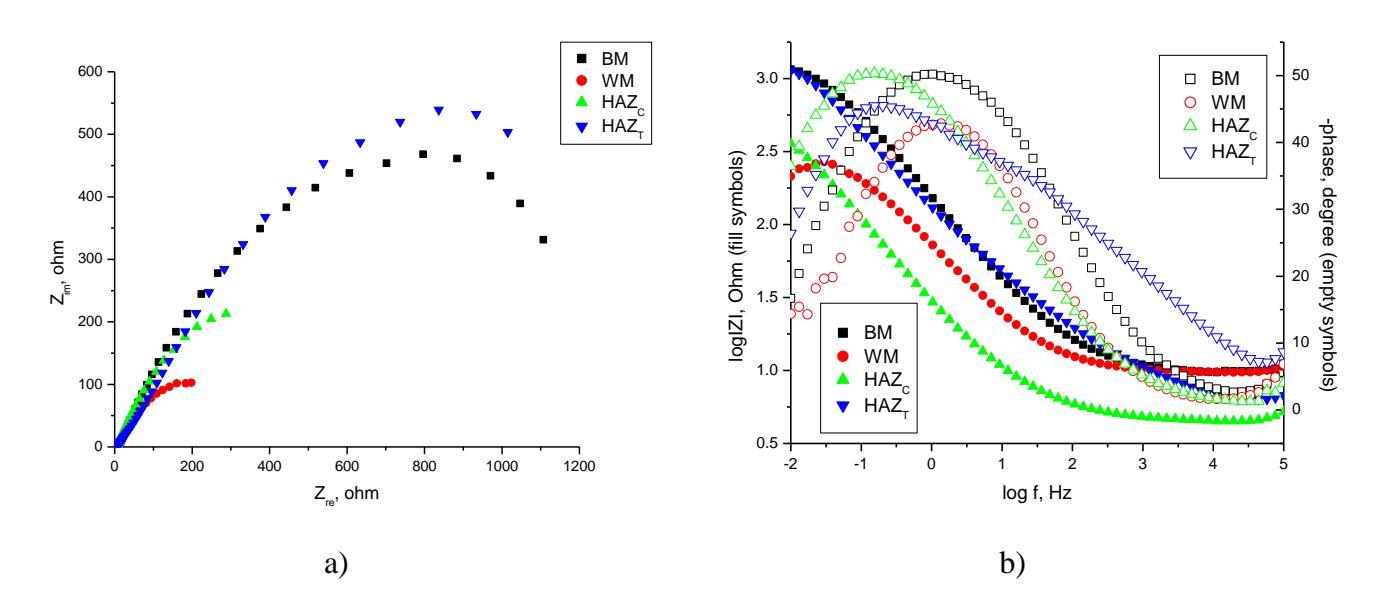
Figure 9. a) Complex Nyquist plane plots and b) Bode plots for the studied specimens.

The microstructural differences are revealing in the EIS spectra. EIS tests were performed in a 3% NaCl solution at 25 °C. Impedance spectra were illustrated in both complex impedance diagrams (Nyquist plot), and Bode amplitude and phase angle plots. In the Nyquist graph (Figure 9a), the imaginary component of the impedance is represented as a function of the real component, whereas the Bode plots (Figure 9b) illustrates the logarithm of the impedance modulus |Z| and phase angle as a function of the frequency f logarithm.
