Effect of Different Loading Conditions on the Service Life of Mine Steel Wire in Corrosive Medium

Songquan Wang^{1,*}, Dekun Zhang², Ningning Hu¹, Jialu Zhang¹

Keywords: Steel wire; corrosion rate; stress corrosion cracking; corrosion fatigue; finite element model

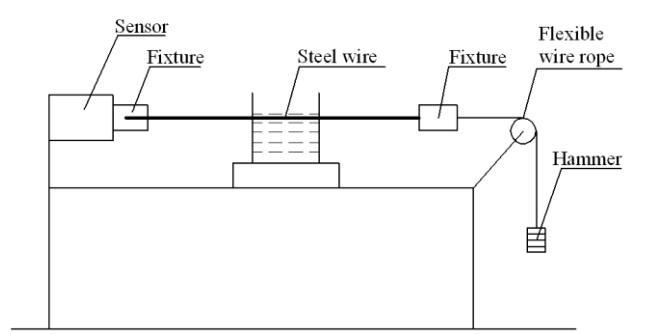
Fig. 1 shows the instruments and principle of constant tensile test (according to GB/T228.1-2010 [25]). The length of steel wire in solution was 3.18 cm to make sure that the worksheet area in solution was 1 cm². The corrosion solution was changed in a consistent manner with the long-term corrosion test. The load of steel wire was obtained by the senor on the left side of test-bed. In order to avoid yield and creep, the stress corrosion behavior of steel wire was studied mainly under the load of 0% UTS (0 MPa, UTS represents the ultimate tensile strength), 50% UTS (875 MPa) and 70% UTS (1225 MPa). The electrochemical impedance spectroscopy was measured by electrochemical workstation of IM6ex type, while the surface and fracture morphologies of steel wire were observed by SEM.

Figure 1. Instruments and principle of constant tensile test

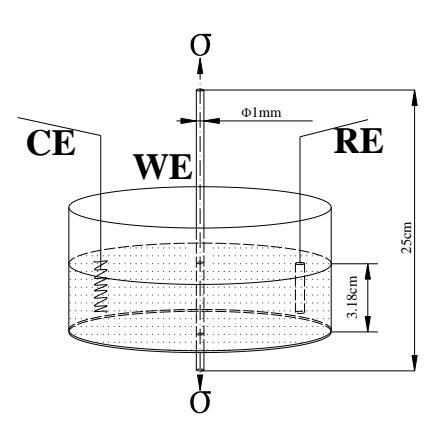
Finally, corrosion fatigue test (according to GB/T 20120.1-2006 [26]) was carried out on fatigue machine of PYW-20 type under the maximum load of 1000 MPa, with loading frequency of 5 and stress radio of 0.5, as shown in Fig. 2. Similarly, the worksheet area of steel wire in solution was 1 cm². The change of corrosion current density of steel wire under the open circuit potential (relative to the Ag-AgCl electrode) was collected by using IM6ex electrochemical workstation, while the surface and fracture morphologies of steel wire were observed by SEM.

Figure 2. Principle map of corrosion fatigue test

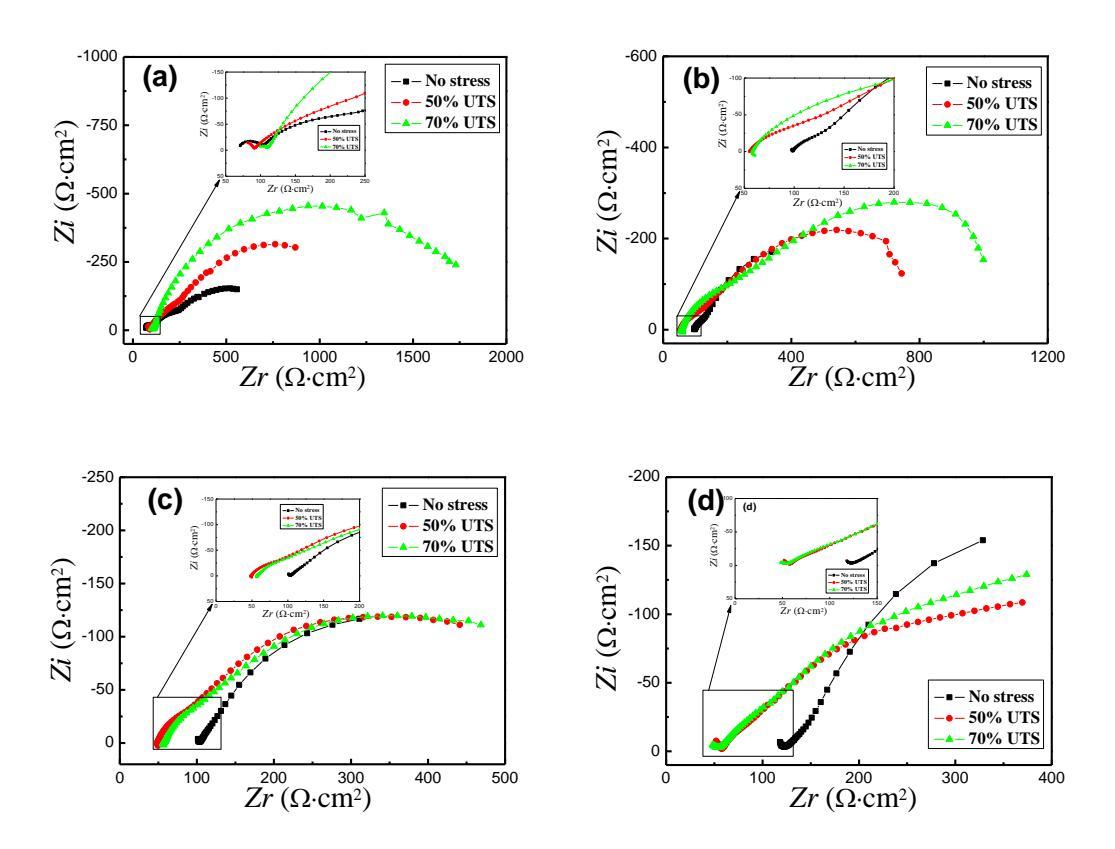
Fig. 3 shows the Nyquist curves of steel wires under different load at different test times in constant tensile test. The steel wire broke at load of 1225 MPa after 23-day testing period, while no fracture occurred on the steel wire with load of 875 MPa within 30 days.

Fig. 3a shows the Nyquist curve of steel wire under three different load after testing for 1 hour. The Nyquist curves of steel wires are all formed by a high frequency capacitive arc and a low frequency capacitive arc at three kinds of stress state. The radius of high frequency capacitance arc which represents the characteristics of corrosion product film of steel wire is smaller than the radius of low frequency capacitive arc, with the latter represents the characteristics of layer amid the wire surface and the rust layer. Curve in the high frequency region indicates that the high frequency capacitance arc characteristic of steel wire is the most obvious. Meanwhile, the high frequency capacitance arc characteristic decreases and becomes no longer complete under the action of load. The results showed that the cracking of corrosion product film occurred by the effect of load, while the protective effect of the film on the substrate decreased. Curve in the low frequency region shows that the radius of low frequency capacitance arc increasing with the increase of the load after testing for 1 hour. Though the size of capacitive arc is related to the corrosion resistance of material, the increase of the steel substrate and corrosion product film, which was caused by the damage of the wire surface. And the damage of wire surface will increase with the increase of the load.

The differences of low frequency capacitance arc radius under different load decrease with the extension of test time. There is no significant difference in low frequency capacitance arc radius after testing for 3 days, and the radius of low frequency capacitance arc under the condition without load becomes the largest after testing for 13 days, as shown in Fig.3c and 3b. This result is due to that the corrosion resistance of steel wire is improved by the effective protection of dense corrosion product film on the matrix. While the corrosion resistance of steel wire with load decreases for the cracking formed on the surface of corrosion product film.

Figure 3. Nyquist plots of steel wires under different loads (a) at 1 h, (b) at 1 d, (c) at 3 d, (d) at 13 d

The comparative studies of Fig. 3 and Fig. 4 show that the corrosion current density of steel wire in the initial phase of corrosion fatigue test is about 20 times larger than that in long-term corrosion test without load. The surface of steel wire is constantly exposed to fresh substrate for the fatigue load, which caused the increasing of the corrosion current density of steel wire. And at the end of corrosion fatigue test, the corrosion current density of steel wire before fracture is about 90 times larger than that in long-term corrosion test at the same of time. The corrosion current density can reflect the corrosion rate of steel wire. All these results can illustrate the effect of different stress states on the corrosion state of steel wire in quantity, and prove that the corrosion rate of steel wire will greatly increase with the application of load at the same time.

A dense film oxide film will be formed on the surface of steel wire in corrosive medium, which can improve the corrosion resistance steel wire with no applied stress. But the film will be damaged under the applied stresses, which reduce the service life of steel wire. The current density under open circuit potential and EIS can reflect the corrosion rate of steel wire [30, 31]. The results of corrosion current density test (Fig. 4) showed that the application of fatigue load could greatly accelerate the corrosion speed of steel wire, and the results of Nyquist plots of steel wires under different loads (Fig. 3) showed that the applied load, the faster the corrosion rate of steel wire.

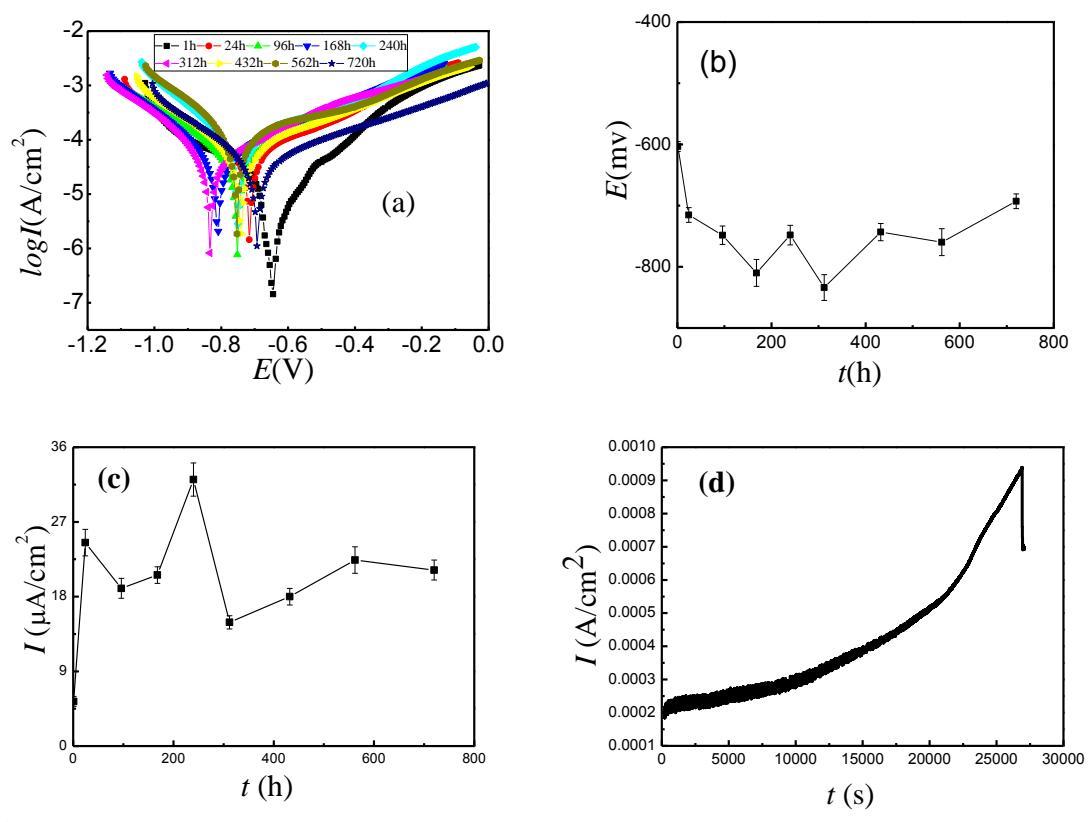
Fig. 4a and Fig. 4b show the polarization curve and corrosion potential of steel wires in longterm corrosion test. Fig. 4c and Fig. 4c show the corrosion current density variation curves of steel wire under the open circuit potential in long-term corrosion test and corrosion fatigue test respectively.

In long-term corrosion test, the corrosion current density is 9 μ A/cm² after soaking for 1 h and gradually increases to about 23 μ A/cm² after soaking for 240 h. The volatility of the corrosion current density before soaking 312 h is bigger than that in the subsequent immersion time. In corrosion fatigue test, the corrosion current density of steel wire under the open circuit potential has a tendency to increase (200-900 μ A/cm²). The pits gradually formed on the surface of steel wire for the effect of corrosion, which produced large amount of plastic deformation zone. At the same time, the wire surface area in the solution increased for the damaging of the surface of steel wire under the cyclic loading, which caused the increase of the corrosion rate of steel wire.

Figure 4. Polarization curve (a) and corrosion potential (b) of steel wires in long-term corrosion test, and corrosion current densities of steel wires (c) in long-term corrosion test and (d) in corrosion fatigue test

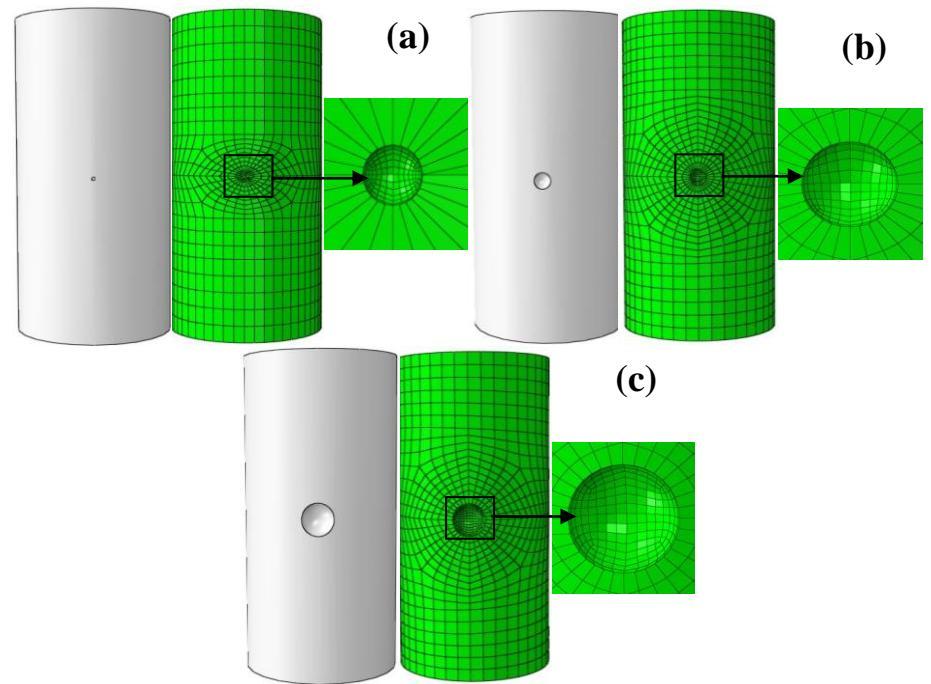
Figure 5. Three dimensional finite element models of steel wires (a) with the corrosion pit radius of 10 μ m, (b) with the corrosion pit radius of 50 μ m, (c) with the corrosion pit radius of 100 μ m

A three dimensional finite element model of steel wire with corrosion pit was established according to the steel wire parameters, as shown in Fig. 5. Different stress states and corrosion degrees can lead to different sizes of corrosion pits. According to the micrographs of corrosion pits of steel wire in different tests [22, 23], wire diameter was set at 1 mm, and the radius of the corrosion pits were to be set to 10 μ m, 50 μ m, and 100 μ m, respectively. The models of steel wires were divided into 9952, 7830, 8716 8-node three-dimensional entity unit reduction integral unit (C3D8R), respectively. And local refinement near the corrosion pit was carried out to prevent vertical displacement and rotational

displacement of steel wire bottom [27, 28]. It's known that the elastic modulus of steel wire was 210 GPA and Poisson's ratio was 0.3. 875 MPa and 1225 MPa of loads were imposed to the top of steel wire at simulation constant tensile test and sinusoidal pressure was applied to the top of steel wire with maximum load of 1000 MPa, loading frequency of 5 and stress ratio of 0.5 at simulation corrosion fatigue test.

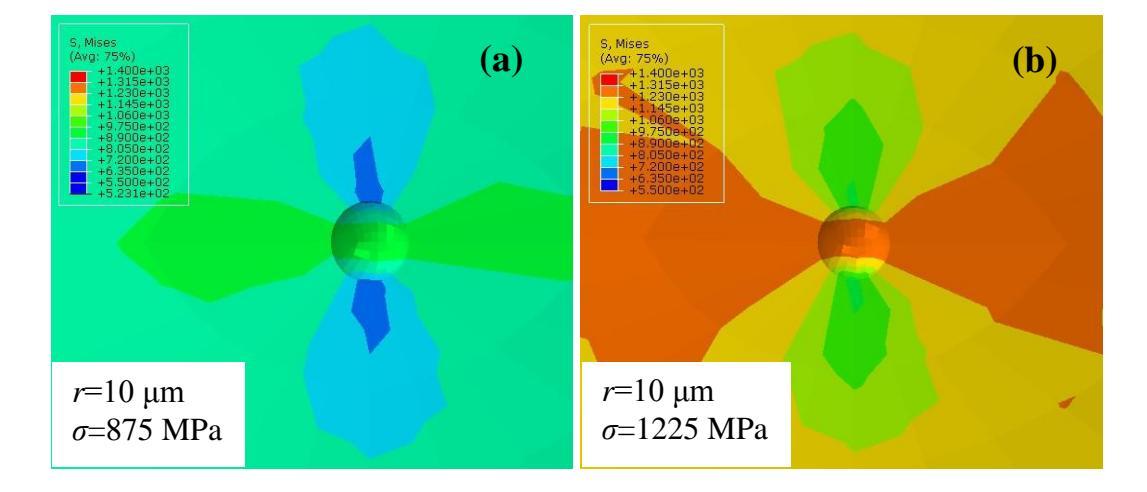
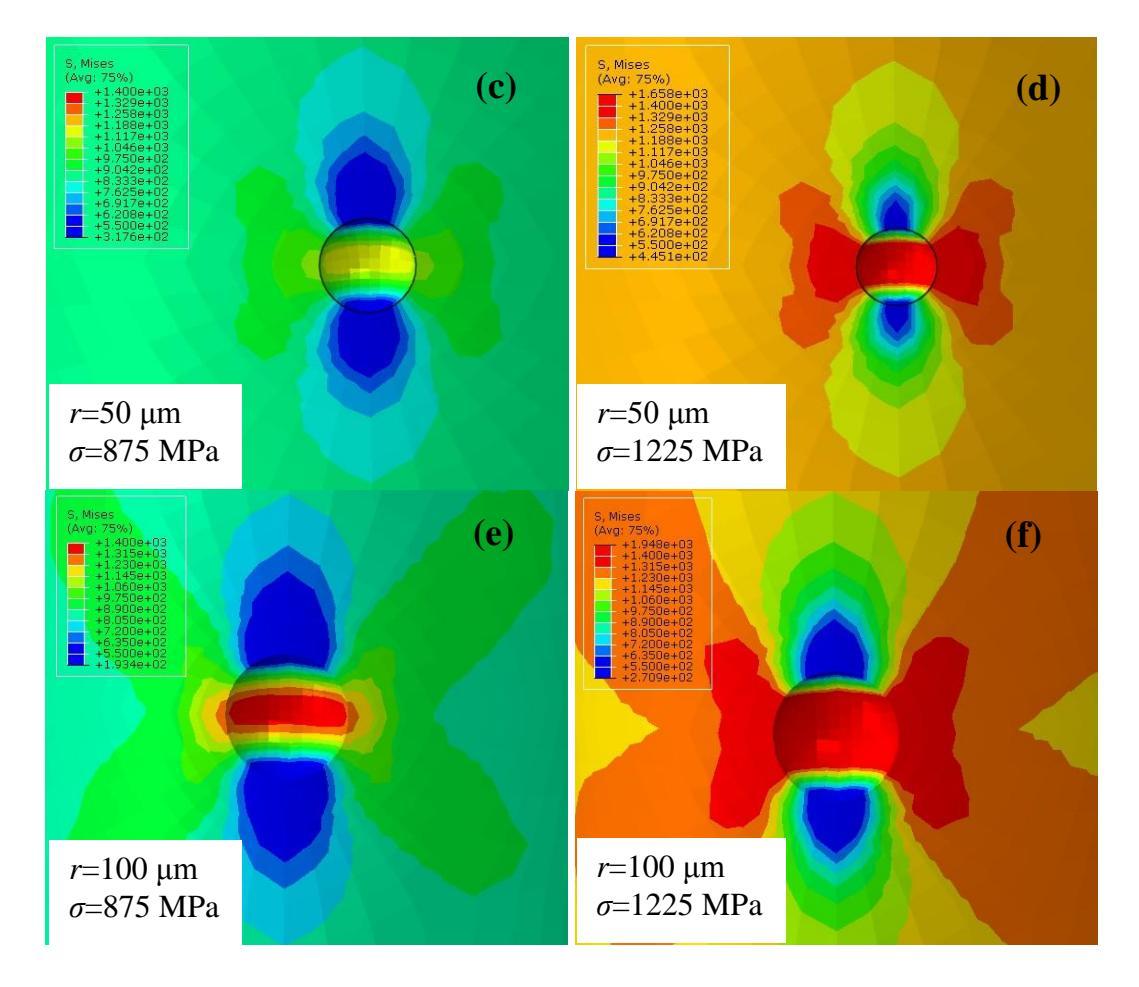
Fig. 6 shows the equivalent stress distribution diagram of steel wire with different corrosion pit radius and load, which is simulated by ABAQUS software. Meanwhile the value of equivalent stress is shown in Fig. 7.

The study indicated that the maximum equivalent stress was reached at the bottom of corrosion pit and extended along the perpendicular direction of load, as shown in Fig. 6. The result can explain that the crack at the direction perpendicular of the load can be found near the corrosion pit under the effect of stress corrosion. The equivalent stress at the bottom of the pits increased with the applied tensile force if the pits were at the same size and also increased with pit radius at the same load. The minimum equivalent stress (910 MPa) was reached when the pit radius was 10 μ m and the load was 875 MPa, while the maximum equivalent stress (1920 MPa) was reached when the pit radius is 100 μ m and the load is 1225 MPa, which had been beyond the tensile strength of steel wire.

The corrosion degrees of steel wires were considered same when the corrosion pits had the same size. The stress concentration phenomenon at the bottom of pit was more obvious with the increase of the load, which caused the increase of equivalent stress. The stress concentration area had a trend of outside expansion along the vertical direction to the load, and the direction was the main crack propagation direction. The results of expansion increased the area of steel wire matrix (as the anode area), which accelerated the corrosion rate for the acceleration of the process of anodic dissolution. While the outside expansion trend of main crack became more obvious with the acceleration of corrosion under the same load. The increase of load can accelerate the corrosion rate of steel wire. Meanwhile the strong anodic dissolution process can accelerate the main crack propagation. The stress corrosion cracking (SCC) susceptibility of steel wire will be improved by the effect of interaction between load and corrosion, which cause the reduction of the service life of steel wire.

Figure 6. Equivalent stress distribution near the pit of different radius under different load

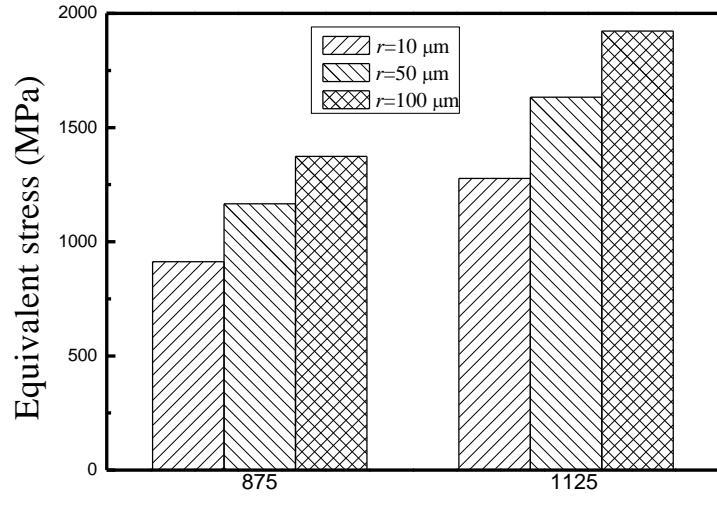
Figure 7. Equivalent stress of the pit bottom of different radius under different load

The contrast between Fig.7 and Fig. 8 showed that the equivalent stress distribution at the bottom of pit with the same radius was influenced by the form of load. The equivalent stress at the bottom of the pit was much larger than the load in constant tensile test. Meanwhile the equivalent stress at the bottom of the pit was much larger than both the load and the stress of the internal region in corrosion fatigue test. The greater the load, the higher the degree of corrosion, and the lager the equivalent stress at the bottom of pit.

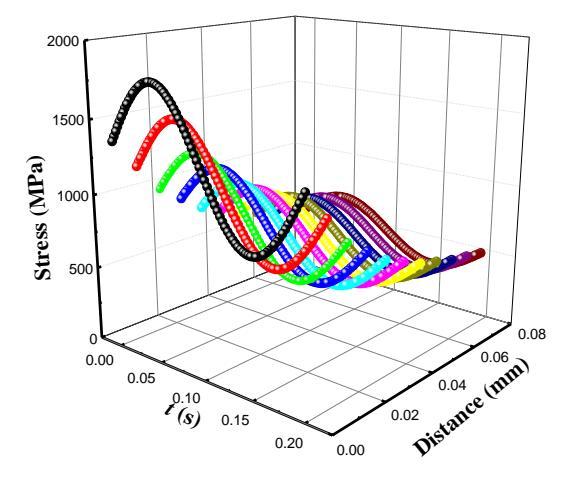
Fig. 8 shows the equivalent stress changes of each point with different distances to the pit (with radius of 100 μ m) bottom of steel wire in one cycle in corrosion fatigue test. The equivalent stress change of each point accorded with the law of sine wave, which was similar to the load of steel wire. The equivalent stress decreased gradually along the inward direction from the bottom of pit.

Figure 8. Equivalent stress changes of each point near the pit bottom of steel wire in one cycle (S=1000 MPa, f=5 Hz, r=0.5)

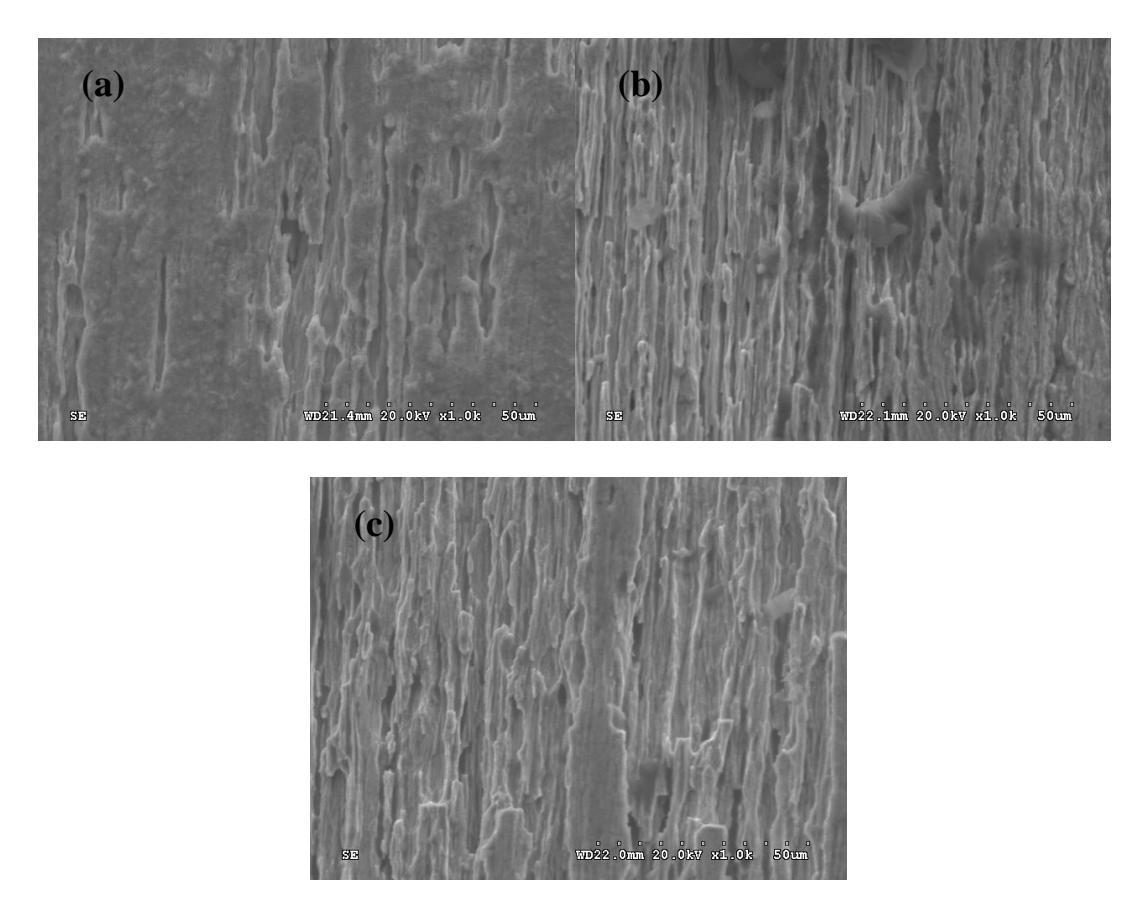
Firstly, the surface morphologies of steel wires under different load in constant tensile test were studied. Fig.9 shows the surface morphologies of steel wires under the load of 0 MPa, 875 MPa and 1225 MPa after testing for 2 days, respectively. The direction of damage on the surface of steel wire under the three different conditions is all along the axial direction. The damage degree under load was significantly higher than that under the condition without load. Moreover, the damage would be aggravated by the raise of load.

Figure 9. Surface morphology of steel wire under different load after testing for 2 days (a) 0 MPa, (b) 875 MPa, (c) 1225 Mpa

perpendicular direction of load, which could prove the theory that the corrosion pits became the source of crack [29]. No obvious transverse cracks were found on the surface of steel wire in Fig. 9, which showed that constant tensile was not easy to cause crack. The fracture mechanism of steel wire under constant stress was mainly the anodic dissolution.

Both constant load and cyclic load can accelerate the expansion of corrosion pits, but only the cyclic load can make the extension direction of pits transverse. While based on the analysis of fracture morphology, the transverse crack in the pit is the source of fatigue fracture. As shown in Fig. 9 and Fig. 10, the load state and corrosion solution have a great influence on the surface and fracture morphology of the steel wire. In the same corrosion solution, the corrosion degree of the steel wire surface is not serious under the condition without load. But load can accelerate the corrosion rate of steel wire, and the severity of corrosion and damage on the tissue surface shows a positive association with load. Moreover, alternating stresses may cause a crack near the pit, which is vertical to load. Same to the study of F. Cao [32] and B. Y. Fang [33], the smooth tensile fracture morphology in the air shows that obvious plastic deformation occurs in the test, meanwhile, the dimple morphology of fiber zone shows that the fracture mechanism of steel wire tested in the air is mainly the ductile fracture. The coexistence of dimple, quasi-cleavage and tear ridge in the fracture morphology of steel wire shows that the fracture mechanism of steel wire in the constant tensile test is coexisted with the ductile fracture and the brittle fracture. According to the study of Z. Shi [34] and B. S. Padekar [35], the ductility of the cracking indicated that the stress corrosion cracking mechanism of steel wire in the constant tensile test was probably hydrogen enhanced localized plasticity. And the fracture morphology of smooth crack source and quasi-cleavage crack expansion area shows that the fracture mechanism of steel wire in the corrosion fatigue test is the brittle fracture [23].

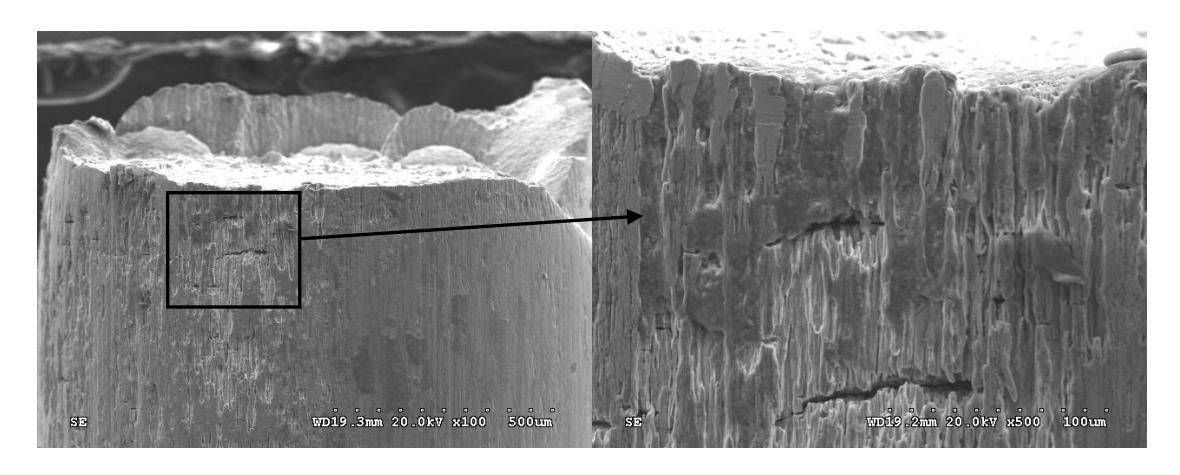
Figure 10. Surface morphology of steel wire after corrosion fatigue (*S*=1000 MPa, r=0.5, *f*=5 Hz)

Afterwards, the surface morphology of steel wire in corrosion fatigue test was studied, as shown in Fig. 10. Comparing Fig.10 with Fig.9, a lot of corrosion pits with deeper depth could be found on the surface of steel wire, which showed that the corrosion of the steel wire surface could be aggravated by the application of cyclic loading. Moreover, the raise of load can increase the number of corrosion pits and enlarge the depth of corrosion pits. The damage along the axial direction could be also founded on the surface of steel wire, but the degree of the damage was less severely than that in long-term constant tensile test. In addition, the direction of crack near the corrosion pits is along the

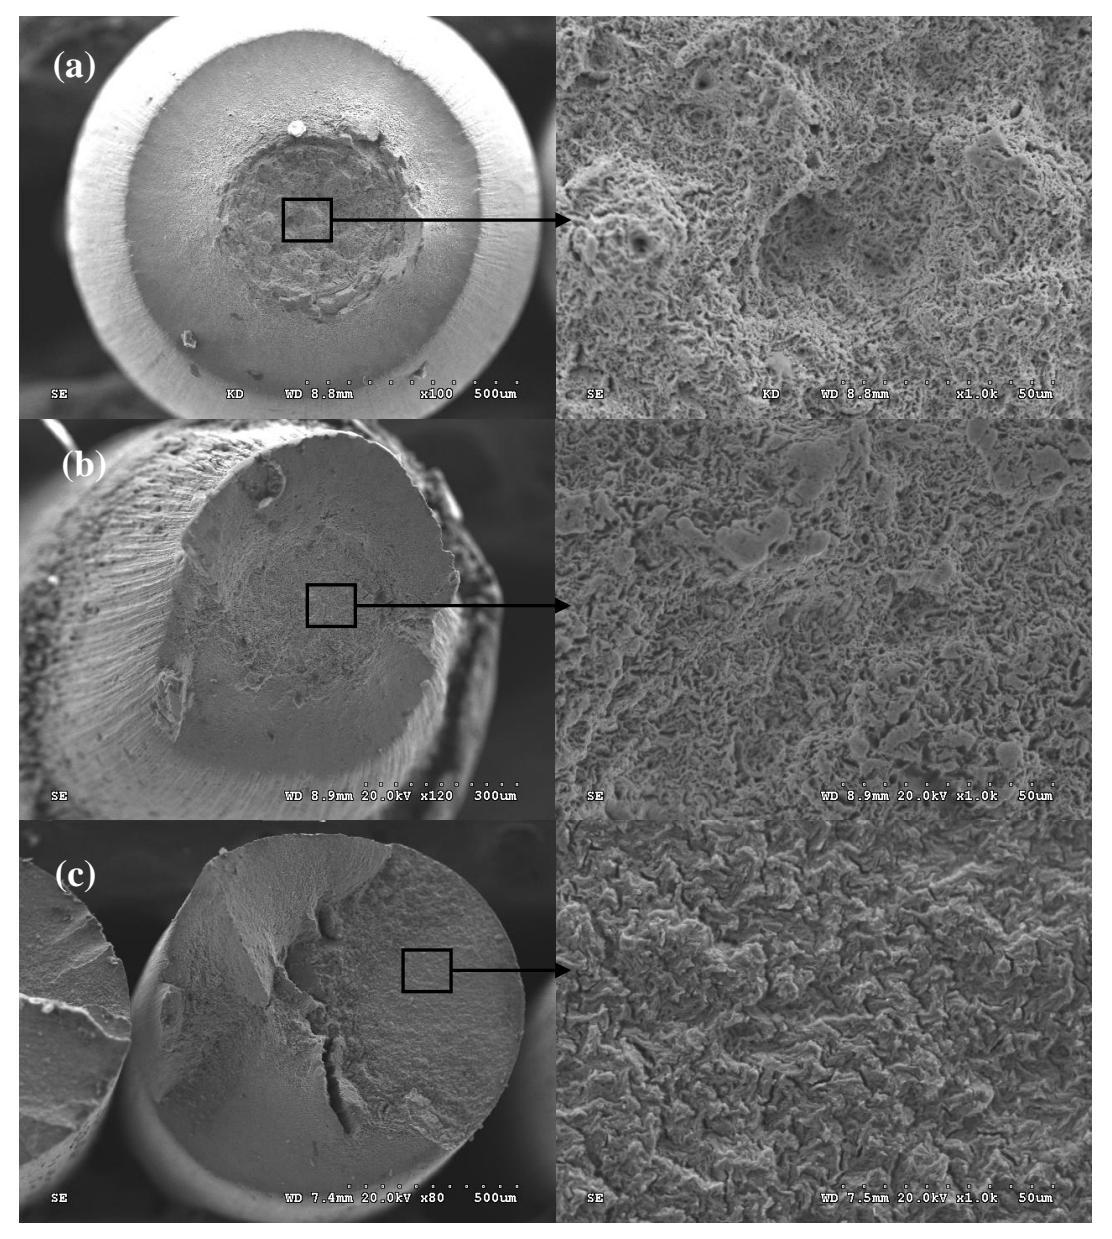
Figure 11. Fracture morphologies of steel wires (a) tensile in air, (b) in constant tensile test, (c) in corrosion fatigue test

In order to study the coupled action of stress and corrosion on the fracture morphology of steel wire, the differences of fracture morphology were observed followed by tensile test in the air (according to GB/T228.1-2010 [23]), constant tensile test and corrosion fatigue test, as shown in Fig.11. According to Fig. 11a, the tensile fracture morphology in the air is divided into shear lip and

fiber zone, where in the shear lip is very smooth, although the fiber zone appears to be dimple with intensively distributed deep hole. The fracture morphology under the load of 1225 MPa after testing for 23 days in constant tensile test shows the same portion with air tensile test, as shown in Fig. 11b. While a long transition area appears along the axial direction between the shear lip and wire surface with some trace of drawing. The fiber zone has a very complex morphology coexisted with dimple, quasi-cleavage and tear ridge. The fracture mechanism is more complex, which shows fracture mechanism is more complex, showing some SCC sensibility. The fracture morphology in corrosion fatigue test is consisted of the crack source, crack expansion area and instantaneous fracture zone, as shown in Fig. 11c. The instantaneous fracture zone mainly shows the dimple morphology.

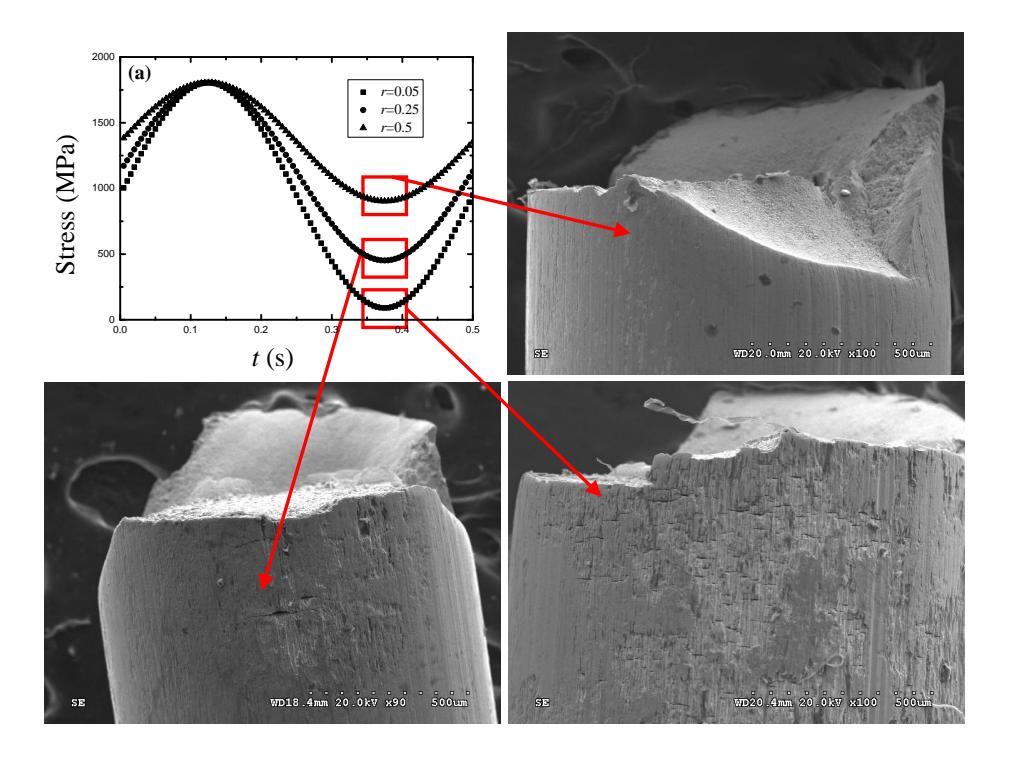
corrosion fatigue behavior of steel wire were mentioned. Fig.12 showed the equivalent stress changes of the pit bottom in one cycle (obtained by the finite element simulation) and corresponding surface morphology of steel wire. Obviously, there is a very close relationship between the surface morphology and the stress state (stress ratio). The number of transverse corrosion fatigue crack increased with the increase of stress ratio. In addition, the number of fatigue crack was also associated with the test time, and the larger the stress ratio, the longer the service life of steel wire, but the stronger the effect of corrosion.

Figure 12. Equivalent stress changes of the pit bottom in one cycle and corresponding surface morphology of steel wire
