Investigation on microstructure, surface and corrosion characteristics of heat treated AISI 420 martensitic stainless steel laser welds in simulated body fluid (SBF)

Ceyhun KÖSE

Faculty of Natural Sciences and Engineering, Department of Mechanical Engineering, Tokat Gaziosmanpaşa University, Tokat, Turkey E-mail: <u>ceyhun.kose@gop.edu.tr, ceyhunia@gmail.com</u>

Received: 26 July 2018 / Accepted: 27 September 2018 / Published: 5 November 2018

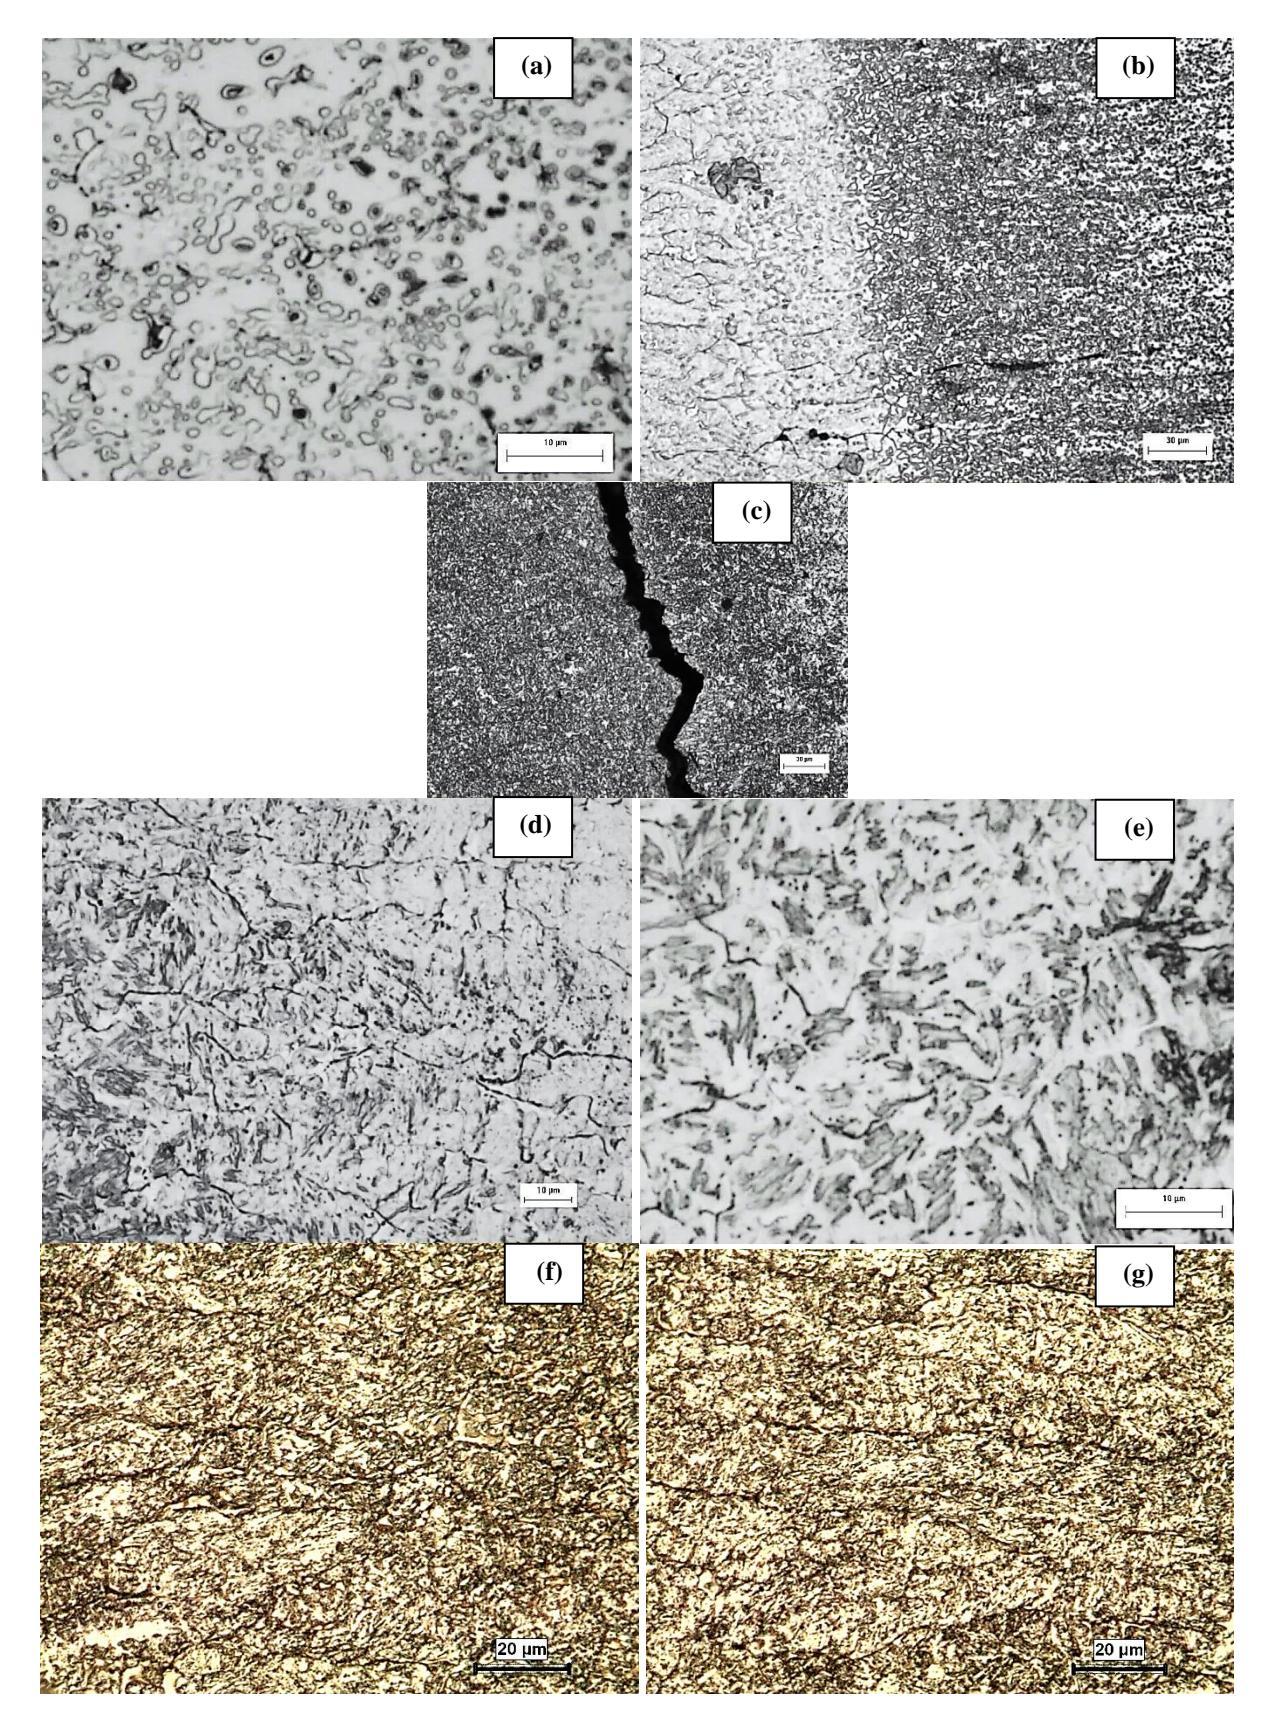
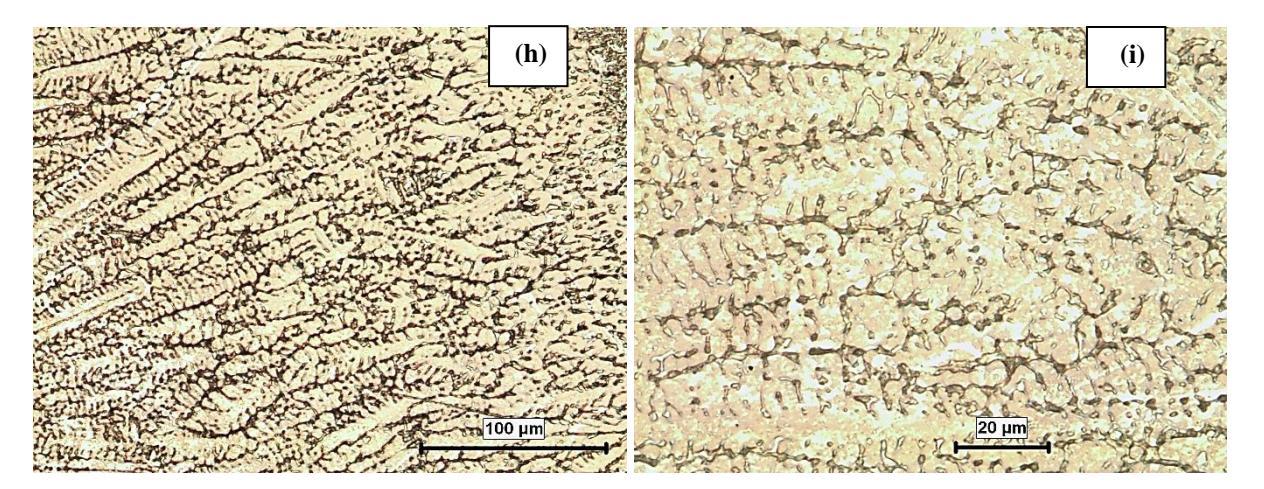
Optical microscopic images of non-heat treated laser welded AISI 420 martensitic stainless steel (Figure 1) revealed that a certain amount of grain growth due to fast cooling depending upon heat input were realized along with a narrow HAZ formation. In weld metal, on the other hand, a predominantly martensitic microstructure was obtained due to lack of necessary time as a result of fast cooling needed for structural transformation. Predominant martensitic nature of weld metal microstructure was the main reason leading to formation of cracks via triggering cold crack propagation (Figure 1). It was understood that weld metal changed its microstructure from cellular grain structure to columnar and equiaxed dendritic grain structure during solidification process of weld metal. Microstructure of weld metal was predominantly of martensitic nature (Figure 1).

Figure 1. The etched non-heat treated of laser welded sample's microstructure images; the non-heat treated sample was oxalic acid etched, (a) base metal, (b) HAZ, (c) the formation of cold cracks in weld metal, (d,e) weld metal, the non-heat treated sample was Villela's reagent etched, (f) HAZ, (g) weld metal, the non-heat treated sample was potassium hydroxide etched, (h) HAZ, (i) weld metal.

• Microstructure of non-heat treated laser welded sample was predominantly made up martensitic phase. Microstructure of heat treated laser welded sample, on the other hand, made up tempered martensite, small amount of ferrite and little amounts of carbides.

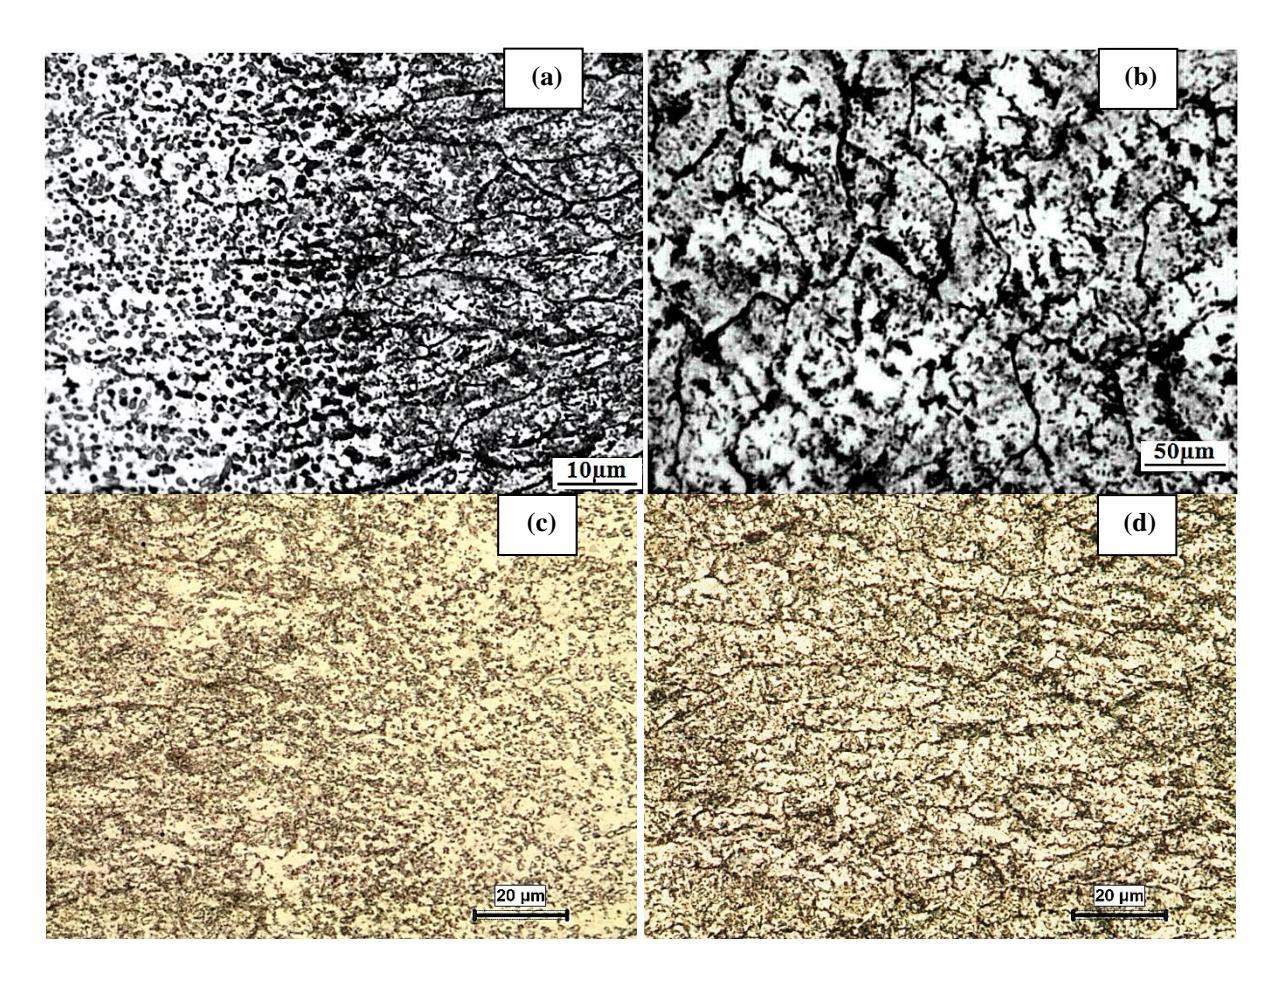
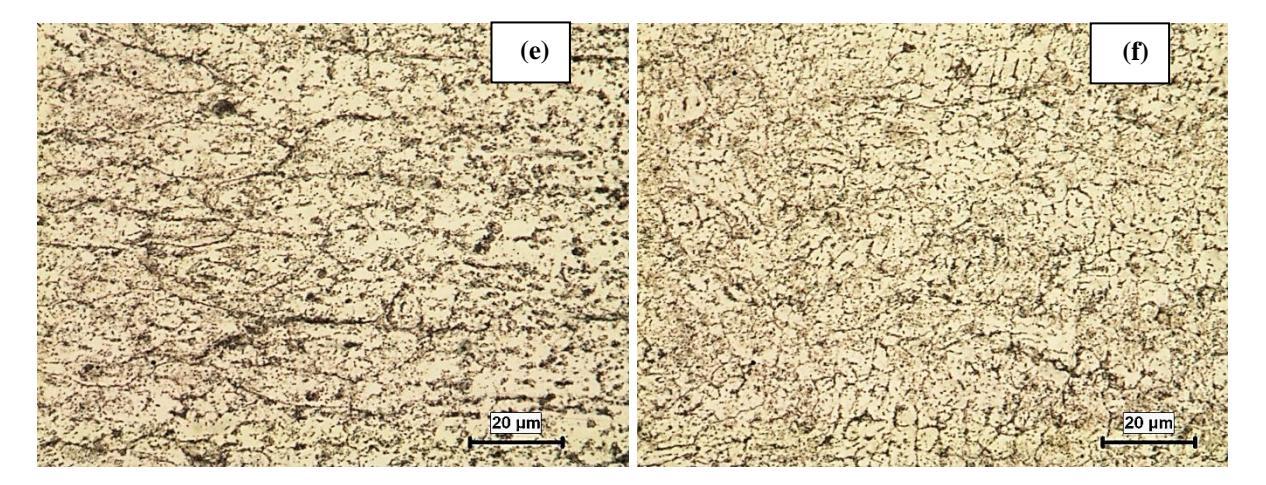
Microstructural changes in heat treated samples, on the other hand, showed that grain growth occurred especially in HAZ and carbide collapses developed depending upon heat input transferred to weld zone and upon whether pre- and postweld heat treatment process was applied (Figure 2 and 3).

Figure 2. The heat treated sample B1 was oxalic acid etched, (a) HAZ, (b) weld metal, the heat treated sample was Villela's reagent etched, (c) HAZ, (d) weld metal, the heat treated sample was potassium hydroxide etched, (e) HAZ, (f) weld metal.

Depending upon tempering heat treatment process at 660 °C for 75 minutes after welding and cooling inside an oven, tempered martensitic structures, slight amount of residual δ -ferrite and very small amounts of carbide collapses were clearly observed in microstructure images of weld metal

(Figure 2 and 3). It is known that δ -ferrite phase has lower resistance to corrosion compared to austenite matrix [26,27]. Based on microstructural examination of heat treated sample, no crack or pore formation was observed in HAZ and weld metal.

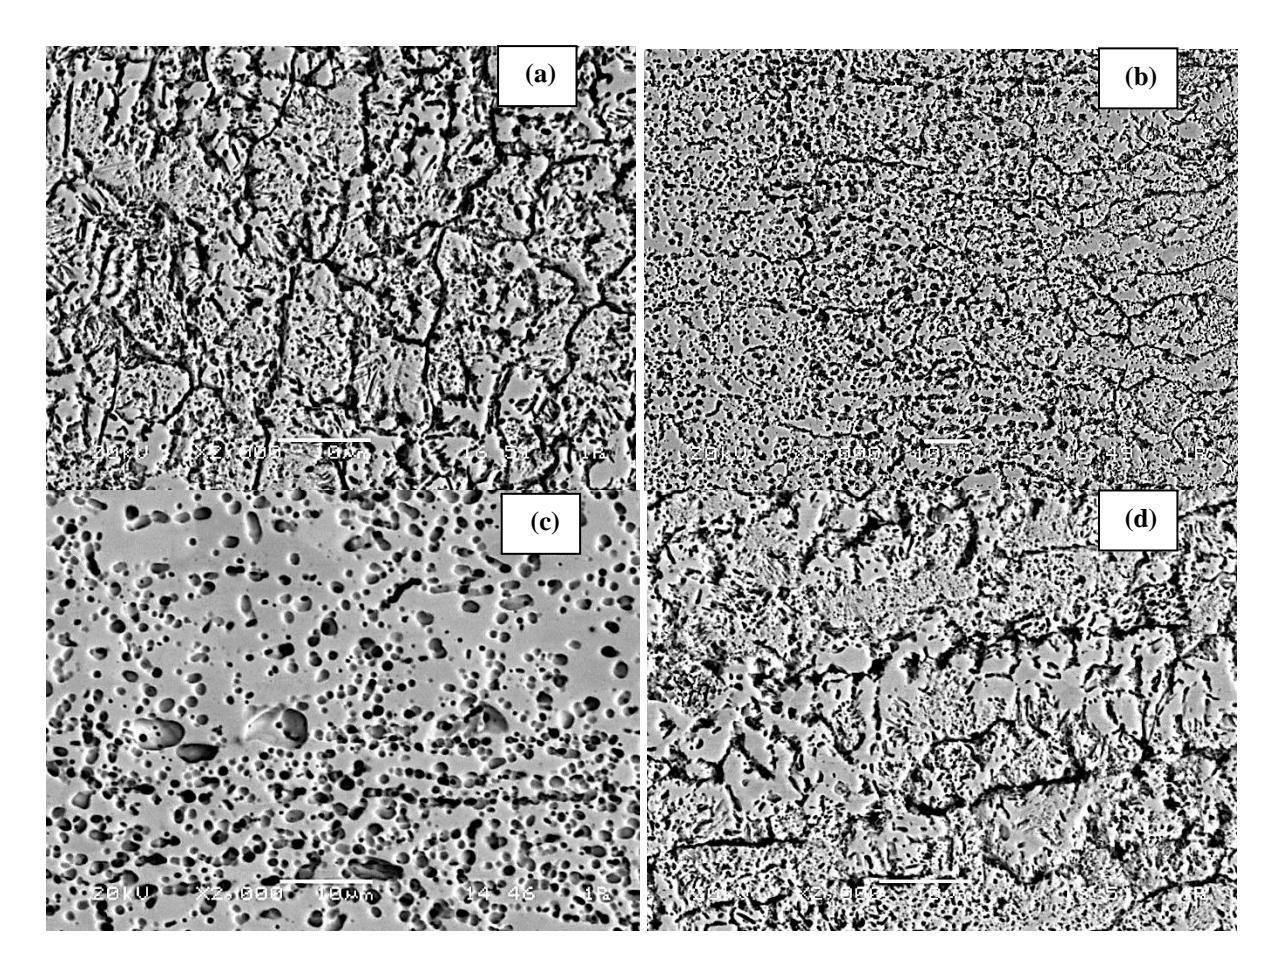
Figure 3. SEM images of laser weldment, the heat treated sample was oxalic acid etched, (a) weld metal, (b) HAZ of sample B1, (c) base metal, (d) weld metal of sample B2.

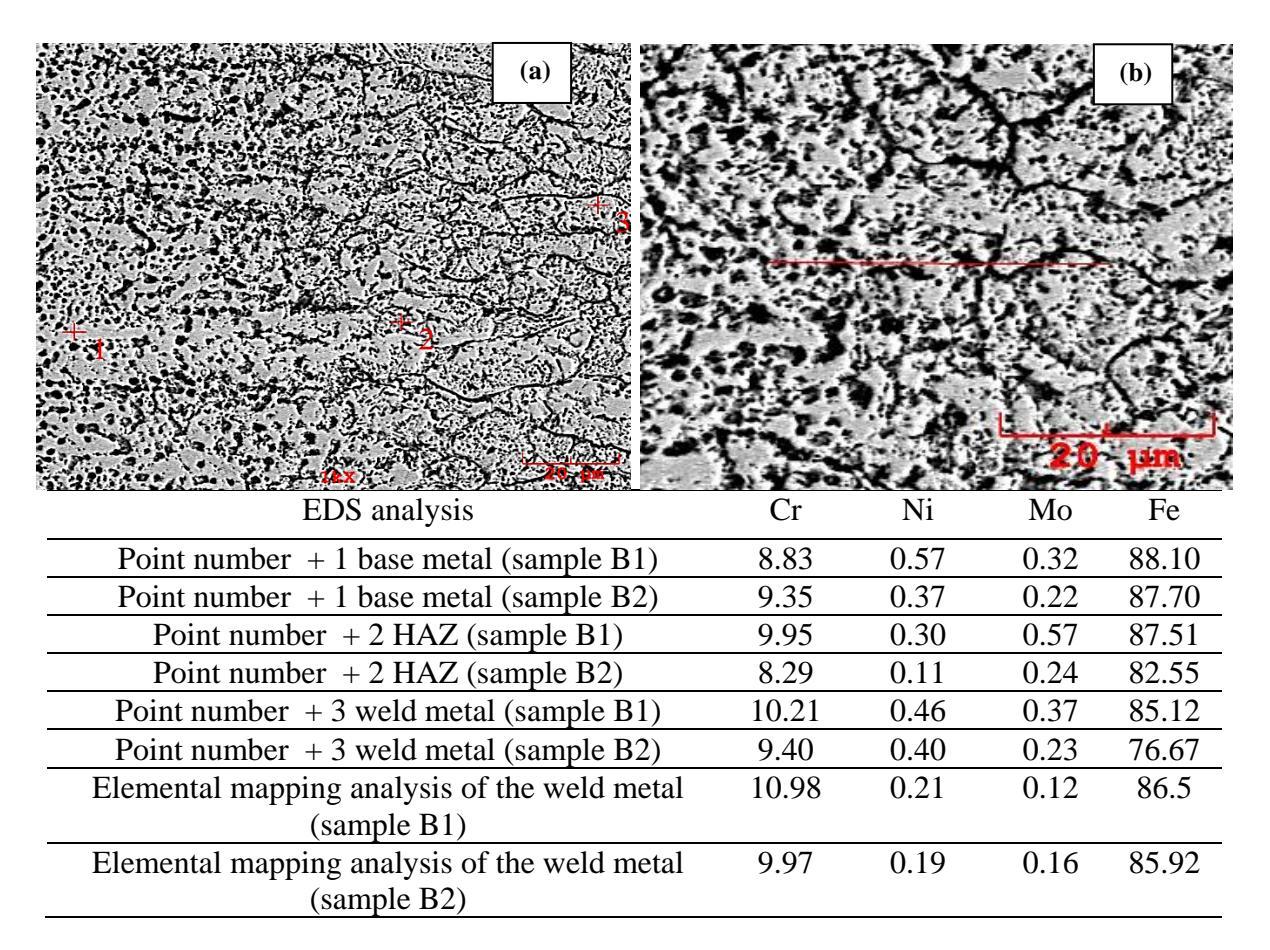
In addition, EDS point analysis was performed in base metal, weld metal, and HAZ of B1 and B2 samples. The results are given in Figure 4. Furthermore, weld metal was analyzed via elemental mapping analysis, and results are shown in Figure 5. A comparison of EDS analysis and elemental mapping shown in Figure 4 and Figure 5 along with spectral analysis results of AISI 420 stainless steel (Table 1) suggest that no marked losses of alloy elements occurred due to welding process. However, EDS point analysis results showed that carbide collapses such as $M_{23}C_6$, $Cr_{23}C_6$ that occurred in weld metal and in HAZ resulted in clear decreases in Cr amounts in alloy element of weld metal as a result of tempering heat treatment carried out after welding and during the cooling period of sample inside an oven. Decrease in amount of chromium was somewhat more in B2 sample. In EDS and elemental mapping analyses, less than 12% of chromium was detected, which is the limit for passive film formation, and this amount is expected to cause the formation of local corrosion in weld metal and HAZ.

Figure 4. EDS analysis of B1 and B2 samples, the heat treated sample was oxalic acid etched, (a) EDS analysis, (b) elemental mapping analysis.

• EDS point analysis on heat treated base metal, HAZ, and weld metal immersed in SBF and elemental mapping analysis of weld metal revealed a decrease of especially chromium element. Depending upon heat treatment process, chromium produced carbides, such as $Cr_{23}C_6$, $M_{23}C_6$, and led to local Cr decreases, causing corrosion sensitivity. In addition, weld heat input affected the corrosion resistance.

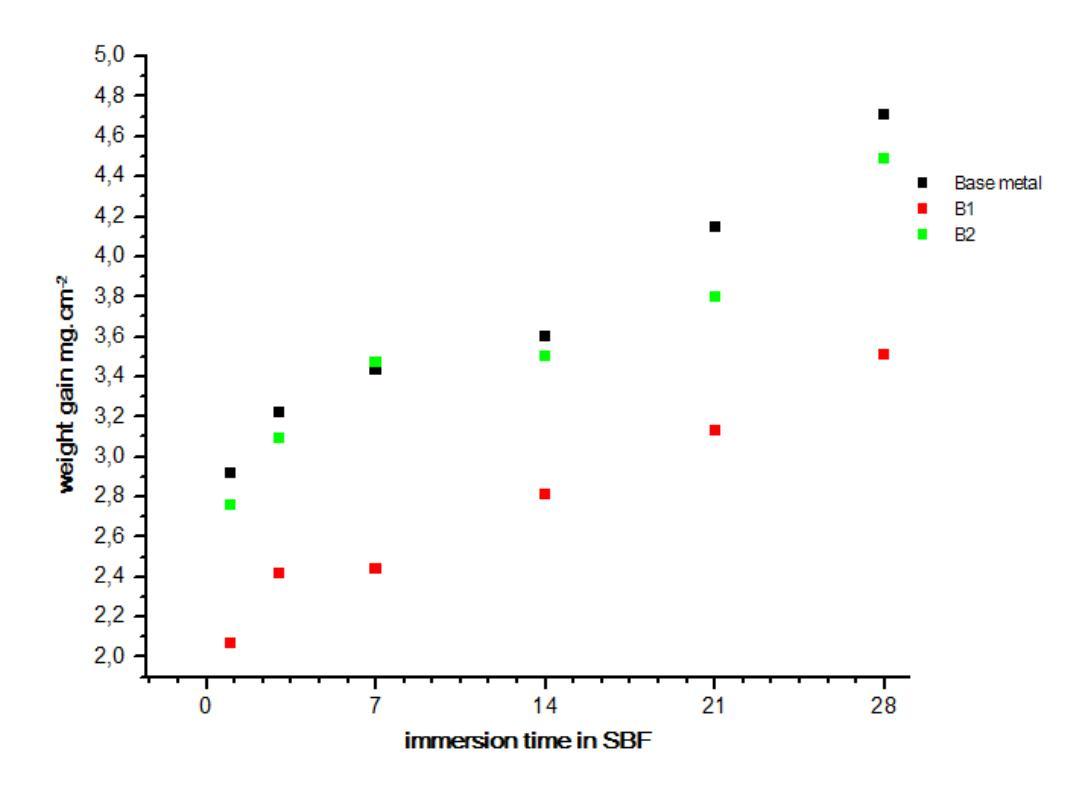
Amount of apatite formed on the surface of all samples after immersing in SBF for different periods was measured using an analytical balance with a 0.0001 g sensitivity. Effect of immersion period in SBF on apatite formation on the surface of samples is shown in Figure 5. Weight gains due to covering of surface of samples with apatite layer after immersing in SBF was calculated using the following formula:

Figure 5. Weight gains by base metal and B1 and B2 laser welded of heat treated samples immersed in SBF for 1, 3, 7, 14, 21 and 28 days

Increase in the thickness of hydroxyapatite layer accumulated on the surface of joint of AISI 420 martensitic stainless steel for different two welding parameters depending upon prolonging immersion period in SBF is clearly seen in Figure 5. As the welding heat input increased, thickness of hydroxyapatite layer, consequently the weight gain, tended to increase. It is hypothesized that laser welded samples affected by weld thermal cycle was promoted to accumulate more apatite mineral by the effect of SBF solution. Hydroxyapatite layer accumulated on the surface of base metal was somewhat higher than that of welded joints for all immersion periods. This result could be due to the effect of pre- and postweld heat treatment process applied to laser welded as well as due to weight gain as a result of corrosion which occurred in experimental samples during immersion in SBF. It was reported that nickel free martensitic stainless steel, preferred for the manufacturing of surgical cutting tools, could have apatite development on the surface and potential bioactivity properties during immersion period in SBF fluid up to 28 days.

Although base metal and laser welded samples were immersed in SBF for the same time period, more apatite accumulation was observed on the surface of base metal. Thus, it appears that a better apatite nucleation and growth took place on the surface of base metal. In addition, it could be concluded that less amount of apatite formation was realized on welding seam due to weld thermal cycle or that apatite layer had less bioadhesive strength on welding seam compared to base metal. It could be concluded that bioactivity properties on welding seam of laser welded samples were lower, though slightly, compared to base metal surfaces.

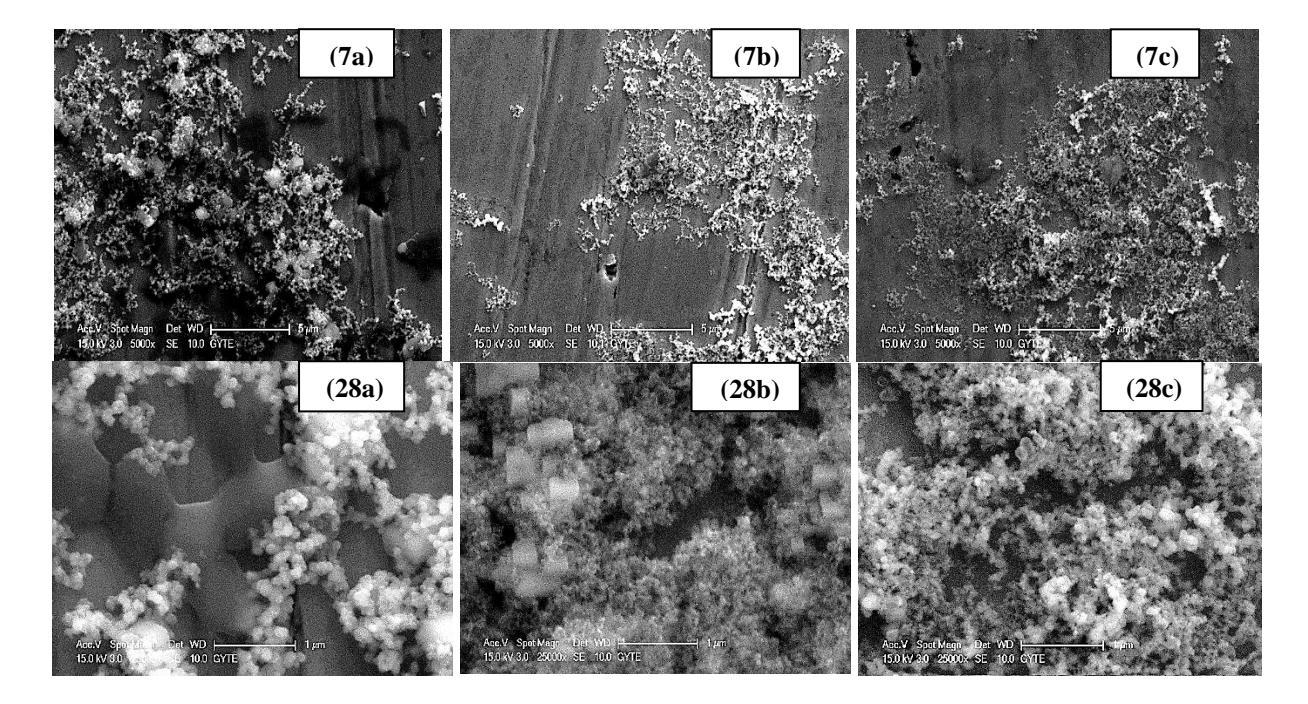
Basically, in vitro apatite forming abilities of implant material or biomaterial surfaces are determined by immersing the material into SBF and measuring [28, 29]. Ability of implant materials to develop and to grow apatite on their surfaces is associated with the ability of surface of that material to have bioactive properties. Materials which have apatite formation on their surfaces can also develop apatite on living bone tissue. In addition, bone attachment and bone growth on apatite layer could occur [30]. SEM examinations of welding seam in laser welded samples revealed that surfaces of samples were covered with apatite at the end of 28th day. SEM examinations also showed that apatite formation did not have a homogeneous distribution on surfaces and had a nano-porous apatite morphology due to the effect of weld metal and HAZ width depending upon joining of AISI 420 stainless steel samples with different welding parameters as well as due to their different heat inputs (Figure 6).

Figure 6. SEM image of apatite formation taking place on surface of base metal (7a and 28a) and on welding seam of laser welded B1 (7b and 28b) and B2 (7c and 28c) heat treated samples immersed in SBF for 7 and 28 days.

• Based on SEM imaging of surfaces of all samples immersed in SBF, apatite development was more pronounced on heat treated base metal surface compared to heat treated laser welded samples. This finding could be explained by better bioactive properties of base metal compared to welding seam of laser welded samples. EDS point analysis results of apatite covered base metal surface and welding seam of laser welded showed Ca/P ratios of lower than 1.67, stoichiometric value of bone. Surface of all samples were covered with apatite minerals called calcium deficient carbonate hydroxyapatite structure with low crystallinity.

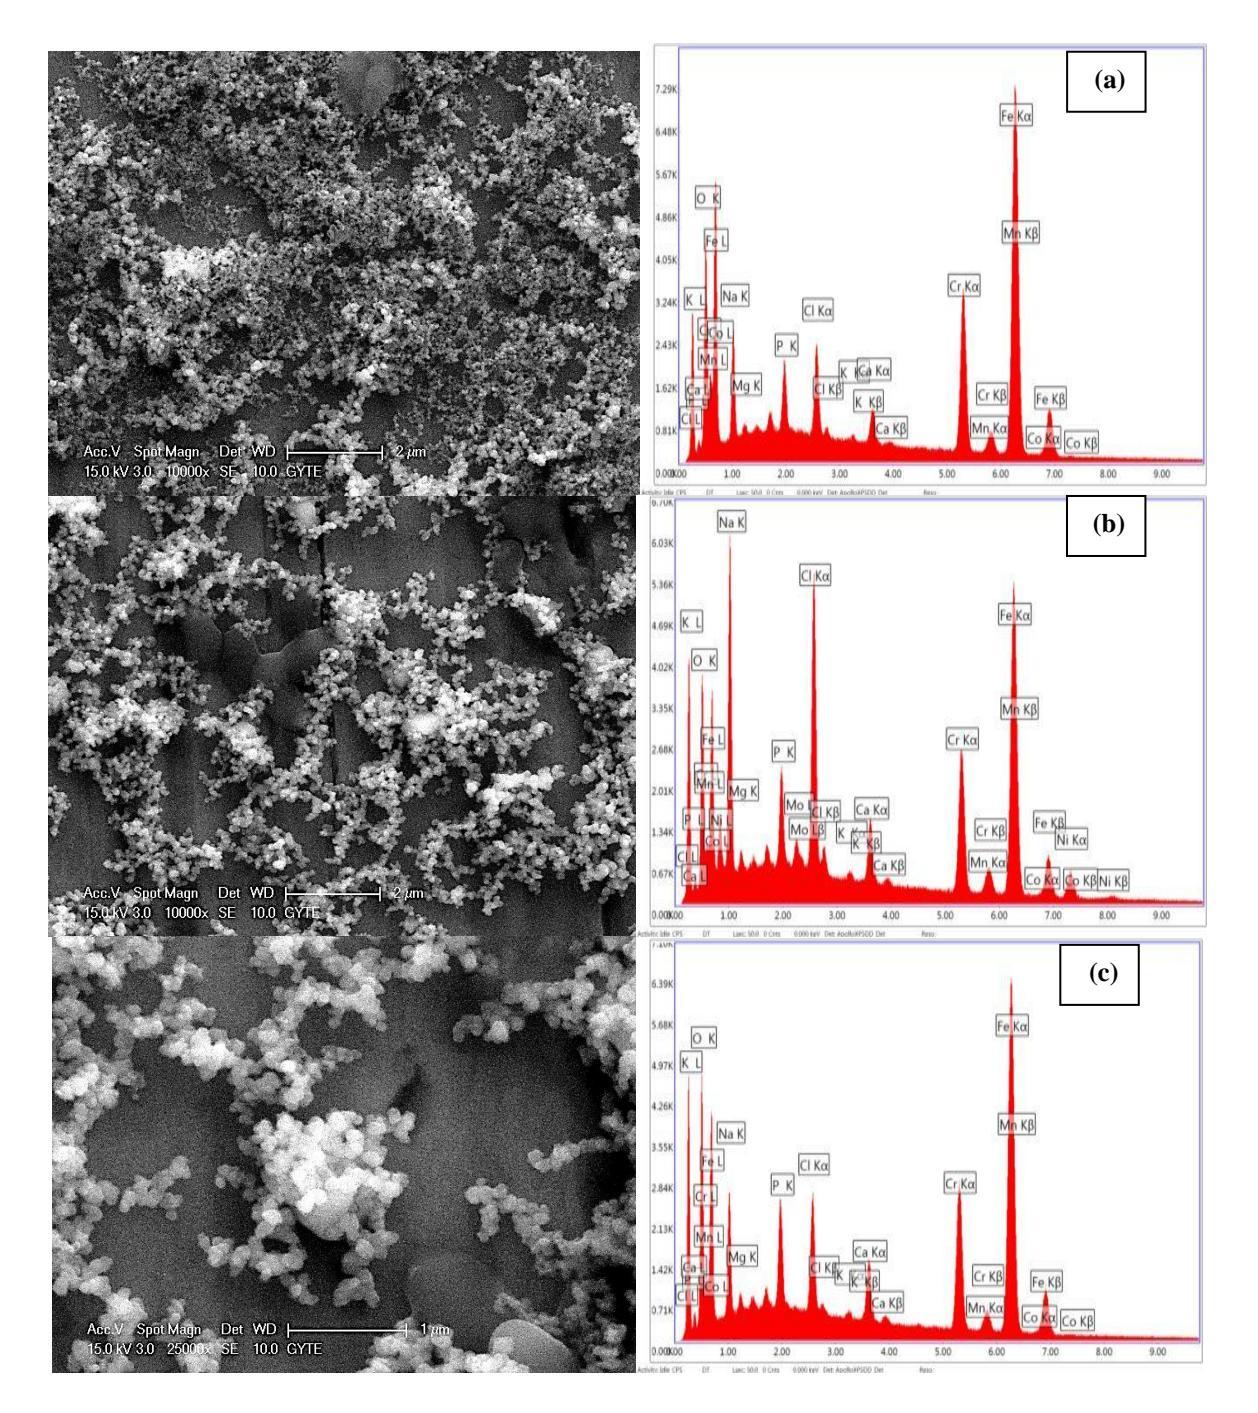
EDS analysis was carried out on welding seam of laser welded samples and on anywhere on base metal which were immersed in SBF for 28 days (Figure 7).

EDS examinations showed the formation of Ca, P, O and Na elements, main constituents of hydroxyapatite, a structure similar to bone tissue, on the base metal sample and on the surface of welding seam. EDS analysis conducted on hydroxyapatite layer formed on the surface of welding seam of samples immersed in SBF up to 28 days revealed that Ca/P ratio tended to increase as the duration of immersion in SBF increased.

Figure 7. EDS point analysis of apatite form that developed on surface (a) base metal, (b) on welding seam of laser welded B1, (c) B2 heat treated samples immersed in SBF for 28 days.

This finding indicates that prolonged immersion might lead to an increase in hydroxyapatite and it shows that apatite accumulation on the surfaces may accelerate depending upon immersion period. Ca/P ratio on the surface of base metal sample immersed in SBF for 28 days was about 1.02, while it was 1.04 and 1.10 on welding seam of laser welded B1 sample and B2 sample, respectively. The ratios in EDS analyses were smaller in early days of immersion (about 0.80-0.90 Ca/P ratio).

Characterization of apatite structure which developed on welding seam after immersing the sample for 28 days in SBF via EDS revealed that the value of stoichiometric Ca/P value of hydroxyapatite for the ratio of bioactive Ca and P ions (Ca/P), ingredients of apatite structure, was less than 1.67. Also, Ca/P ratios of samples were similar to each other. Stoichiometric Ca/P value of hydroxyapatite is 1.67. However, when Ca/P ratios of apatite layer that accumulated on welding seam of laser welded AISI 420 stainless steel samples and on the surface of base metal samples which were immersed in SBF are lower than 1.67. That can be called as calcium deficient carbonate hydroxyapatite structure with low crystallinity [31, 32]. There are many types of hydroxyapatite and they are classified based on Ca/P ratio [31].

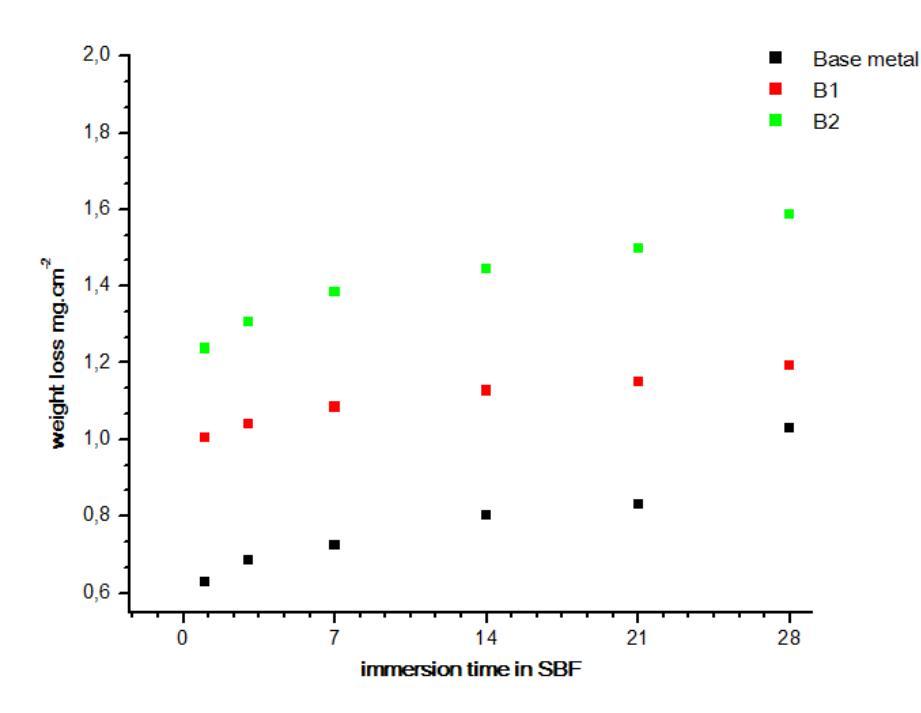
Weight loss results of laser welded and base metal samples immersed in SBF for 1, 3, 7, 14, 21 and 28 days are given in Figure 8. Base metal samples incurred less weight loss compared to samples joined using different two laser welding speeds, which was indeed an expected result (Figure 8).

Figure 8. Weight loss rates of AISI 420 stainless steel Base metal and B1 and B2 heat treated samples immersed in SBF for 1-28 days

Results clearly indicate a weight loss in base metal and laser welded samples depending upon the duration of immersion in SBF (Figure 8). Although AISI 420 stainless steel samples had been joined via laser welding method with low heat input, it was clear that samples were affected by weld thermal cycle, and a sensitivity occurred in weld metal or HAZ compared to base metal, and this sensitivity resulted in weight loss in laser welded samples. It should also be mentioned that the weight losses here were in considerable amounts. The main reason for such a result was relatively limited chemical composition of AISI 420 martensitic stainless steels compared to other stainless steel types. Considering the weight loss of base metal and laser welded samples immersed in SBF for 28 days, weight loss was 0.0025 g in base metal, 0.0029 g in sample B1, and 0.0046 g in sample B2. It appears that in general weight loss in AISI martensitic stainless steel samples during the immersion in SBF was affected by heat input. It was observed that B1 sample joined with lower heat input had less weight loss. Protective oxide layer that formed on the surface of laser welded and base metal supported the stability of samples against weight loss during immersion in SBF. It is important to note that stainless steels produce a passive oxide film on their surfaces with passivation process as a result of their chromium content [Fe,Ni)O(Fe,Cr)₂O₃]. In physiological conditions, chrome oxide layer forming on the surface [13, 33] prevents the transport of metallic ions and electrons, thereby lowering corrosion rate [33].

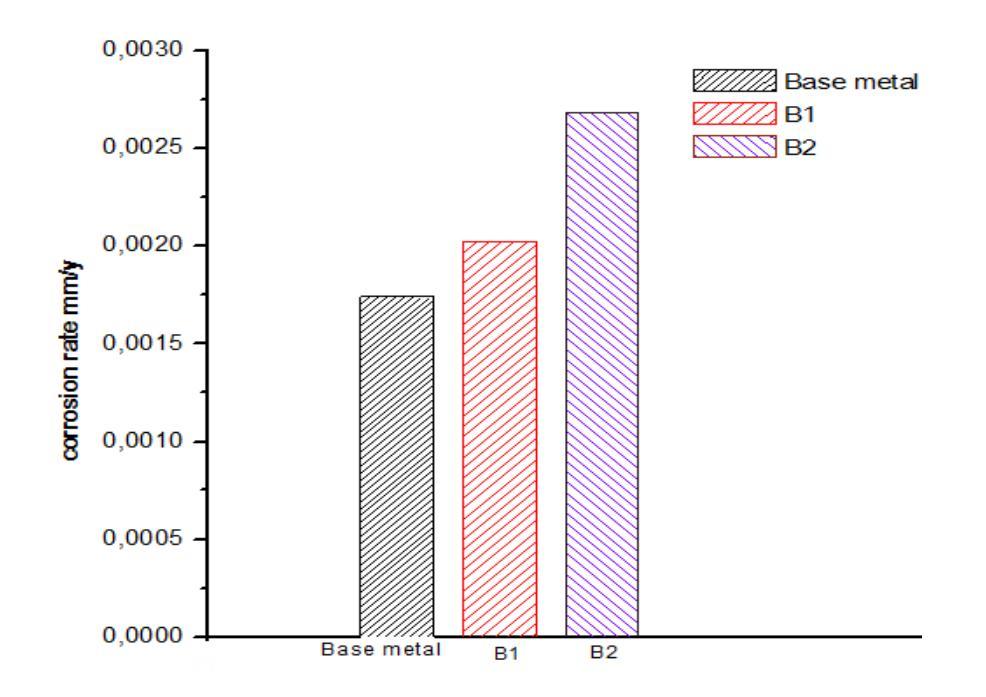
Corrosion rates of laser welded and base metal samples in SBF calculated based on weight loss were given in Figure 9.

Figure 9. Corrosion rates of base metal, B1and B2 heat treated samples immersed in SBF for 28 days.

Relatively high corrosion rates in laser welded and base metal samples are given in Figure 9. When we consider the corrosion rates of samples from laser welded AISI 420 stainless steel, it could be seen that different two welding parameters used for joining the samples led to different corrosion rates. Different corrosion rates observed in samples could be due to different heat inputs as well as due to carbide collapses observed especially in HAZ. In addition, similar observed corrosion rates in base metal and welded samples could essentially be due to heat treatment process applied to martensitic stainless steel. Insufficient resistance of samples to corrosion could be due to 0.035% carbon content of

• It was concluded that heat treated base metal and laser welded samples of AISI 420 stainless steel using different two welding speeds had corrosion rates higher than the tolerable corrosion rate to be used as an implant inside human body. These results strongly support the idea that heat treated base metal and laser welded AISI 420 martensitic stainless steel cannot be used as temporary or permanent implant in human body. However, results with this material could be improved using various surface treatment methods.

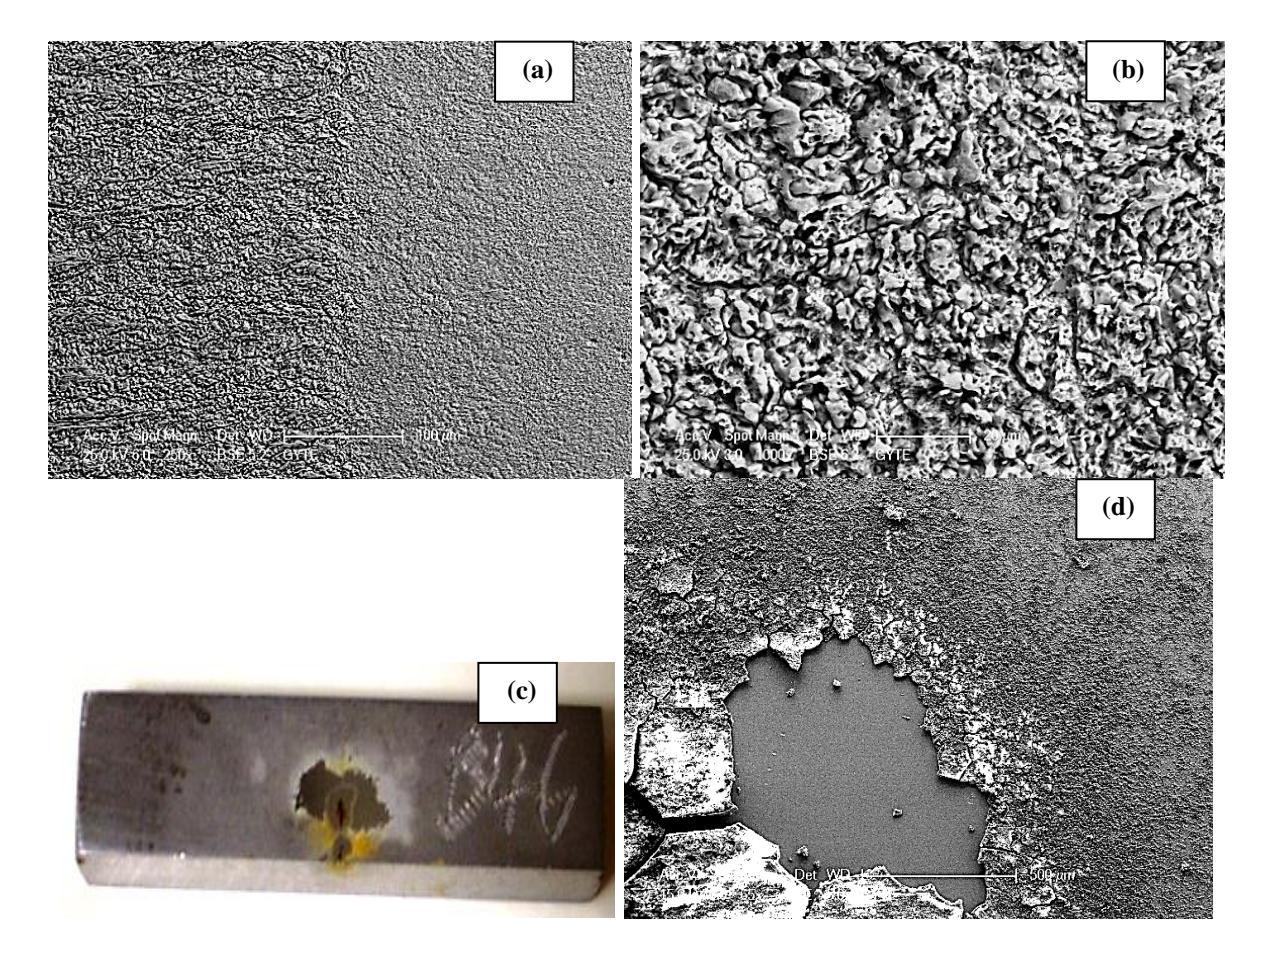
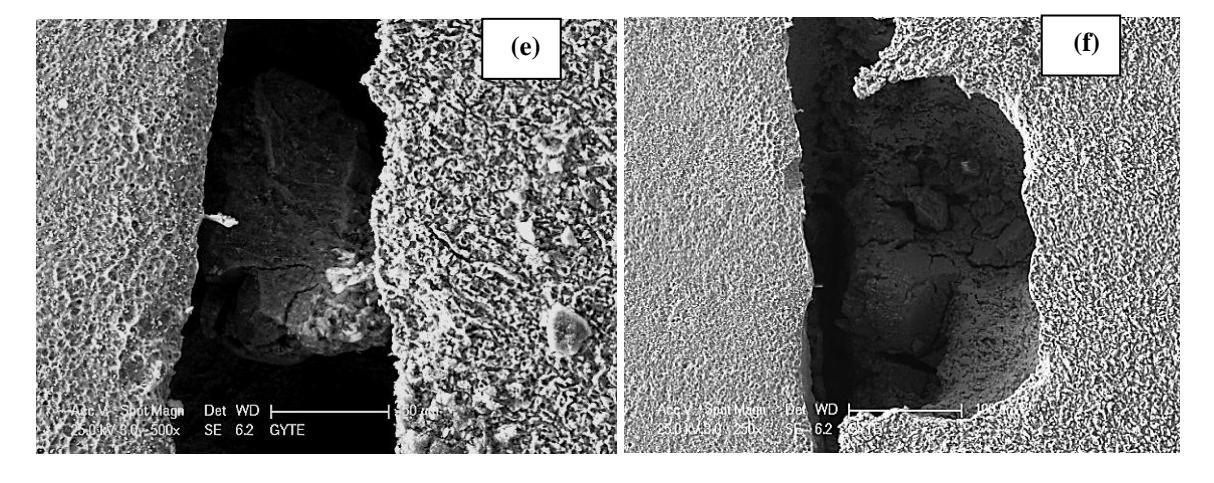
Figure 10. SEM images taken from base metal, HAZ and weld metal from (a) and (b) B1, (c) macro image, (d), (e) and (f) HAZ from B2 heat treated samples immersed in SBF for 28 days.

After cleaning with nitric acid solution (HNO₃) to remove corrosion products that could be produced on the surface of laser welded samples immersed in SBF for 28 days, SEM-EDS examinations were carried out, and the images are given in Figure 10 and 11. No formation indicating corrosion mechanisms were observed on base metal, HAZ, and weld metal of B1 sample (Figure 10 (a) and (b). EDS analysis showed that amount of chromium in B1 sample was higher than that in B2 sample. However, an examination of SEM images of B2 sample which was joined using a higher heat input did not reveal any corrosion or crack in base metal and weld metal, but indicated that a complete dissolution occurred in HAZ, chromium oxide layer was locally disrupted, and an intense corrosion mechanism took place.

Corrosion development could be due to chromium carbide or nitride forming around HAZ in addition to microsegregation, which occurred in heat treatment conditions. Results of EDS analysis (Figure 11) showed that chromium ratio in corrosion zone of HAZ increased considerably compared to corrosion forming on base metal or on weld metal. Excessive chromium amount in corrosion region in fact represents the local content in chromium oxide layer dissolved in the surface of sample and should not be confused with general chromium content of material structure. Observation of chromium carbide or nitride formations especially in HAZ in optical microscope, and SEM-EDS, mapping analysis of samples before the corrosion test should be evaluated as an indication that these regions could have sensitivity against corrosion. It is well known that corrosion starts in the regions where these formations are located, and spreads rapidly.

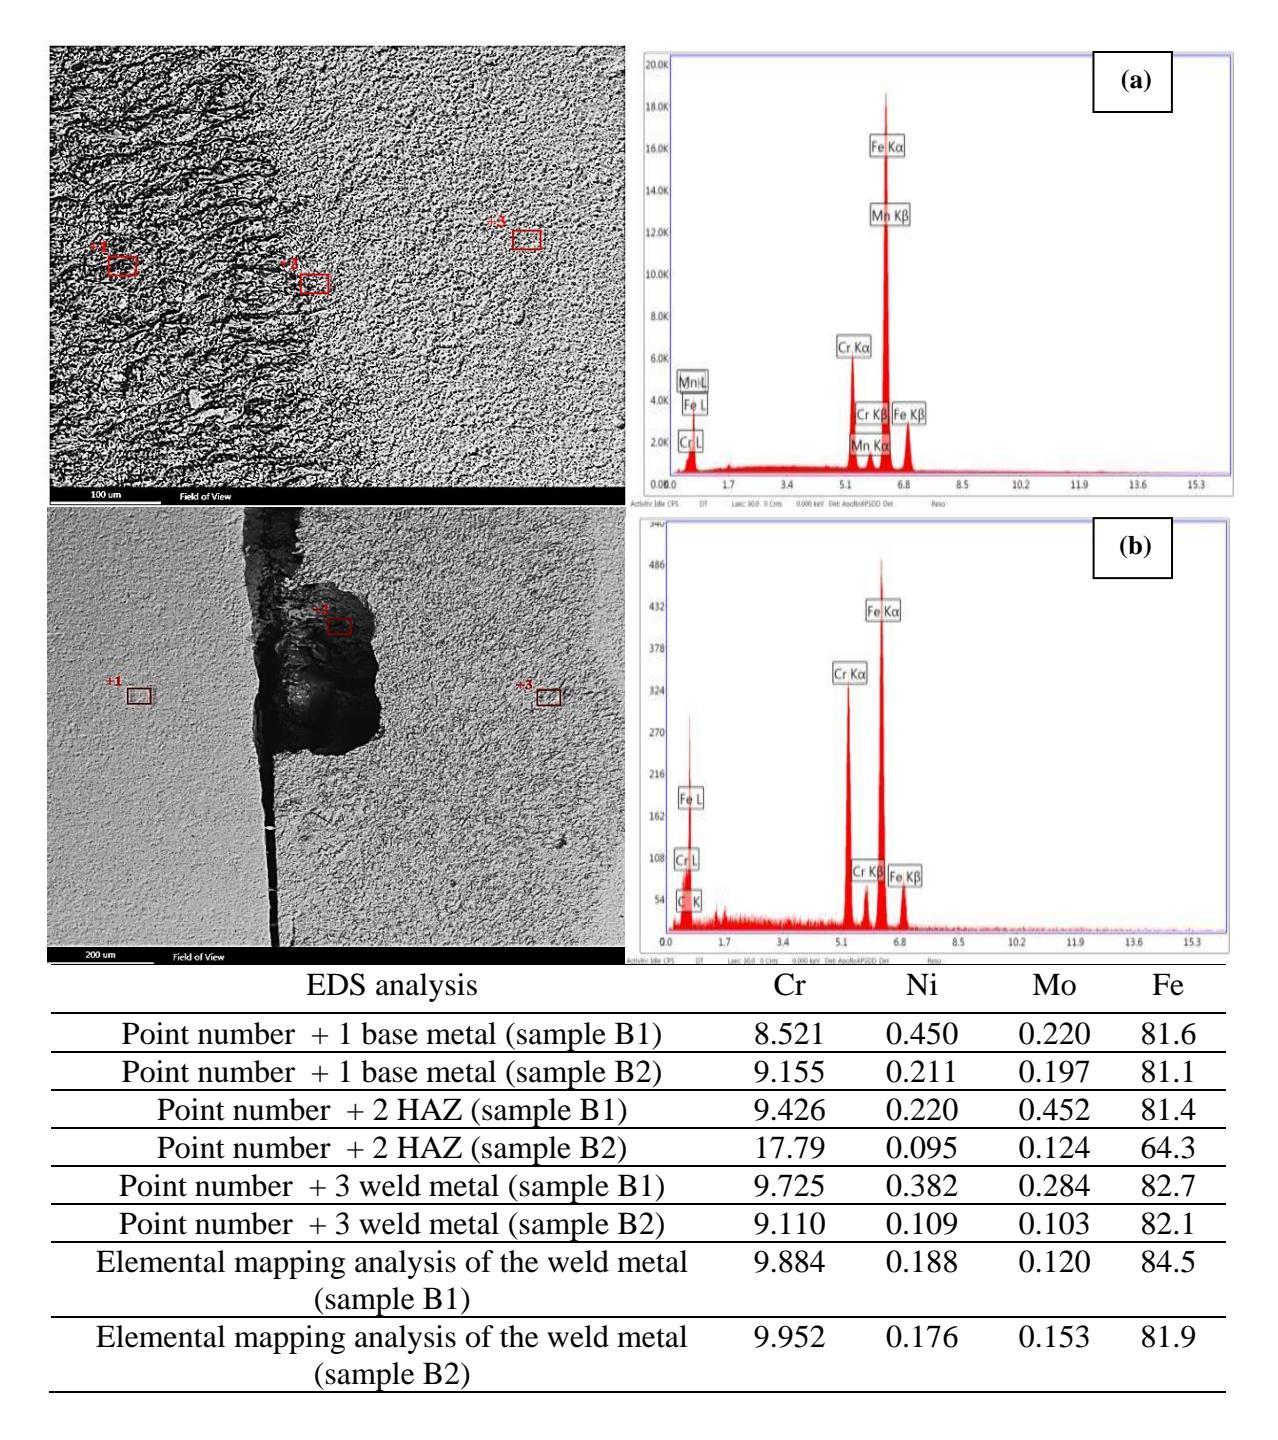
Figure 11. EDS point analysis of base metal, HAZ and weld metal from (a) B1, (b) B2 heat treated samples immersed in SBF for 28 days.

Weaker corrosion resistance has been observed in the sample, which is joined with high heat input due to more accumulation of large-sized carbides in the grain boundaries and softened microstructure. It is important to note that large-sized carbides reduce corrosion resistance more than small carbides [38]. Isfahany et al who investigate the properties of electrochemical corrosion of heat treated martensitic stainless steel suggest that there is an influence of the dissolution of alloying elements, such as chromium and carbon in the microstructure on the behavior of the corrosion of martensitic stainless steel and they suggest that the degradation of chromium oxide passive film layer on surfaces supports corrosion resistance [39]. The amount of passivating elements has an effect on the corrosion resistance of AISI 420 martensitic stainless steel [40]. This study also suggests that the
