Short Communication

Effect of Passive Film on Cavitation Corrosion Behavior of 316L Stainless Steel

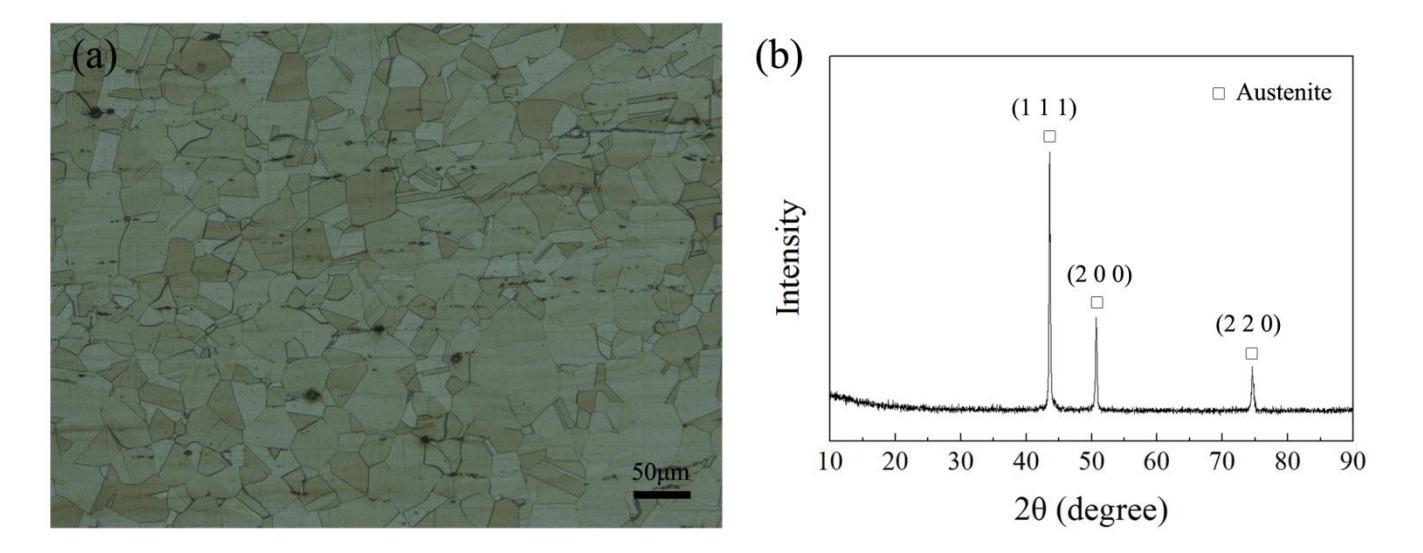
Fig. 1 shows the microstructure and X-ray diffraction (XRD) pattern of 316L stainless steel. The microstructure was observed to be homogeneous (Fig. 1a). Combined with the XRD results (Fig. 1b), it can be concluded that the metallographic structure of the material conformed to austenite.

Figure 1. Microstructure (a) and XRD pattern (b) of 316L stainless steel.

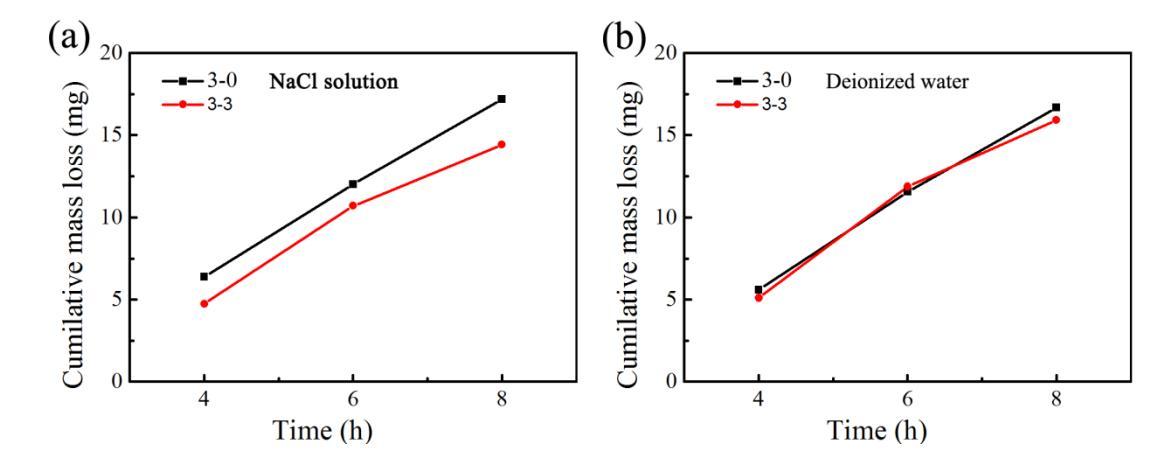
The cumulative mass loss as a function of effective cavitation erosion time for 316L SS in NaCl solution and deionized water is shown in Fig. 2, and the corresponding results were listed in Table 2. In NaCl solution (Fig. 2a), the values for 316L SS exposed to continuous cavitation erosion-corrosion were observed to be higher than the pulse mode. For cavitation erosion for 8 h, the mass loss caused by the continuous cavitation was 17.19 ± 0.65 mg, which was almost 1.2 times the mass loss observed for pulse mode (14.43 \pm 0.67 mg). In deionized water (Fig. 2b), the weight loss for pulse cavitation erosion-corrosion was similar to the continuous mode, which indicated that the mechanical damage to the NAB alloy was nearly the same. It also implied that there was no difference in the cavitation strength between the two modes of the ultrasonically vibrating device in this case. Thus, the damage caused to steel by the pulse cavitation erosion in NaCl solution was lighter than the continuous cavitation mode. It could be inferred that the passive film, formed immediately by the corrosion reaction during the absence of cavitation erosion for 3 s under pulsed mode, reduced the cavitation erosion damage to the substrate. [15].

Figure 2. Cumulative mass loss of 316L SS as a function of cavitation erosion–corrosion time in (a) NaCl solution and (b) deionized water.

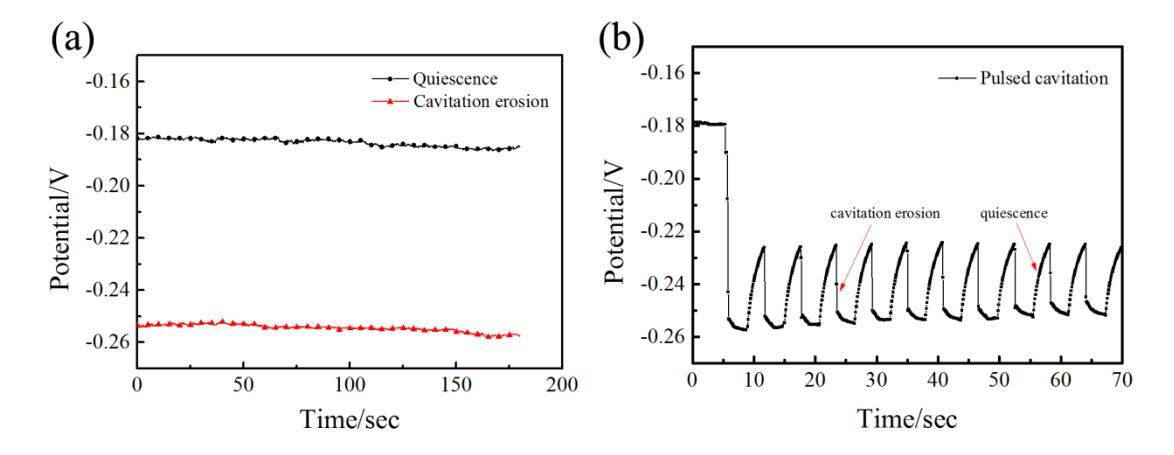
Fig. 3 shows the OCP of steel for quiescent, continuous and pulse cavitation erosion–corrosion in NaCl solution. It was observed that cavitation erosion induced the negative shift of OCP, in both continuous and pulsed modes. During cavitation erosion, the OCP of 316L SS was affected by two competing factors, the increase of mass transport (oxygen) and the corrosion film detachment [9, 16]. Vigorous stirring under cavitation erosion enhances the oxygen supply to the substrate surface, thus, accelerating the cathodic polarization reaction and the resulting positive shift of OCP, whereas the corrosion film detachment shifts the potential in the active direction by exposing the fresh base metal. [17]. In the case of continuous cavitation (Fig. 3a), OCP was stabilized at a more negative value of -0.25V than in stationary NaCl solution (around -0.18V), which was consistent with the results reported before [18]. It was owing to the fact that the film destruction was dominant as compared to the accelerated mass transport. The surface of steel was always bare under continuous mechanical shock, thus, the corrosion potential was stabilized around -0.25V in continuous mode. Under pulse cavitation erosion in NaCl solution, the potential of 316L SS rose to -0.235 V and subsequently decreased to -0.26V periodically (Fig. 3b). This phenomenon was observed due to the rapid formation of the passive film as cavitation erosion stopped, along with shedding of the passive film as cavitation erosion appeared.

Figure 3. OCP of 316L stainless steel measured in NaCl solution under (a) continuous cavitation erosion and (b) pulse cavitation erosion conditions.

Therefore, it can be concluded that in the process of continuous cavitation erosion, the steel surface was subjected to continuous mechanical shock, and the passive film on the surface of the material could not be formed or formed at a rate lower than being peeled off, thus, the steel surface was always bare. As the pulse cavitation erosion occurred, the passive film healed quickly in the absence of cavitation erosion, which protected the matrix from damage. Thus, the mass loss in the case of pulse cavitation erosion of stainless steel is observed to be lower than the continuous mode

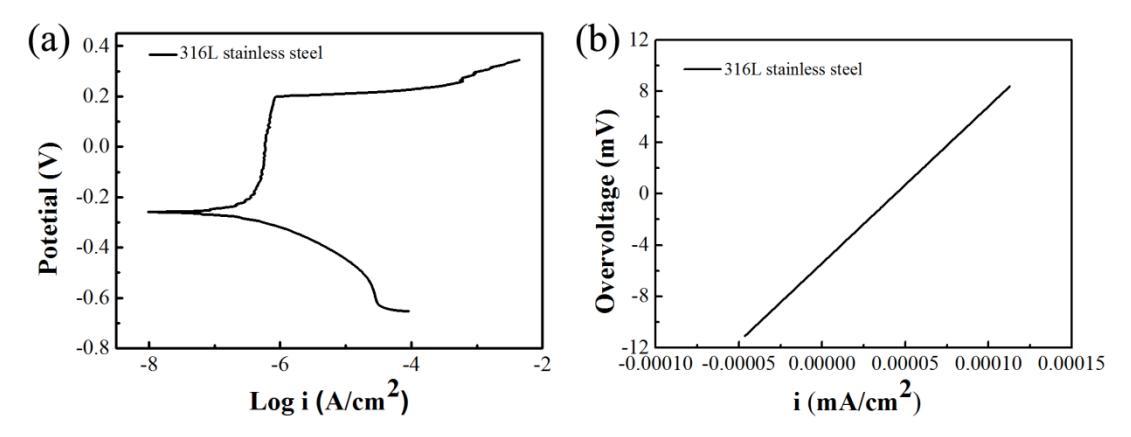
Figure 4. Potentiodynamic polarization curve (a) and linear polarization plots (b) of 316L stainless steel measured in NaCl solution.

The exposed area was calculated as 1.94 cm^2 according to the size of the horn, whereas i_{corr} was calculated according to equation (1). The corresponding electrochemical parameters are summarized in Table 3, evaluated from the potentiodynamic polarization curve and linear polarization plot shown in Fig. 4.

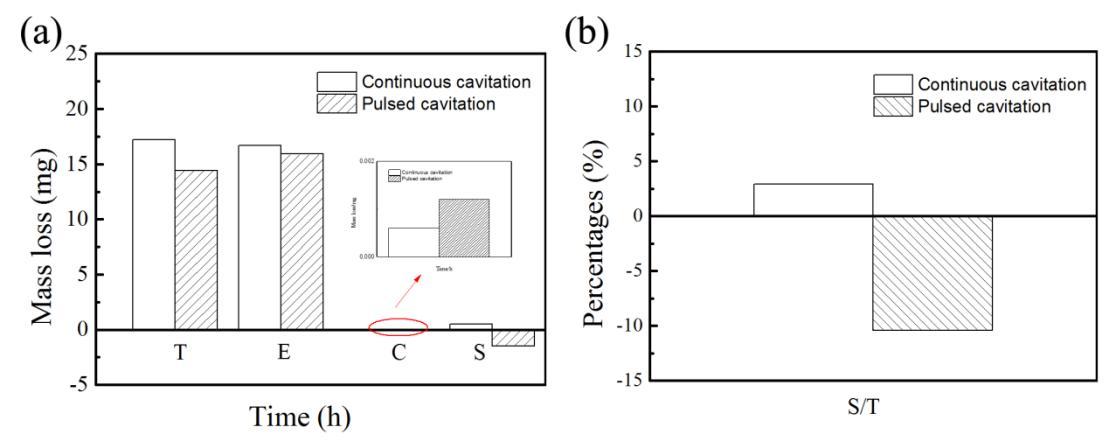
Figure 5. Mass loss contributed by pure corrosion (C), pure erosion (E), cavitation erosion-corrosion (T), and synergy (S) as well as the corresponding contribution of synergy on T for 316L stainless steel after effective cavitation erosion for 8 h in NaCl solution.

The values of T, C, E and S as well as the contribution of S on T for cavitation erosion duration of 8 h are shown in Fig. 5 and Table 4. In NaCl solution, the value of T under continuous cavitation erosion–corrosion was higher (17.19 mg) than the pulse mode (14.43 mg). The mass loss from E for continuous (16.69 mg) and pulsed (15.93 mg) modes was observed to be almost similar. As observed from Table 4, the value of C was 0.0006 mg for continuous cavitation erosion which was less than 0.0012 mg for pulsed mode, attributed to the shorter duration for the samples exposed to NaCl solution in continuous mode. In addition, the value of synergy in the continuous mode was 0.499 mg, while a negative value of -1.50 mg was obtained in the pulse mode .Moreover, 316L SS exhibited negative synergistic (S/T of -10.40%) characteristics of cavitation erosion and corrosion in pulse cavitation mode, while presented a typically positive synergistic (S/T of 2.90%) for continuous mode. The similar result was reported in the micro–abrasion–corrosion behavior of S32760 stainless steel due to excellent repassivation performance in NaCl solution. It pointed out that the large negative synergies produced by the two-body wear mechanism may be a reflection of the differences in repassivation kinetics and/or composition of the passive films reducing the overall level of two–body abrasion [21]. Compared with continuous cavitation erosion–corrosion, passive film formed by corrosion reaction during pulse cavitation erosion–corrosion enabled the matrix to resist the damage of cavitation erosion, thus, exhibiting negative synergistic characteristics.

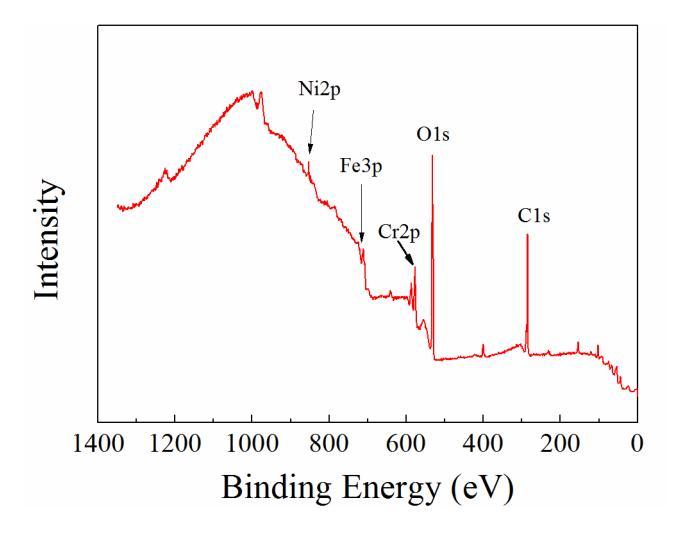
The excellent corrosion resistance of 316L stainless steel was mainly due to the dense passive film formed on the surface, which blocked the transmission of ions between the metal surface and corrosive solution, thereby, reducing the corrosion rate. Fig.6 and Fig.7 demonstrate the full and narrow XPS spectra of the passive film after 7 days of immersion in 3.5 wt. % NaCl solution. Obvious Cr_{2p} , Fe_{2p} and O_{1s} peaks as well as a weak Ni_{2p} peak were observed in the spectrum, indicating that the main constituent elements of Cr and Fe in the passive film existed in the oxide form. The binding energy of the Cr_2O_3 and Fe_2O_3 peaks was 576.4 eV and 710.4 \pm 0.1 eV respectively [17]. It was consistent with the conclusion that the passivation film was composed of chromium oxide as the inner component and iron oxide as the outer component [22, 23].

Figure 6. Full XPS spectra of the passive film on the surface of 316L stainless steel after immersion in NaCl solution for 7 days.

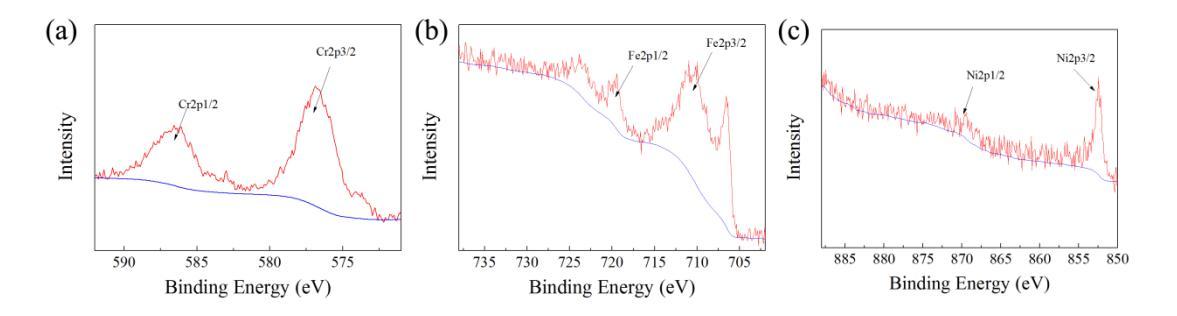
Figure 7. XPS spectra of Cr, Fe and Ni in passive the film on the surface of 316L stainless steel after immersion in NaCl solution for 7 days.

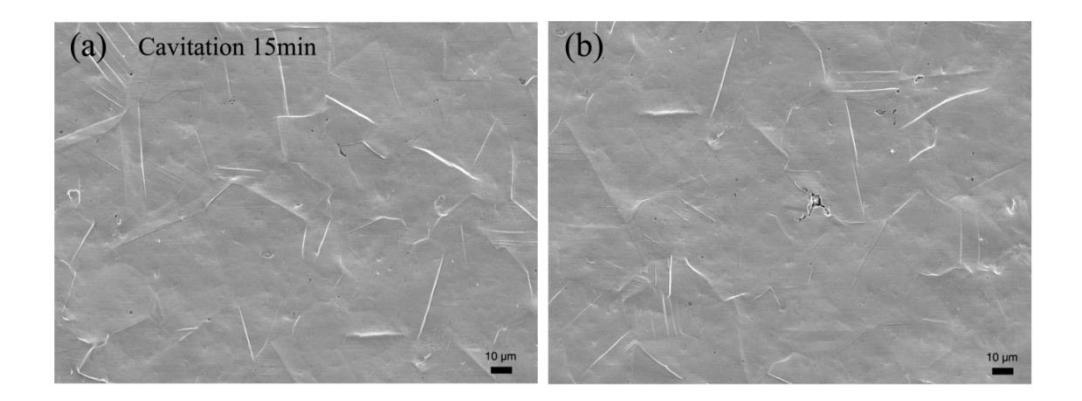
Cavitation morphology was carried out to gain further insights into the cavitation erosion– corrosion behavior of 316L stainless steel, as shown in Fig.8. The pulsed cavitation erosion–corrosion behavior of 316L stainless steel was observed to be different from the continuous mode in NaCl solution, which was mainly related to the passivation film. The corresponding mechanism has been proposed in Fig.9. Prior to the initiation of cavitation (Fig.9a), the stainless steel surface in NaCl solution was quickly passivated to form a double-layer passivation film, wherein the inner layer was Cr_2O_3 and the outer layer was Fe_2O_3 .On initiation of cavitation, the passive film on the steel surface became thin and eventually ruptured under the mechanical impact [24]. After passive film was destroyed, the fresh substrate was directly subjected to mechanical impact, and the surface of the material underwent plastic deformation (Fig. 8). With time, the fatigue cracks sprouted at the grain boundaries and penetrated into the interior of the material (Fig. 8 and Fig.9b). As the cavitation erosion stopped, the steel surface was rapidly repassivated to form an oxide film thinner than before, which protects the substrate from subsequent cavitation damage (Fig.9c). [25].

Figure 8. Damage morphology of 316L stainless steel after cavitation erosion in NaCl solution for 15 min.

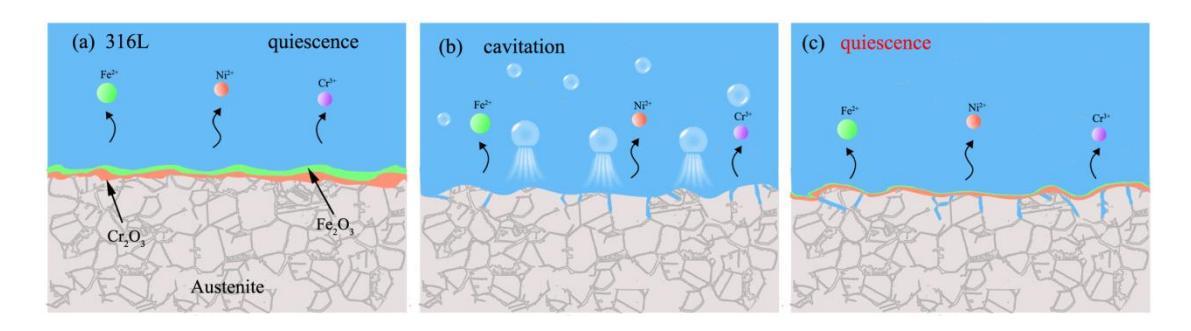
During pulse cavitation erosion–corrosion, the passive film was periodically formed and destroyed. In the continuous process, the surface of 316L SS was constantly mechanically impacted by the bubbles, and the surface could not form a passive film, thus, keeping it in bare state. Therefore, the passive film formed intermittently in pulse behavior alleviated the cavitation damage to the substrate.

Figure 8. Schematic of the cavitation erosion–corrosion behavior of 316L stainless steel in NaCl solution.
