Study on Cavitation Behavior of Pipe String in Gas Storage Well under Gas-Liquid Environment

Hang Yan¹, Yifei Yan^{2,*}, Xiangzhen Yan¹

¹ College of Pipeline and Civil Engineering, China University of Petroleum, Qingdao 266580;
 ² College of Mechanical and Electronic engineering, China University of Petroleum, Qingdao 266580
 *E-mail: <u>20180056@upc.edu.cn</u>

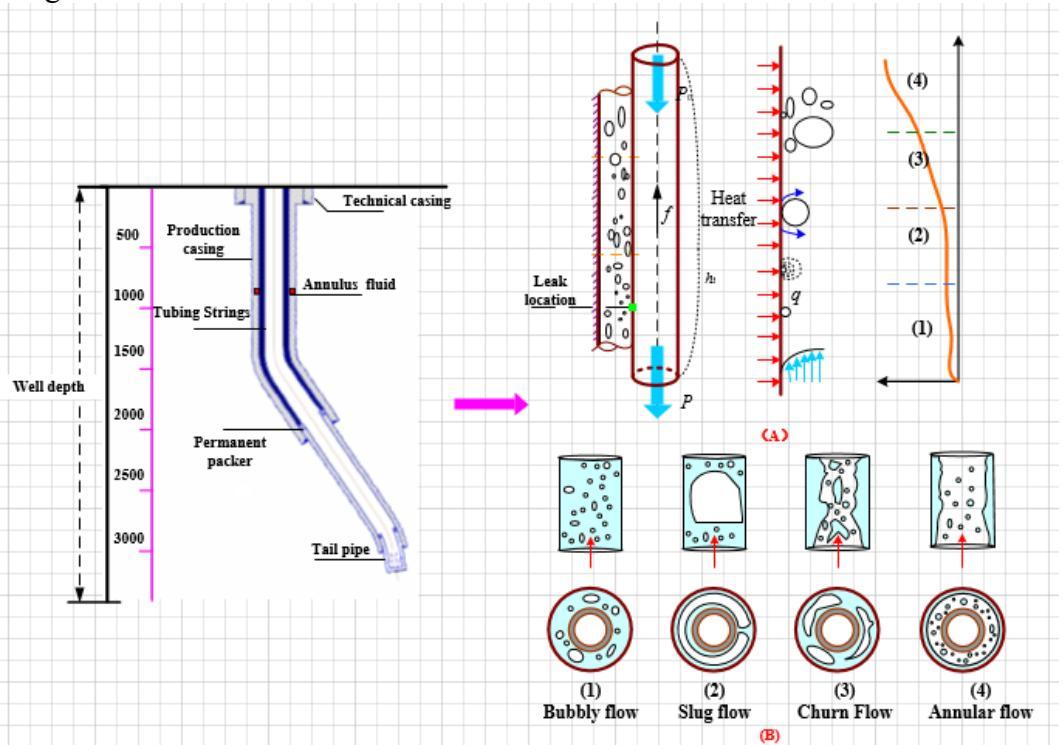
Figure 1. Gas-liquid two-phase flow in the annulus of UGS well

Experimental conditions: As shown in Fig.1, the annular space was 893 m deep, calculated temperature was about 70 °C, and the calculated annular pressure was 5–20 MPa. Under the studied experimental conditions, the gas-liquid ratio of the mixed fluid was described by the pressure value in the reactor, and the cavitation process of the fluid was described by setting the stirring speed of 10 m/s.

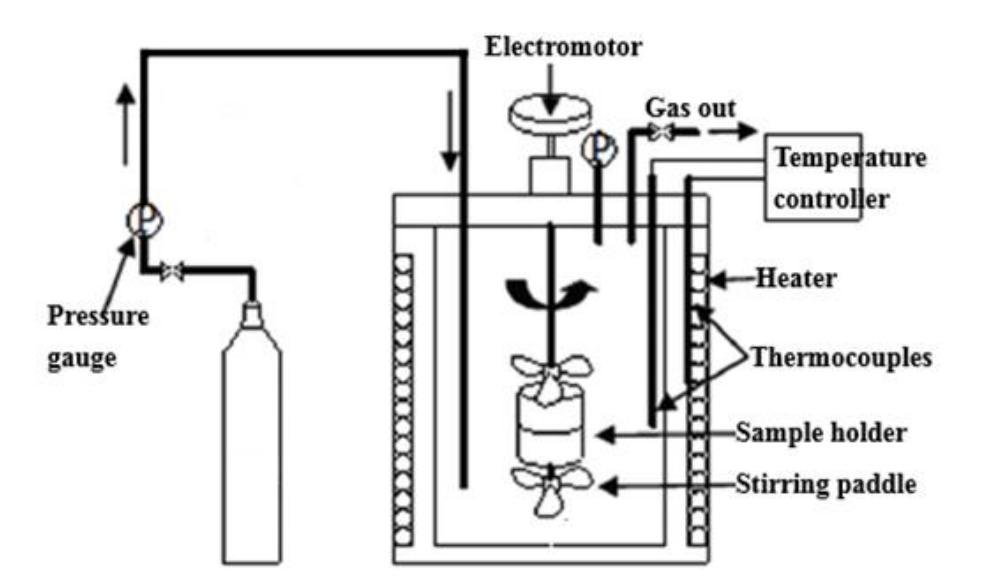
Figure 2. Experimental apparatus: high temperature - pressure reactor

Based on high temperature-pressure reaction kettle, the three-electrode test system was adopted

to conduct the electrochemical tests (see Fig.2). Annular protection liquid was adopted as the experimental solution. The reactor was pressurized with high purity N_2 and the pressure was monitored by pressure valve in real time. The temperature was adjusted with the temperature controller, and the flow velocity was controlled by rotating the blade. In the three-electrode test system, the working electrode (WE) was 13 Cr with the size of $25 \times 25 \times 2 \text{ mm}^3$ (the elemental composition in Tab.1), the reference electrode (RE) was SCE (saturated calomel electrode), and the auxiliary electrode (AE) was Pt electrode. The reference electrode was in contact with the solution through the Luggin-Haber capillary and the distance between the tip and the X80 steel surface was less than 2 mm to ignore the IR drop due to solution [10].

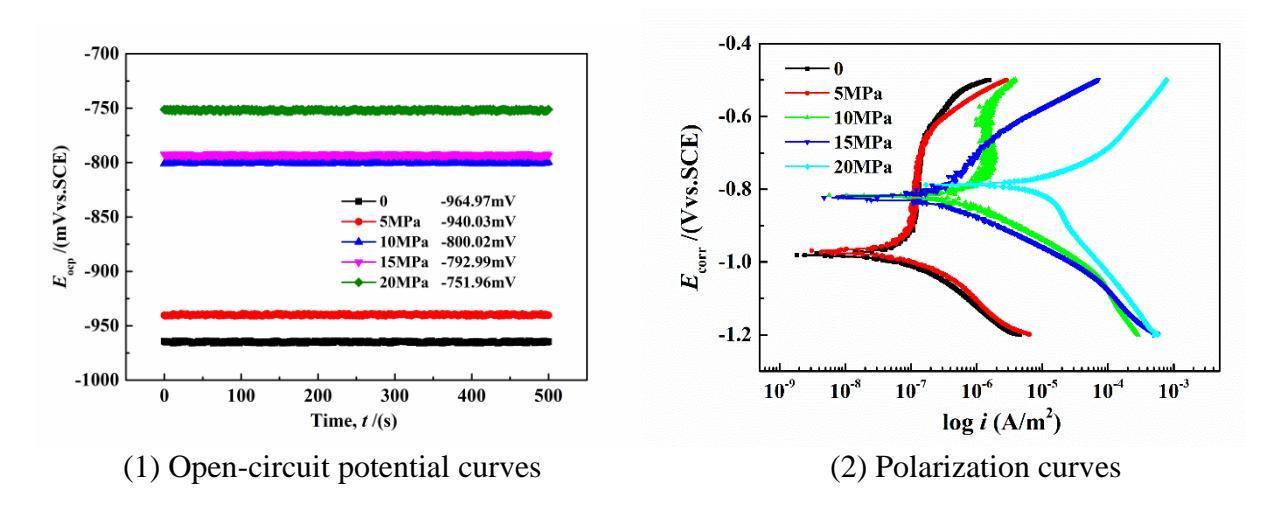
Figure 3. Open-circuit potential curves and polarization curves of 13Cr in annular protective solution under different leaked-gas pressure of 0-20 MPa with the flow velocity of 2 m/s at the beginning of the experiments

Fig.3 shows the change of open-circuit potential (E_{OCP}) and polarization curve of 13Cr under different pressure conditions at the beginning of the experiments of stabilization. With the increase in pressure in the annulus, the open-circuit potential displayed a trend of positive deviation, which indicates that the corrosion tendency of the 13Cr increased. At the same time, when the pressure increased from 5 MPa to 10 MPa, the open-circuit potential demonstrated a large positive deviation, up to 140 mV, suggesting that the reaction process on the metal surface underwent a fundamental change [12].

From the point of the field test results, when the pressure in the annulus reached 5 MPa, prominent gas leak in the annulus had occurred. Under the condition of 0–5 MPa pressure, two polarization curves were synchronized, at which corrosion potential (E_{corr}), corrosion current density (I_{corr}), and cathode / anode Tafel constant (β_a and β_c) were generally equal. Moreover, there was clear passivation range in the anodic polarization curves, indicating that the solution could be approximately regarded as the single liquid phase with little dissolved gas. Under these circumstances, the corrosion was inhibited by the corrosion inhibitor and passivation film of Cr, and the impact of dissolved gas could be neglected [13-15]. With the increase of gas pressure in the annulus, the gas solubility in the protective solution was also increased. When the pressure was 10 MPa, the whole polarization curve moved towards the right and upwards, the corrosion rate increased, and the corrosion potential was positively shifted. However, there was still a clear passivation interval in the anodic polarization curve. However, with the further increase in pressure to 15 MPa and 20 MPa, the anode passivation area completely disappeared and the metal displayed activated corrosion, at which the corrosion rate may

As shown in the Tab.1, both corrosion potential and corrosion current density increased with the increase in pressure. At the same time, when the pressure was greater than 5 MPa, both of them increased rapidly, indicating that the corrosion process on the metal surface had changed significantly. From the system as a whole, in the gas-liquid two phase environment, firstly, annulus protection fluid formed a protective film on the metal surface. Secondly, 13 Cr is a stainless steel and can form a layer of passivation film to slow down the corrosion of tubing string [17,18]. However, with the rise in pressure and under the action of flow rate, formation and rupture of gas bubble on the metal surface directly led to the destruction of two layers of protective film [19-21]. Therefore, when the pressure increased to 15 MPa, the metal activation corrosion morphology was displayed.

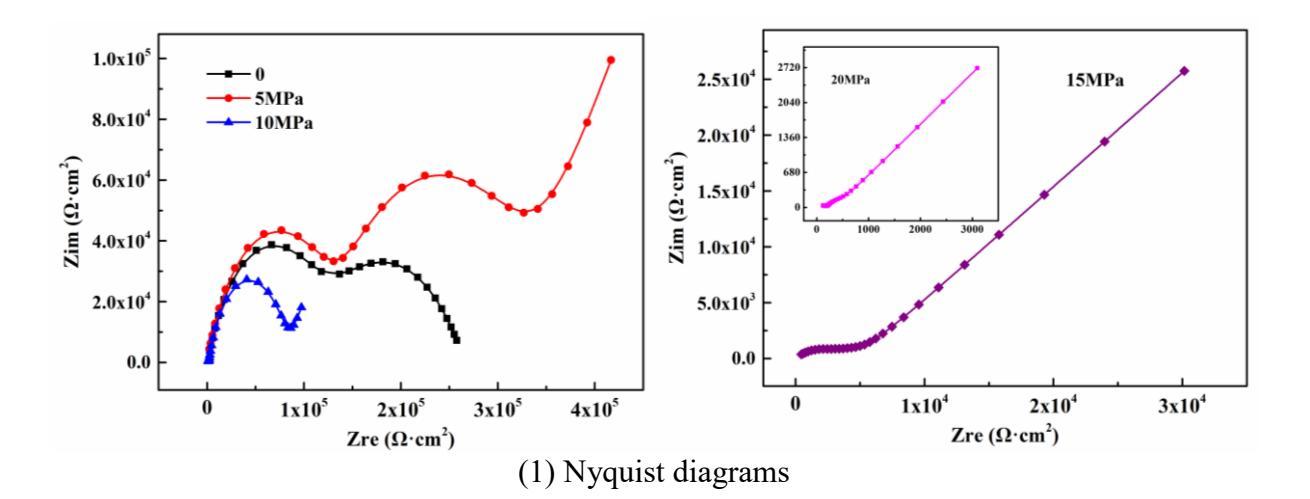
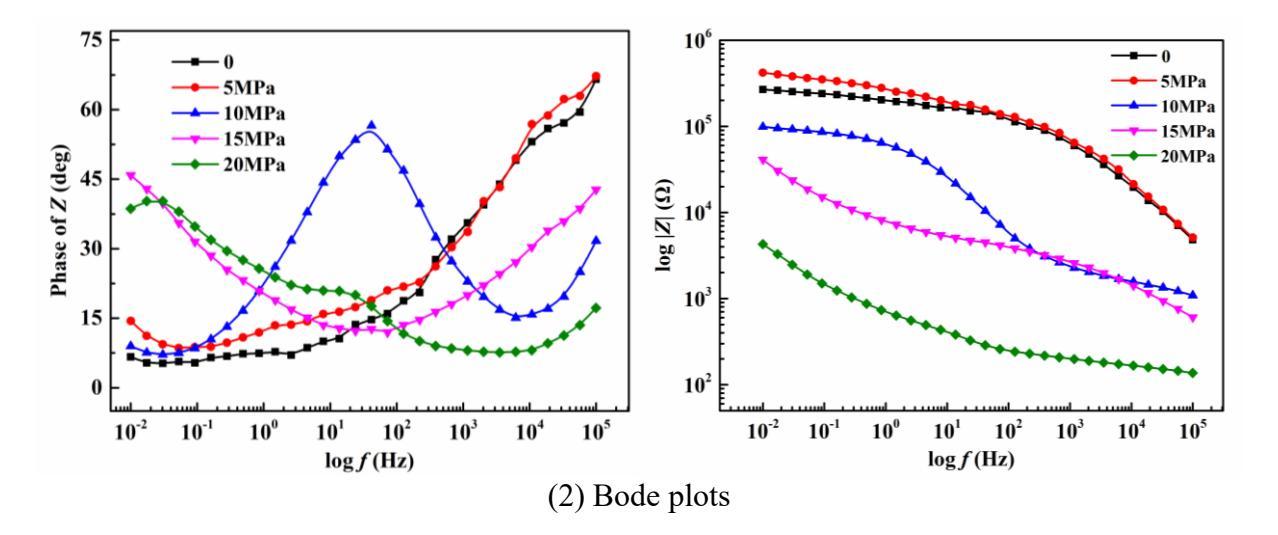
Figure 4. EIS curves of 13Cr in annular protective solution under different leaked-gas pressure of 0-20 MPa with the flow velocity of 2 m/s at the beginning of the experiments

Fig.4 displays the electrochemical impedance curves of 13Cr under different pressure conditions at the beginning of the experiments. Under pure liquid phase condition, Nyquist diagrams displayed clear bi-capacitation resistance, signifying the protective film of the annulus and passivation film of 13Cr. Therefore, the fitting circuit was selected as $R_s(QR_p)(Q_{dl}R_{ct})$. With the increase in pressure, under the action of flow velocity, Nyquist diagrams displayed clear Warburg diffusion characteristics, signifying that the formation - rupture process of gas double at the metal surface damaged the protective films [22,23]. Therefore, the fitting circuit was selected as $R_s(QR_p)(Q_{dl}(R_{ct}W)$: R_s as solution resistance, Q as the system capacity, R_p as the polarization resistance, Q_{dl} as passivation membrane capacitance matrix, R_{ct} as the charge transfer resistance, and W as Warburg diffusion impedance. The fitting results are shown in Tab.2, where the fitting errors were all of the order of 10⁻⁴, displaying a high fitting accuracy [24].

With the gas leakage, the pressure in the annulus increased. However, when the pressure increased from 0 to 5 MPa, the high frequency characteristic of 13Cr did not change, while the mass diffusion process occurred at low frequency, indicating that the outer corrosion inhibitor layer was affected at this time [25]. With further increase in pressure, the capacitor-reactance radius of both the high frequency and low frequency decreased, indicating that the damage of the gas bubble to the double layer was intensified. As shown in the Bode plots, when the pressure reached 10 MPa, the characteristic of intermediate frequency resistance had completely disappeared. When the pressure reached 15–20 MPa, the bilayer membrane had less capacitor resistance. In the Nyquist diagrams, there was a large Warburg diffusion tail, while in the Bode plots, the impedance dropped rapidly and maximum phase angle occurred at the high frequencies. These results indicate that the bilayer membrane structure was completely destroyed and the metal structure was in the process of activated corrosion [26,27]. This result is the same as that of the polarization curve analysis.

The change rules of the relevant fitting results with pressure showed that the two capacitances namely Q and Q_{dl} increased with the rise in pressure, while the resistances of R_p and R_{ct} decreased. As per the change law of charge transfer resistance (R_{ct}), when the pressure was greater than 10 MPa, the charge transfer resistance basically remained unchanged, suggesting that the surface passivation layer was completely destroyed and the metal had entered the activated corrosion stage, i.e., cavitation occurred.

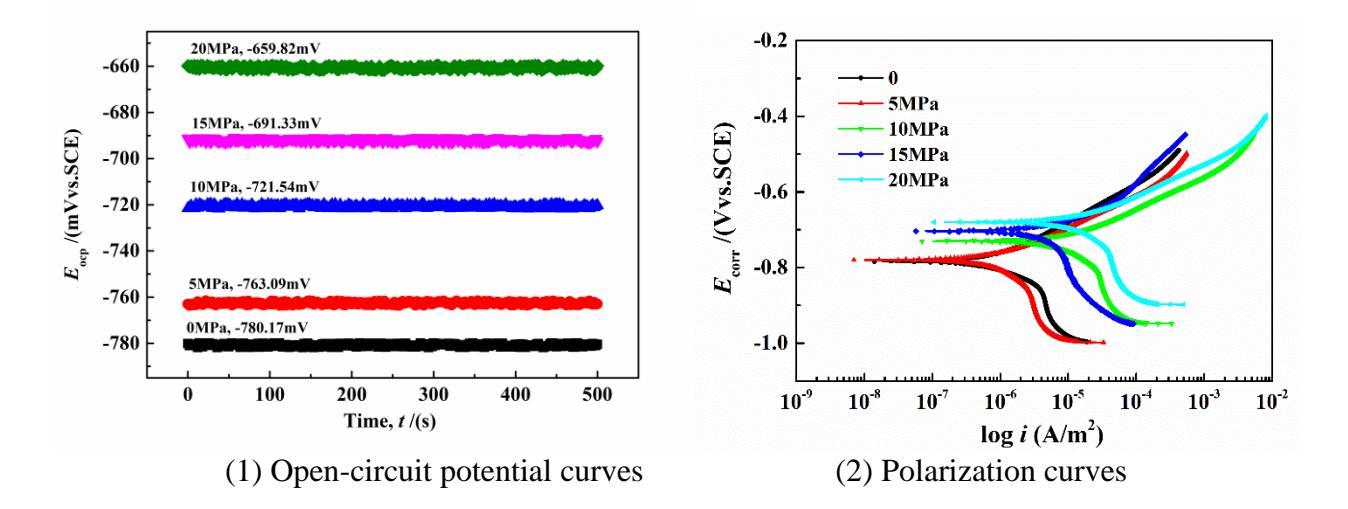
Figure 6. The open-circuit potential curves and polarization curves of 13Cr in annular protective solution under different leaked-gas pressure of 0-20 MPa with the flow velocity of 2 m/s after experiment 24 h

Fig.6 shows the open-circuit potential and polarization curves of 13Cr under different pressure conditions after experiments for 24 h. The fitting results are shown in Tab.3. Compared with the stage at the beginning of the experiments, the open-circuit potentials of 13Cr were all positively offset under different pressure conditions, indicating that with the progress in corrosion process, the corrosion tendency of 13Cr increased [28]. Under the action of flow rate, the double-layer film on the metal surface was in the process of continuous destruction and formation under the action of erosion. At this time, the polarization corrosion process was in the activation corrosion process, and prominent anodic passivation interval completely disappeared. These results suggest that the double-layer protective film structure on the metal surface was damaged by the leaked gas under long-term experimental conditions. At the same time, with the rise in pressure, the corrosion potential and corrosion current

density increased significantly, suggesting that with more severe damage of bubbles to the metal surface, the corrosion control process changed from anode control to cathode control [29].

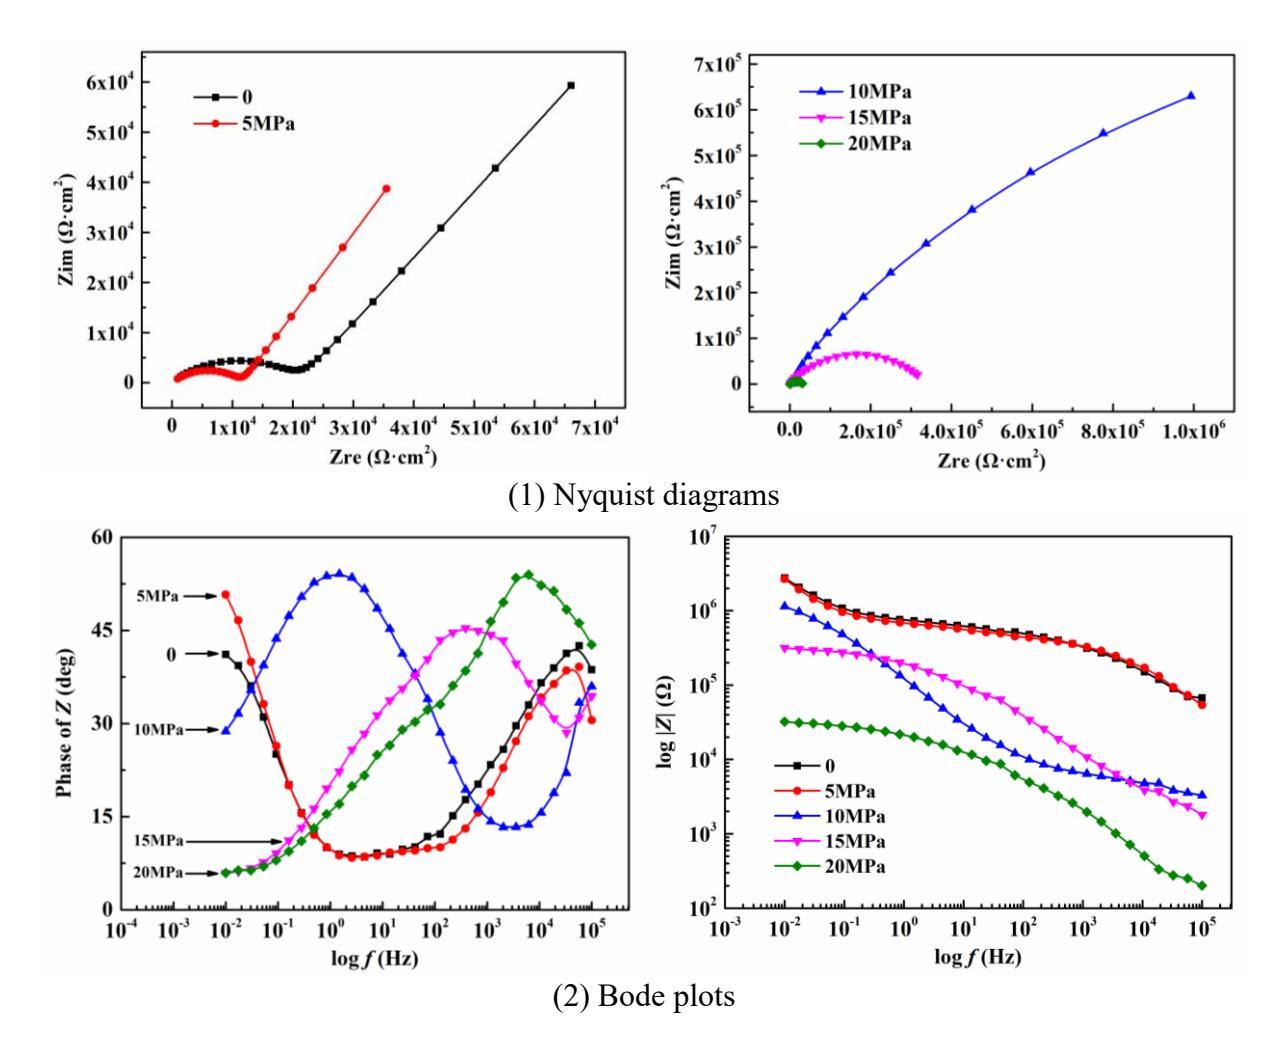
Figure 7. EIS curves of 13Cr in annular protective solution under different leaked-gas pressure of 0-20 MPa with the flow velocity of 2 m/s after experiment 24 h

Fig.7 displays the electrochemical impedance curves of 13Cr under different pressure conditions after experiments for 24 h. After long time of experiment, under the effect of flow velocity, double membrane structure on the surface was in the destruction and generation process. Therefore, under the condition of pure liquid, Warburg apparent diffusion impedance characteristics occurred in its Nyqisut diagram. Hence, the fitting circuit was selected as $R_s(QR_p)(Q_{dl}(R_{ct}W): R_s$ as the solution resistance, Q as the system capacity, R_p as the polarization resistance, Q_{dl} as the passivation membrane capacitance matrix, R_{ct} as the charge transfer resistance, and W as the Warburg diffusion impedance. As the pressure increased, the metal substrate was completely exposed to the corrosion environment at this time, and the polarization curve displayed that the metal was in the activated corrosion state at this time. Therefore, under the pressure of 10–20 MPa, there were two time constants in the Bode plots. Hence, the fitting circuit was selected as $R_s(Q(R_p(C_{dl}R_{ct})))$, where C_{dl} is the capacitance of the double electric layer. The fitting results are shown in Tab.4, where the fitting errors were all of the order of 10⁻⁴, demonstrating a high fitting accuracy.

As per the electrochemical impedance curves, under the conditions of pure liquid (0–5 MPa), due to the flow action, the double membrane diffusion occurred, while the radius of capacitive reactance arc decreased due to the increased pressure, presenting an increased capacitance $(Q=7.27\times10^{-7}\rightarrow1.00\times10^{-6} \text{ F/cm}^2)$ and decreased resistance $(R_p=2.15\times10^4\rightarrow1.17\times10^4 \ \Omega\cdot\text{cm}^2)$. Therefore, there were two time constants in the log*f*- φ curves at highest frequency (10⁵ Hz) and lowest frequency (10⁻² Hz), named as the mass diffusion process and charge transfer process, respectively. With the rise in pressure, the Nyqusit curves of 10–20 MPa displayed the characteristics of double capacitive reactance and the Warburg diffusion characteristics disappeared. This is because when the pressure reached 10 MPa, the corrosive environment changed from single liquid phase to the gas-liquid two-phase. Under long-term experiment, the double-layer film on the metal surface was destroyed, and the metal matrix was completely exposed to the corrosive environment, displaying the state of activated corrosion. At the same time, with the increase in pressure, the cavitation effect on the metal surface became stronger, leading to a gradual decrease in the double layer capacitance on the metal surface ($C_{dl}=2.51\times10^{-7}\rightarrow1.60\times10^{-8}$ F/cm²), while the charge transfer resistance remained basically unchanged ($R_{ct}=3.39\times10^{6} \ \Omega \cdot cm^{2}$).

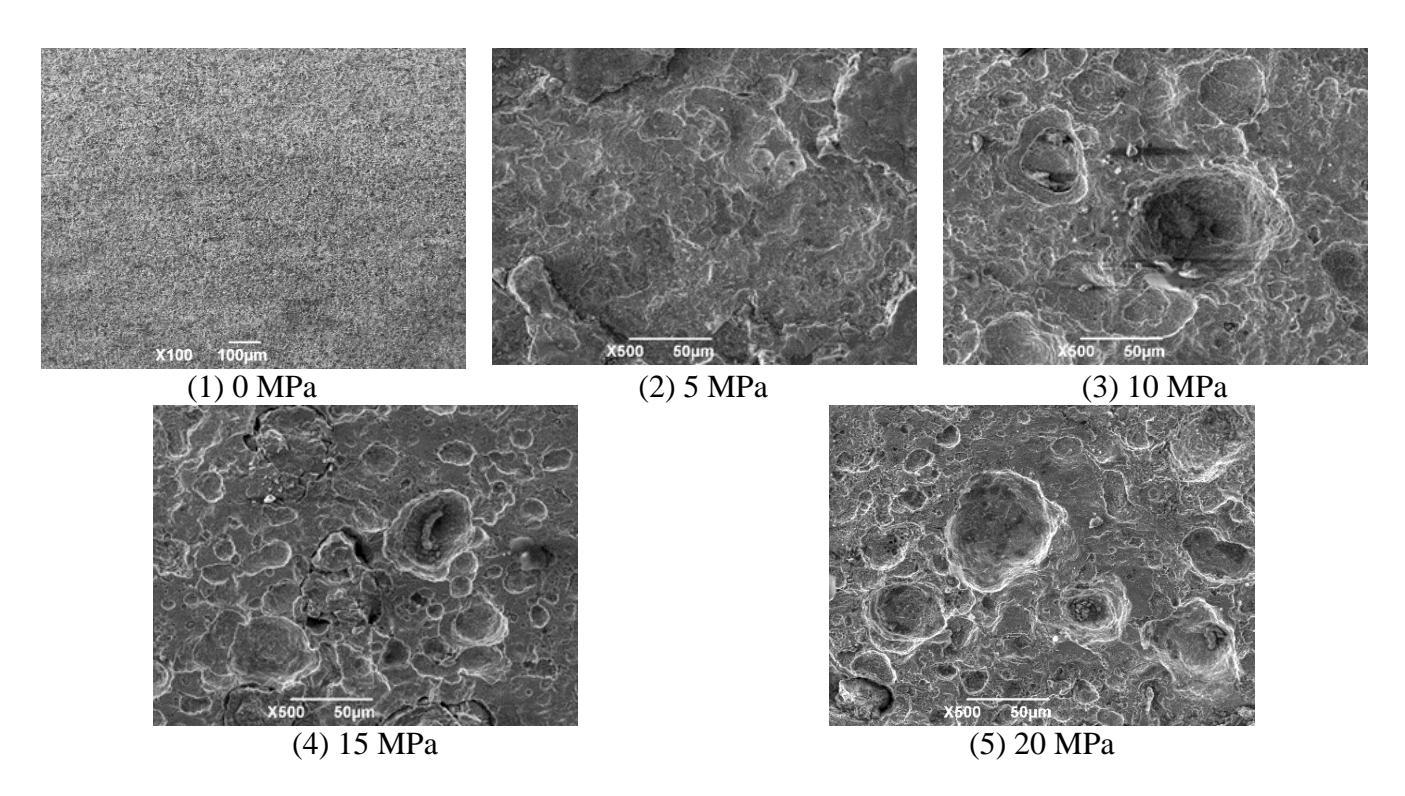
Figure 8. Analysis of local cavitation characteristics of 13Cr surface in annular protective solution under different leaked-gas pressure of 0-20 MPa with the flow velocity of 2 m/s after experiment 24 h

When the experimental time was 24 h, the sample was taken out and the surface corrosion products were removed using standard derusting liquid [30,31]. As shown in Fig.8, the local characteristics of metal surface under different gas pressures were analyzed via SEM. As shown in Fig.9, through binarization treatment, the distribution characteristics of the corrosion pits were observed on the whole metal specimen surface.

When there was no gas leakage, i.e., the gas pressure in the corrosive environment was 0, the entire metal surface was jointly protected by the corrosion inhibitor and passivation film, and the metal surface had no prominent corrosion characteristics, as shown in Fig.8(1). When the gas pressure leakage reached 5 MPa, although the internal corrosion environment could still be approximated as pure liquid phase, the erosion aggravated the damage to the double-layer membrane structure and the metal surface presented the characteristics of layered corrosion [32]. When the gas pressure increased to 10 MPa, clear cavitation characteristics appeared on the metal substrate. Higher the pressure, more were the cavitation pits, indicating that the corrosive environment changed into the gas-liquid two-phase and led to cavitation. As shown in the binarization treatment of the overall metal corrosion pit distribution, the number of cavitation pits increased significantly with the rise in pressure, indicating that cavitation was the main reason for the corrosion failure of the string due to gas leakage in the

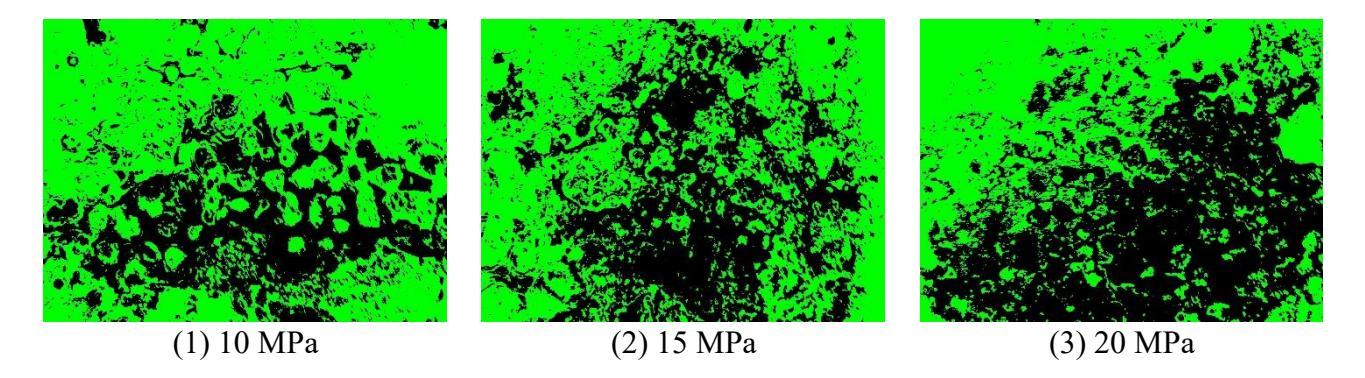
Figure 9. Development of cavitation characteristics on 13Cr surfaces in annular protective solution under different leaked-gas pressure of 10-20 MPa with the flow velocity of 2 m/s after experiment 24 h
