International Journal of ELECTROCHEMICAL SCIENCE www.electrochemsci.org

Corrosion Behavior of 2205 DSS Base Metal and ER 2209 Weld Metal in a Deposited Ash/Water Suspension

Keywords: waste-to-energy plant; ash/water suspension; pitting; 2205 DSS base metal; ER2209 weld metal

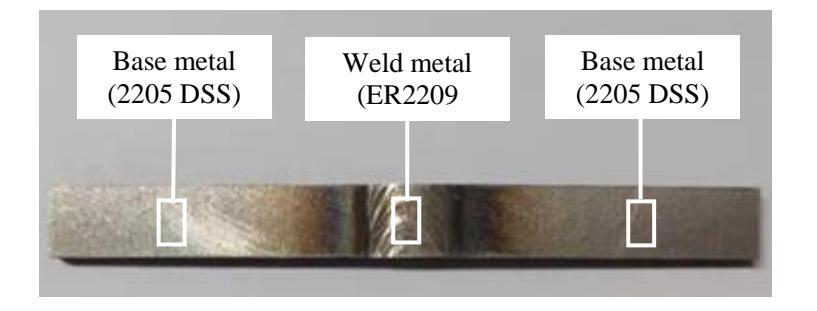
Figure 1. The welded plate and the sampling location of the base metal (BM) and the weld metal (WM).

The experimental materials came from a welded plate with a thickness of 5 mm, in which 2205 DSS was the BM and ER 2209 was the filler metal, as shown in Figure 1. The chemical compositions of the 2205 DSS BM and the ER2209 WM are given in Table 2. The white frame area in Figure 1 was cut to obtain the BM and WM specimens. The dimension of all specimens was 10 mm \times 10 mm \times 5 mm. All specimens were polished step by step with sandpapers from 800 to 2000 mesh and were then degreased with ethanol and cleaned with distilled water.

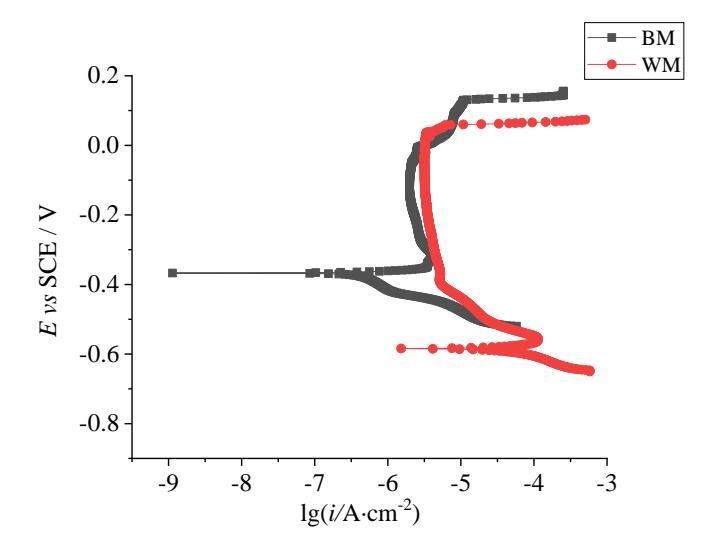
Figure 2. Polarization curves of the BM and the WM after immersion in the deposited ash/water suspension for 1 h at 80 °C.

Firstly, the polarization curves of the BM and the WM were measured after being immersed in the deposited ash/water suspension for 1 h and 12 h. The results are shown in Figure 2 and Figure 3.

The polarization curves in Figure 2 and Figure 3 show that after 1 h of immersion the pitting potential (E_b) of the BM and the WM was 0.127 V and 0.034 V, respectively. After immersing for 12 h, the E_b of the BM and WM negatively shifted to -0.172 V and -0.240 V, respectively. According to the above results, under the same immersion time, the E_b of the BM was higher than that of the WM. Take the passive current density at the polarization value of 0.25 V for comparison. After immersing for 1 h, the passive current densities of the BM and the WM were 2.01 μ A·cm⁻² and 4.93 μ A·cm⁻². respectively. However, after 12 h of immersion, the passive current densities of the BM and the WM increased to 16.37 μ A·cm⁻² and 41.21 μ A·cm⁻², respectively. There are similar reports [21,22] that in some harsh corrosive media, the corrosion current density of metals increases with time, indicating that the corrosion damage of materials is intensified. The results in Figure 2 and Figure 3 show that under the same immersion time the passive current density of the WM and its increase are greater, indicating that the corrosion resistance of the passive film on the WM surface was relatively poor. The passive current density of the WM fluctuated greatly after immersion for 12 h, implying poor stability of the passivation film. It may be that the surface of the WM electrode was in a metastable state [23], and the passivation film was more susceptible to damaged. By comparing the E_b values for 1 h and 12 h, it is seen that the E_b of both the BM and the WM gradually decreased with the increase in immersion time, while the passive current density gradually increased with the immersion time, indicating that with the extension of the immersion time the corrosion resistance of both the BM and the WM decreased. In addition, the corrosion potential (E_{corr}) of the two materials shifted negatively with the extension of the immersion time, indicating the deterioration of the performance of the passivation film on the electrode surface.

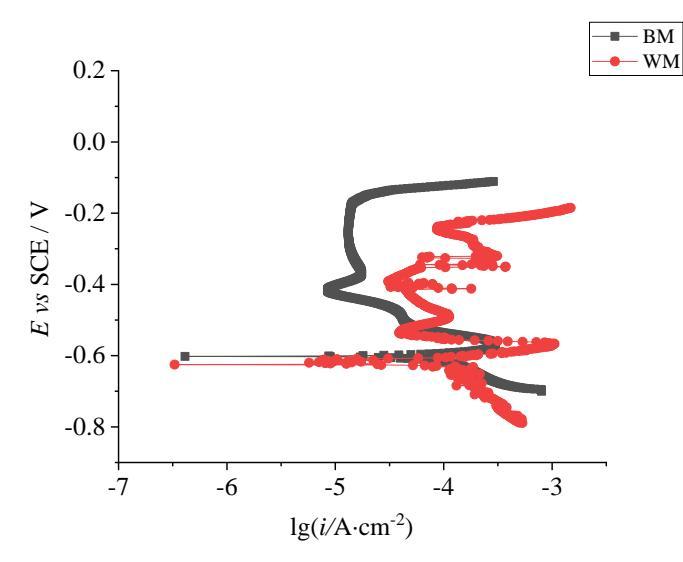
Figure 3. Polarization curves of the BM and the WM after immersion in the deposited ash/water suspension for 12 h at 80°C.

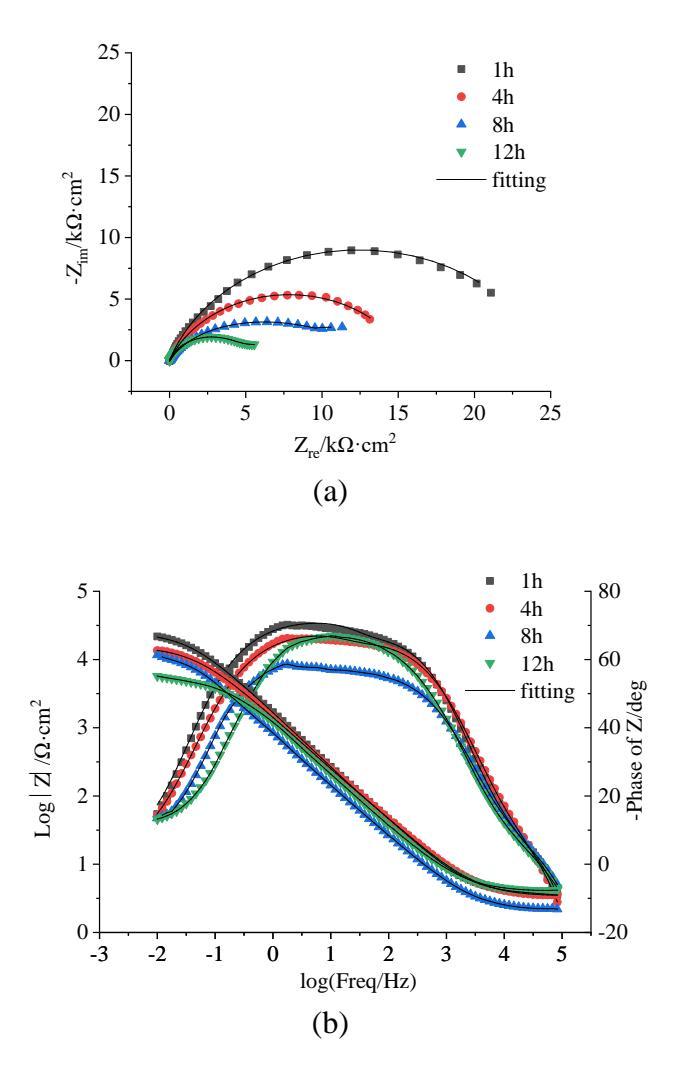
Figure 4. Electrochemical impedance spectroscopy (EIS) of the 2205 DSS BM immersed in the deposited ash/water suspension for different times at 80 °C. (a) Nyquist plot. (b) Bode plot.

To further compare the performance of the passive film on the surface of the BM and the WM, EIS of the two materials was performed in the deposited ash/water suspension after immersing for 1 h, 4 h, 8 h, and 12 h. The results are shown in Figure 4 and Figure 5.

The deposited ash/water suspension used in the experiment was a highly corrosive solution, with a chloride ion concentration of 100.78 g/L, a conductivity of 125 ms \cdot cm⁻¹, and a pH of 4.5, as shown in Table 1. In such a relatively harsh medium, the passivation film on the surface of polished stainless steel is not easy to form, and the formed passivation film can also be easily damaged. Figure 4 and Figure 5 show that, for both the BM and the WM in the deposited ash/water suspension, the capacitive arc diameter in the Nyquist plot was reduced with the increase in the immersion time, indicating that the corrosion resistance of both materials was reduced, as described by Sinhmar et al. [24].

The total resistance, R_{total} ($R_{\text{total}} = R_i + R_{\text{pit}}$), was used to compare and analyze the fitting results. The R_{total} value of the BM and the WM in Table 3 decreased with the increase in immersion time. When the immersion time increased from 1 h to 12 h, the R_{total} of the BM decreased from 25.33 k $\Omega \cdot \text{cm}^2$ to 7.07 k $\Omega \cdot \text{cm}^2$, and the R_{total} of the WM decreased from 19.81 k $\Omega \cdot \text{cm}^2$ to 3.27 k $\Omega \cdot \text{cm}^2$. Under the same immersion time, the R_{total} value of the BM electrode was always higher than that of the WM electrode. After immersing for 12 h, the R_{total} value of the WM dropped by 6.05 times, while that of the BM electrode dropped by 3.58 times, indicating that the weld metal suffered more severe corrosion than that of the BM. Zhai et al. [26] also found the lower impedance value of the WM electrode, and believed that the surface film on WM was less protective.

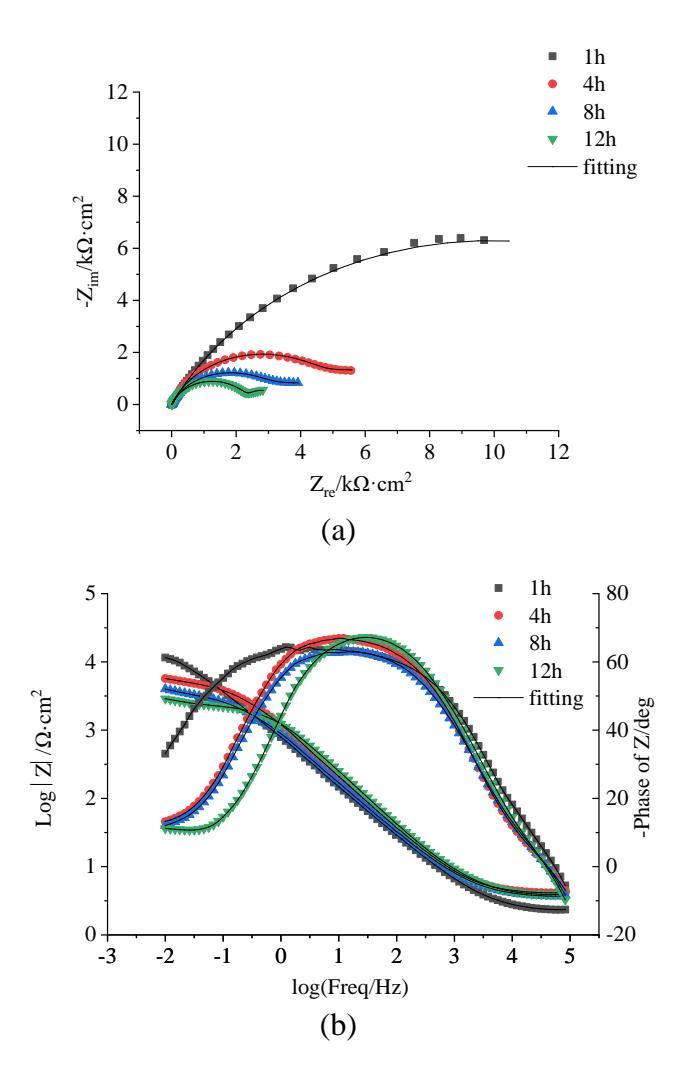
Figure 5. EIS of the ER2209 WM immersed in the deposited ash/water suspension for different times at 80 °C. (a) Nyquist plot. (b) Bode plot.

When the immersion time reached 8 h (for the BM) and 4 h (for the WM), two capacitive arcs appeared in the Nyquist plot, indicating that the electrode surface was in the developmental stage of pitting corrosion at this time [25]. The EIS before and after pitting were fitted with the equivalent circuits in Figure 6(a) and Figure 6(b), respectively, where R_s is the solution resistance, R_i is the interface resistance, Q_i is the interface capacitance, Q_{pit} is the electric double layer capacitance in the corrosion hole, and R_{pit} is the charge transfer resistance in the corrosion hole. The fitting results are shown in Table 3.

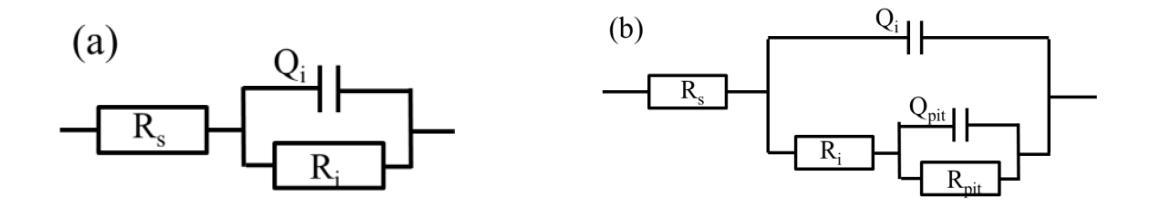
Figure 6. Equivalent circuits for fitting.

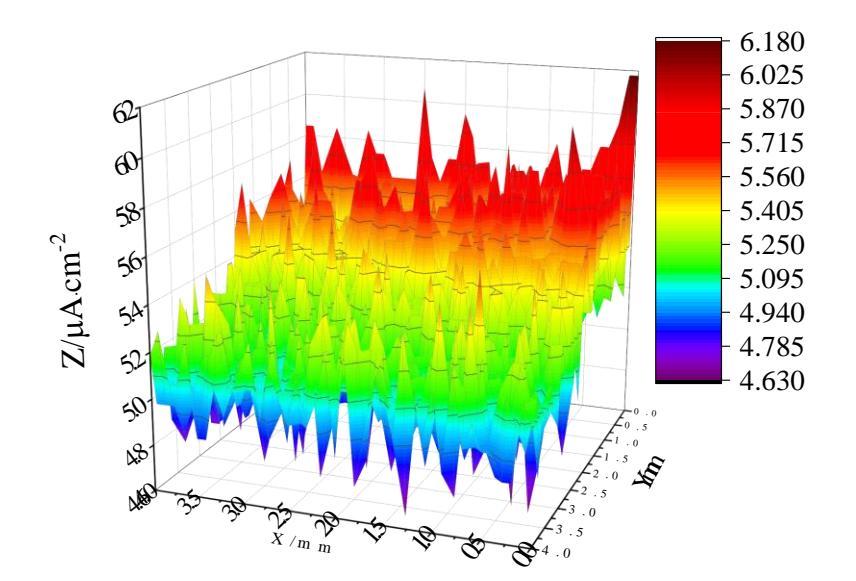
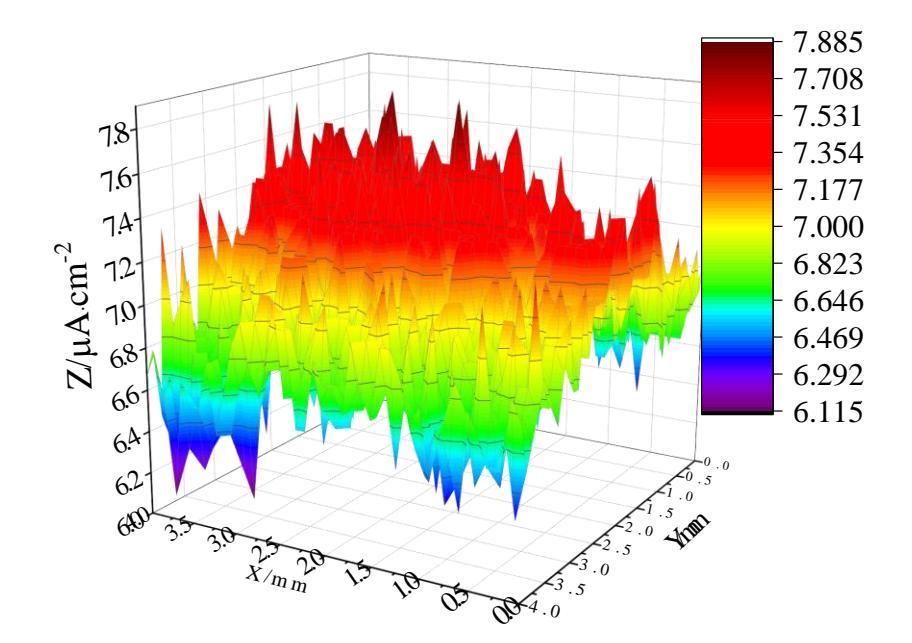
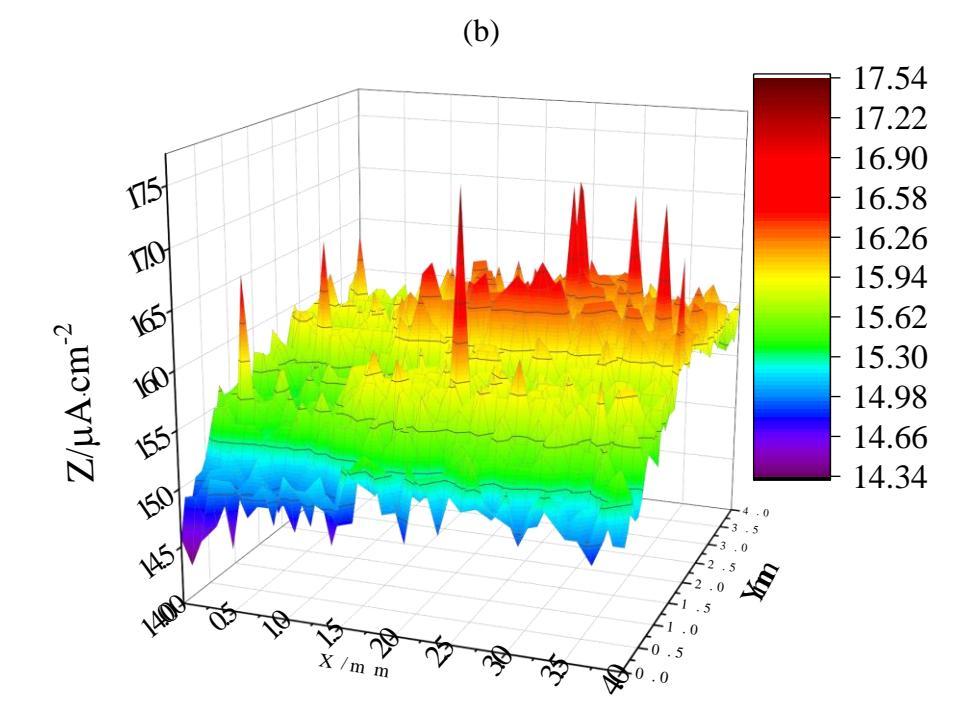
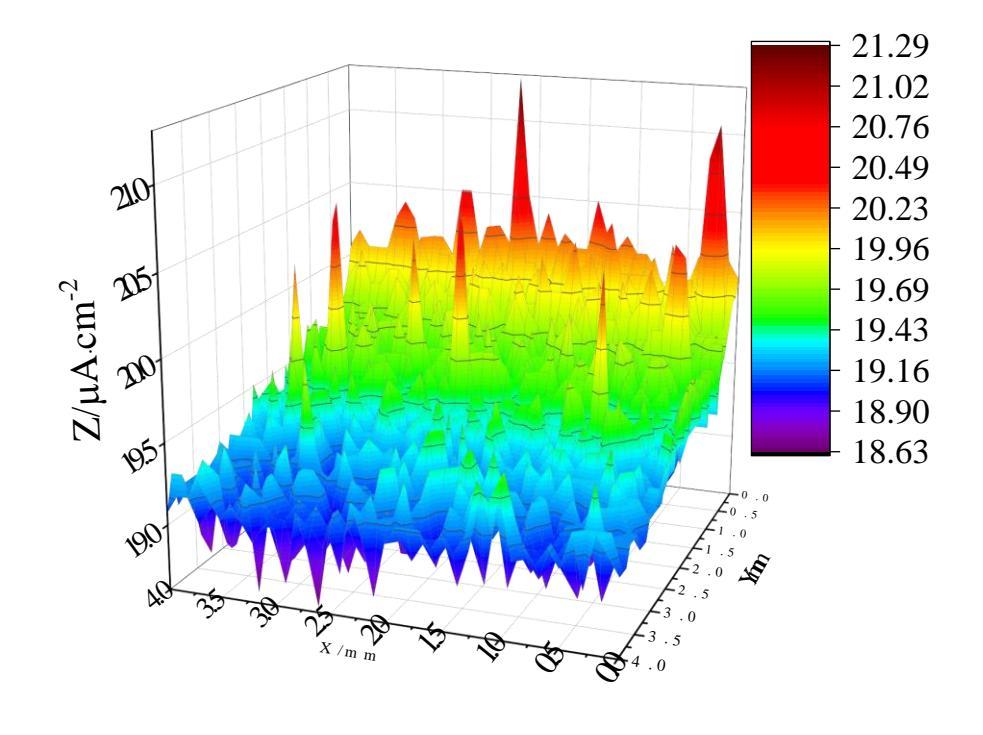
Figure 7. Scanning Vibrating Electrode Technique (SVET) results of the 2205 DSS BM after immersion in the deposited ash/water suspension for different times at 80 °C. The immersion times were (a) 1 h, (b) 4 h, (c) 8 h, (d) 12 h.

SVET measurements were carried out on specimens immersed in the deposited ash/water suspension for different times to obtain the pitting corrosion sensitivity and the localized electrochemical inhomogeneity of the 2205 DSS BM and the WM. The results are shown in Figure 7 and Figure 8.

Figure 7 shows that the surface current density of the BM gradually increased with the increase in immersion time. After immersing for 1 h, the surface current density distribution of the BM was comparatively uniform, most of which remained between 5.2 and 5.6 μ A·cm⁻², indicating that there was no obvious pitting corrosion at this time. When the immersion time was 4 h, most of the surface current density remained between 6.8 and 7.4 μ A·cm⁻². As the immersion time in the deposited ash/water suspension increased from 4 h to 8 h, most of the surface current density reached 15.0 – 16.0 μ A·cm⁻². However, there were several active sites on the metal surface where the current density suddenly increased to about 17.0 μ A·cm⁻² [27]. According to Mena et al. [28], these active sites with a sudden increase in current density are anode sites where the nucleation of a corrosion pit begins. As the immersion time was extended to 12 h, the surface current density increased to 19.0 – 20.0 μ A·cm⁻², and the current density of those active sites increased to 20.5 – 21.0 μ A·cm⁻². After immersing for 12 h, the number of active sites on the electrode surface did not increase significantly, but the current density of the active sites increased markedly, indicating that the pits became deeper and no obvious new pits appeared on the surface of the BM.

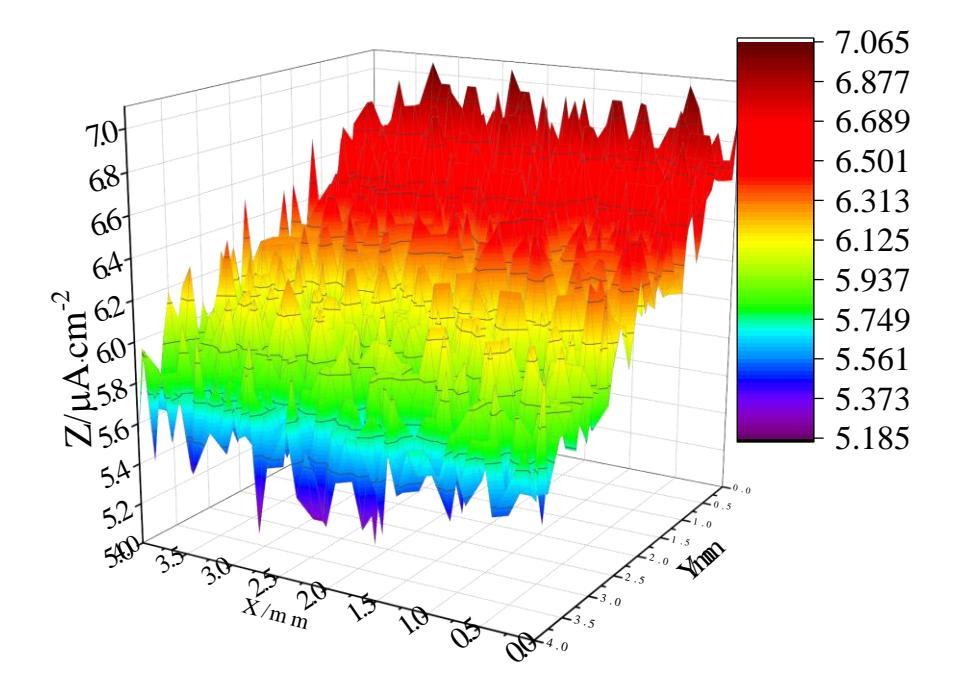
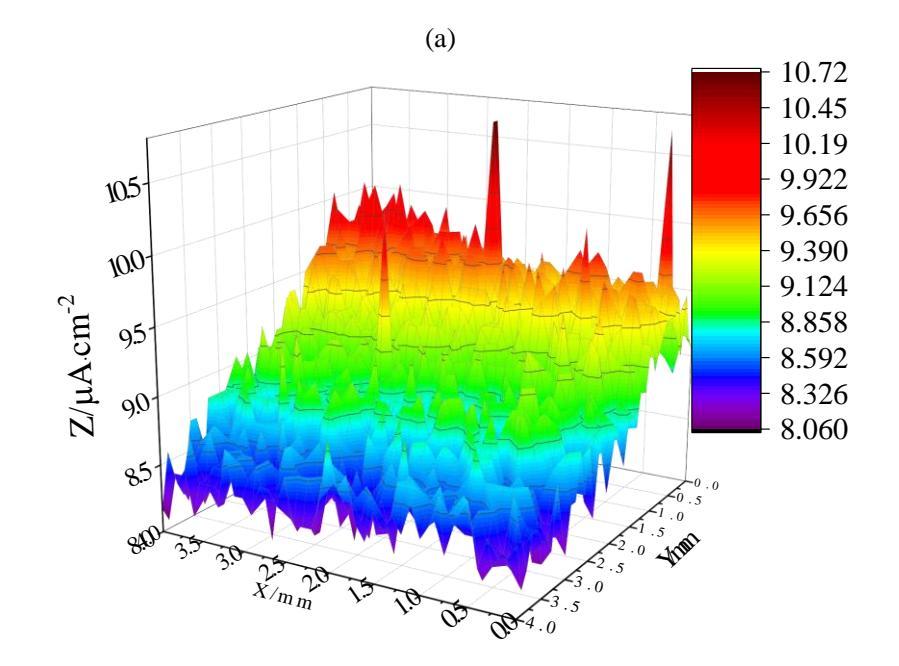
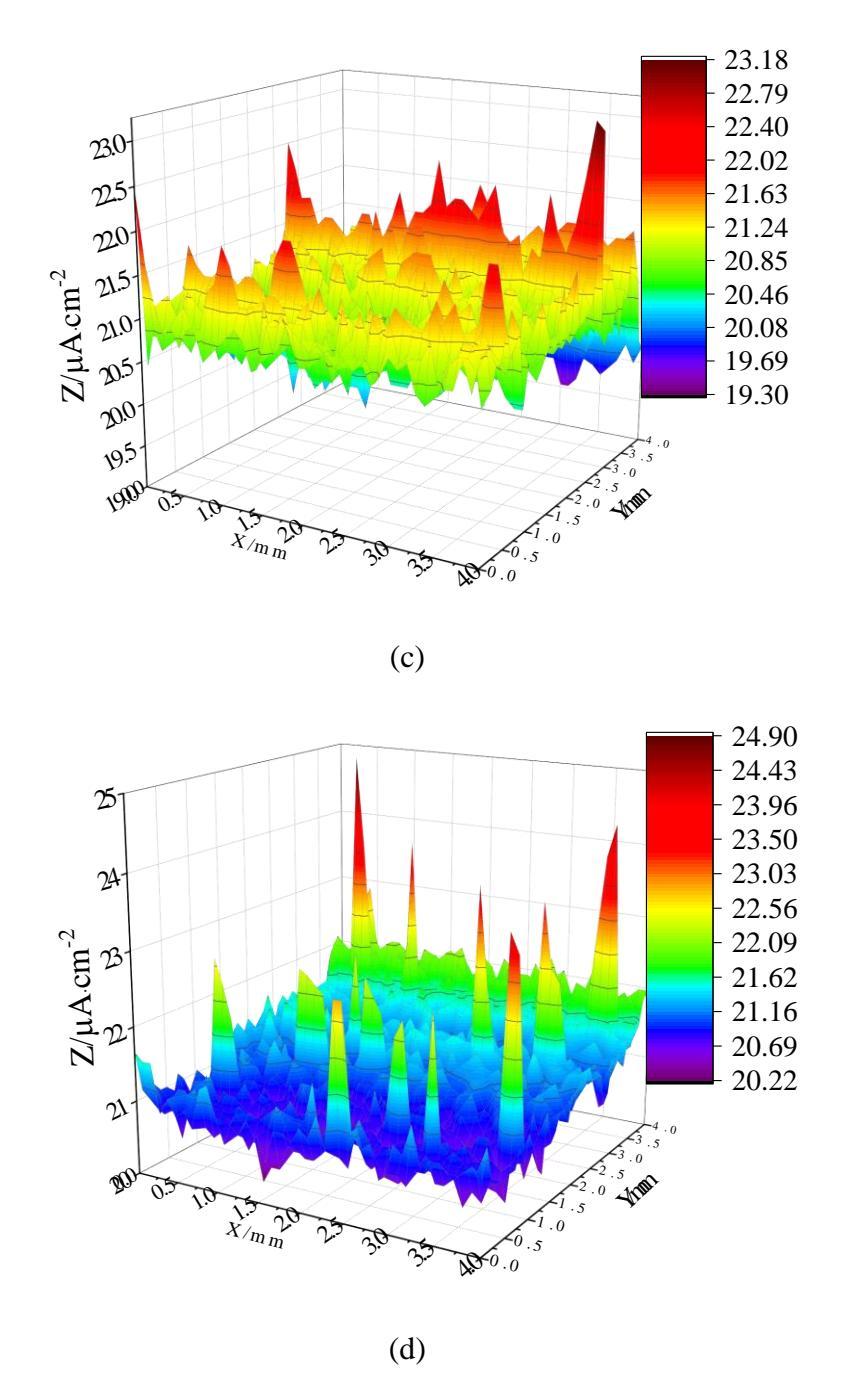
Figure 8. SVET results of the WM after immersion in the deposited ash/water suspension for different times at 80 °C. The immersion times were (a) 1 h, (b) 4 h, (c) 8 h, (d) 12 h.

The SVET results of the WM in the deposited ash/water suspension in Figure 8 show a similar trend as that of the 2205 DSS BM. With the increase in immersion time, the surface current density and the number of active sites gradually increased. However, the surface current density of the WM increased faster than that of the BM, and the active sites appeared earlier. After immersing for 4 h, most of the surface current density of the WM electrode increased to $8.5 - 9.5 \,\mu\text{A}\cdot\text{cm}^{-2}$, and the current density of the active sites increased to $10.0 - 10.5 \,\mu\text{A}\cdot\text{cm}^{-2}$. However, there was no obvious active site on the surface of the BM under the same immersion time. After immersing for 8 h, the surface current

density of the WM increased to about 21.0 μ A·cm⁻², which was higher than that of the BM that of immersed for 12 h. After 12 h of immersion, the current density of the active sites on the WM surface increased to about 25.0 μ A·cm⁻², and the number of active sites was significantly more than that for the 8 h immersion, indicating that the density and depth of the pits further increased [29]. Compared with the BM under the same immersion time, there were more active sites on the WM surface and the current density was higher, indicating that the pitting corrosion resistance of the WM was obviously poorer than that of the BM in the deposited ash/water suspension.

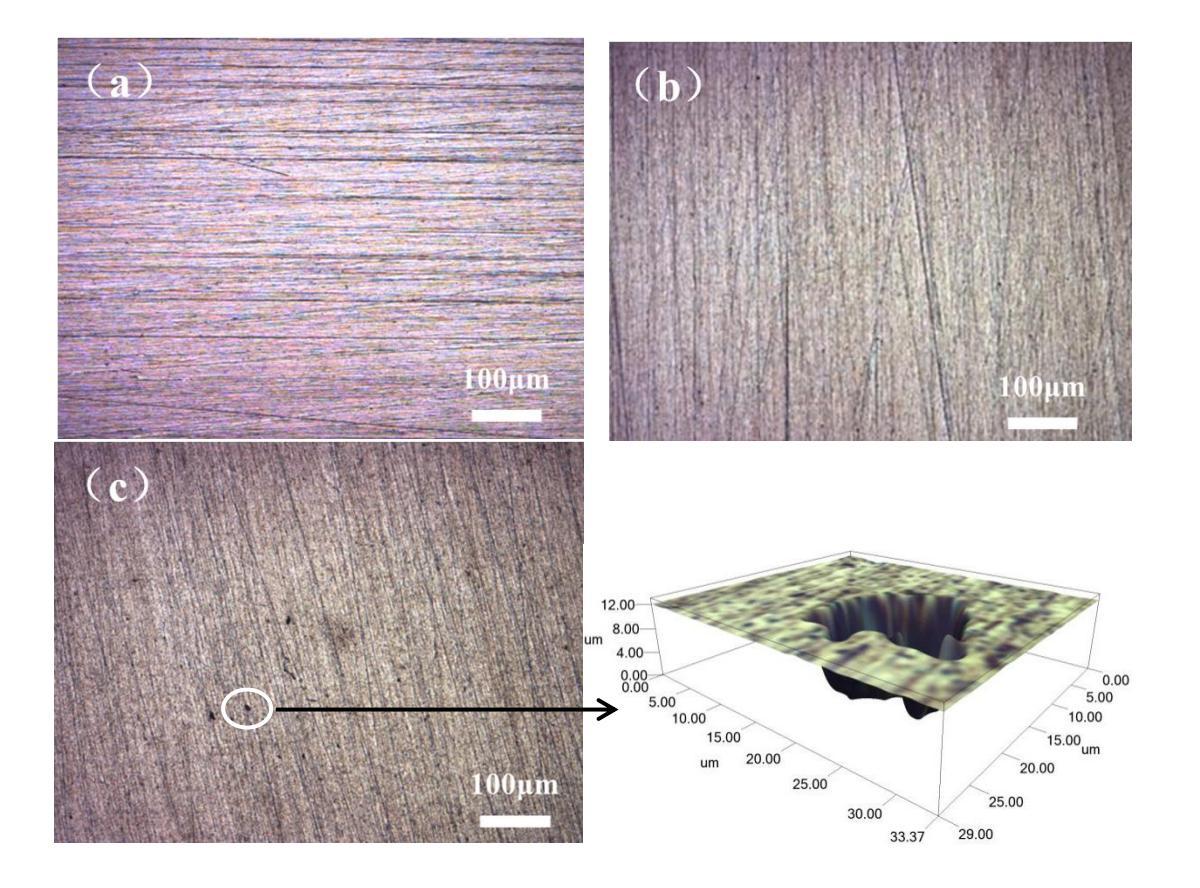
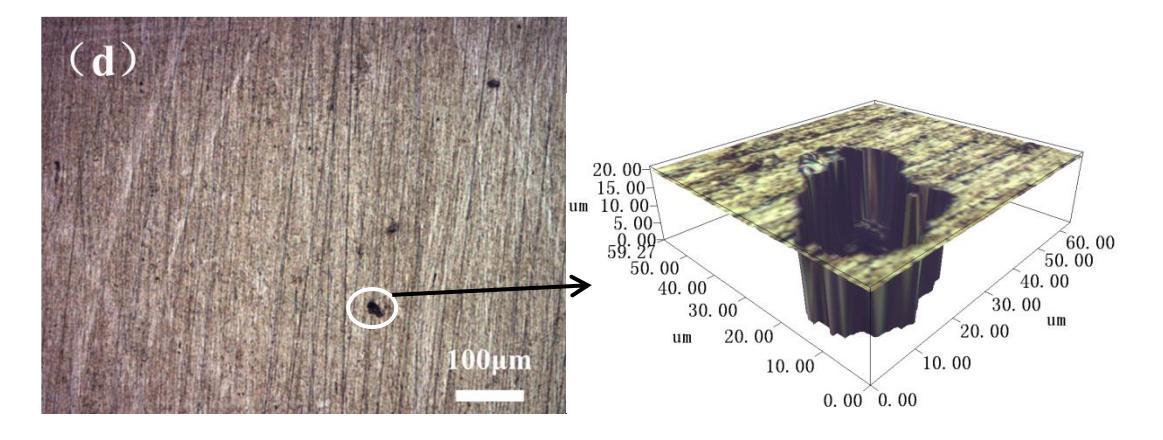
Figure 9. Surface morphology of the 2205 DSS BM immersed in the deposited ash/water suspension for different times at 80 °C. The immersion times were (a) 1 h, (b) 4 h, (c) 8 h, (d) 12 h.

Figure 9 and Figure 10 show the surface morphology of the BM and the WM specimens immersed in the deposited ash/water suspension for different times. The surface roughness (Ra) of various specimens is summarized in Table 4.

The results in Figure 9, Figure 10, and Table 4 show that as the immersion time increased pitting corrosion gradually occurred on the surfaces of the BM and the WM, and the *Ra* value gradually increased. Corrosion can lead to an increase in the roughness of the metal surface, and the occurrence of pitting can cause a rapid increase in the *Ra* value [20, 30, 31]. After immersion in the suspension for 1 h and 4 h respectively, no obvious pits appeared on the BM surface, and the *Ra* value increased from 0.733 μ m to 0.775 μ m. After immersing for 8 h, pitting corrosion appeared on the BM surface, and the *Ra* value increased to 0.875 μ m. When the immersion time reached 12 h, the *Ra* value increased to 0.957 μ m, and the pit width increased from 15 μ m (8 h) to about 50 μ m, and the pit depth increased from about 12 μ m (8 h) to about 20 μ m.

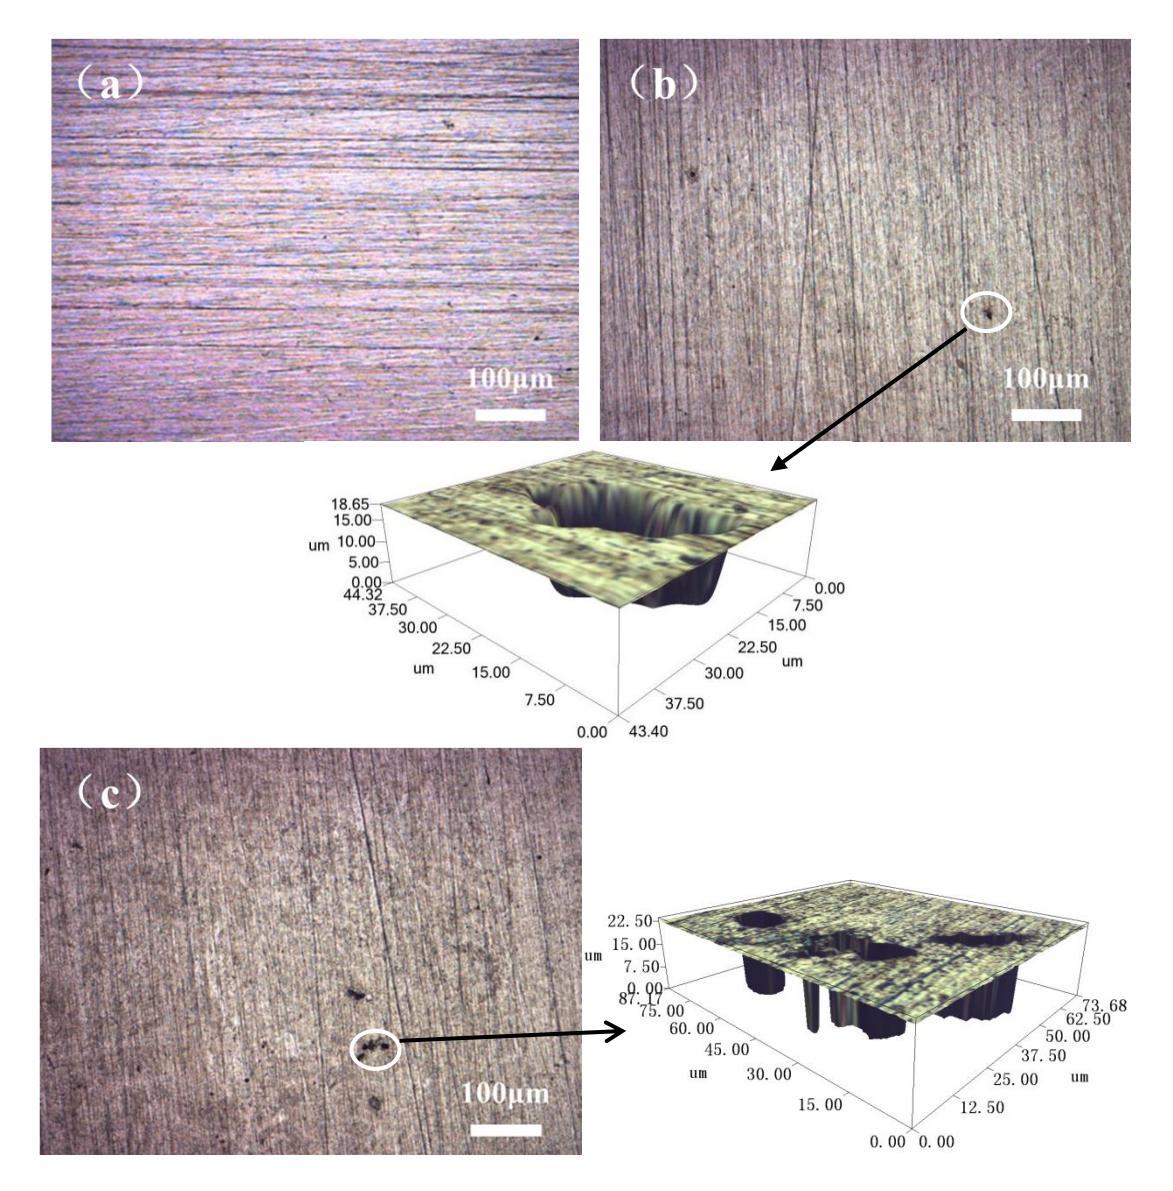
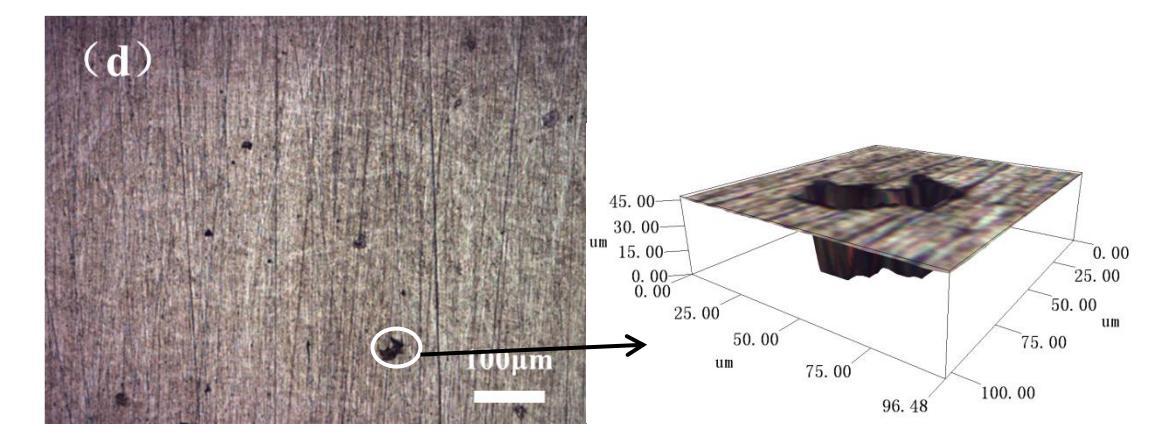
Figure 10. Surface morphology of the WM immersed in the deposited ash/water suspension for different times at 80 °C. The immersion times were (a) 1 h, (b) 4 h, (c) 8 h, (d) 12 h.

The change in the surface morphology of the WM in the deposited ash/water suspension with time was similar to that of the BM, and pitting corrosion gradually appeared with the increase in immersion time. After immersing for 1 h, there were no obvious pits on the WM surface, and the value of *Ra* was close to that of the BM. As the immersion time increased the corrosion severity of the WM was significantly greater than that of the BM. After 4 h of immersion, pits appeared on the WM surface, and the *Ra* value increased from 0.739 μ m to 0.830 μ m. After immersing for 8 h, the pitting corrosion of the WM surface was more serious, and the *Ra* value was close to that of the BM immersed for 12 h. The pitting corrosion and roughness of the WM surface further increased when immersed for 12 h. The above results were consistent with the EIS and SVET results.

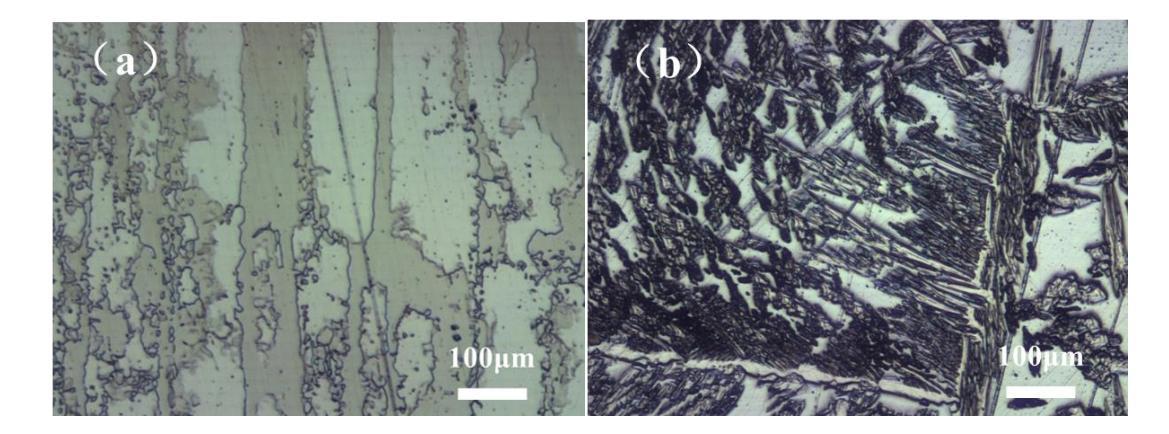
Figure 11. Surface morphology after etching for the (a) 2205 DSS BM and (b) ER2209 WM.

The microstructure of the etched BM and WM was observed, and the results are shown in Figure 11. In addition, the surface microstructure of the WM after the measurement of polarization curve was also observed. The result is shown in Figure 12.

Figure 11(a) shows the metallographic structure of the 2205 DSS BM, which presents a typical two-phase structure. The dark grey ferrite was the matrix, and the light grey part was austenite. The two phases have clear grains and boundaries.

Figure 11(b) shows the metallographic structure of the WM, which was also composed of ferrite and austenite phases. However, compared with the BM, its metallographic structure was very different. In the metallographic structure of the WM, the phase area of ferrite with dendrites was much larger than that of the austenite, covering almost the entire surface. Through analysis software, it was calculated that the austenite content was 49.9% in the BM, which was very close to the optimal corrosion resistance ratio of DSS [3]. The austenite content in the WM was only 39%, that is, the WM had a high proportion of ferrite. However, the good corrosion resistance of DSS welded joints mainly depends on the equal area proportion of ferrite and austenite phases [7]. The area proportion of the austenite phase in the WM was quite different, which should reduce its corrosion resistance.

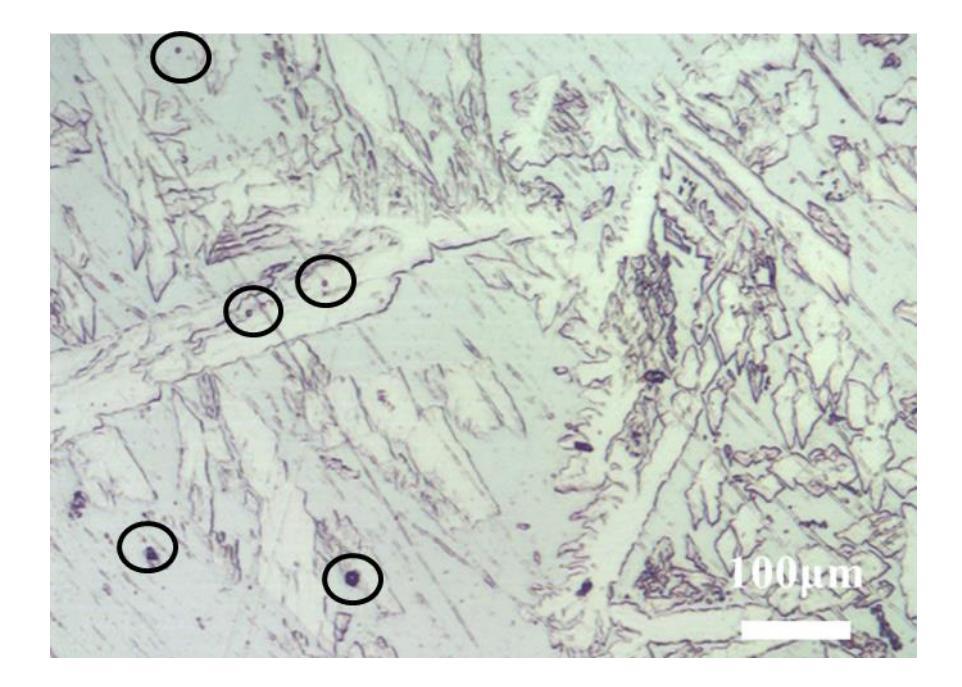
Figure 12. The etched microstructure of the WM after measurement of the polarization curve.

Figure 12 displays the microstructure of the WM etched after measurement of the polarization curve. It can be seen that pitting corrosion mainly occurred in the phase boundary between austenite and ferrite phases, and some of the pitting corrosion occurred in ferrite. The above results indicated that pitting corrosion was prone to occur on the two-phase boundary and preferentially developed along the ferrite. Other researchers have obtained similar results [32, 33], and have proposed that this type of corrosion is caused by the electrochemical difference between austenite and ferrite phases [33]. In the corrosion process, the ferrite was the anode and the austenite was the cathode [34]. The ferrite content of the WM was about 61%, which was obviously higher than that of the BM. This may be why

the corrosion resistance of the WM is lower than that of the BM. Geng et al. reached a similar conclusion [35].
