Effect of Chloride Ions on the Corrosion of Galvanized Steel Embedded in Concrete Prepared with Cements of Different Composition

Received: 28 September 2013 / Accepted: 22 November 2013 / Published: 8 December 2013

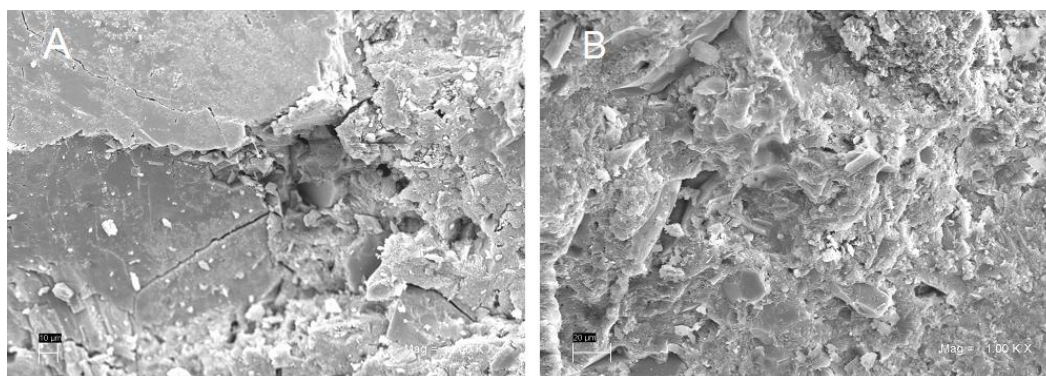
Fig. 1 shows micrographs of the two types of concrete. It can be seen that the Ordinary Portland concrete has larger pores and microfissures can also be seen on its surface, while the Pozzolanic concrete shows smaller pores and a rougher more homogenous surface.

Figure 1. Micrographs of the two types of concrete obtained using a SEM. A) Ordinary Portland Concrete; B) Pozzolanic Concrete. (1000x) [26].

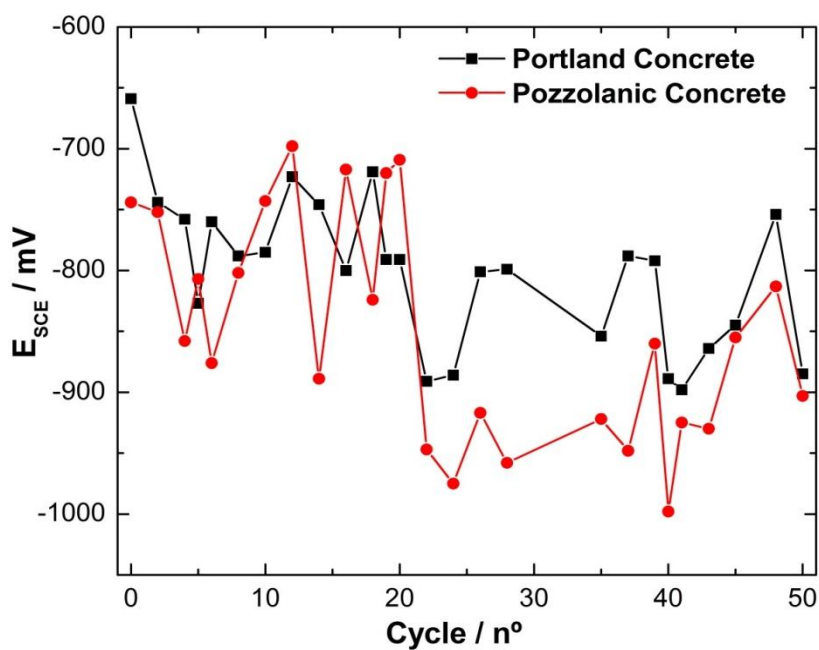
The variation over time of the average of three measurements of corrosion potential for the galvanized steel embedded in Ordinary Portland and Pozzolanic concrete are shown in Figure 2. The

galvanized steel embedded in Ordinary Portland concrete shows initial values of corrosion potential around $-650 \text{ mV}_{\text{SCE}}$, while the bar embedded in Pozzolanic concrete gives values around $100 \text{ mV}_{\text{SCE}}$ more negative, denoting a higher level of activity mainly due to the difference in pH between the concrete types. It is known that galvanized steel possesses a pH stability range of 6 to 12.5, within which the corrosion rate of the zinc is around 10 mpy or less [1]. This pH range increases to 13.3 [1, 7, 21, 25, 27] with the formation of calcium hydroxy-zincate (CHZ) as a corrosion product [29], which reaches its highest point of stability at this pH, presenting a more homogenous and compacted distribution over the zinc.

After the 50 cycles, the values of corrosion potential for the galvanized steel in the two types of concrete end at around -900 mV , indicating that the steel frame is still in a passive state. However, the variation in the values over time shows a better behavioral tendency for the galvanized steel embedded in the Ordinary Portland concrete due to the C_3A content in the pure Portland cement which, as explained above, reacts with the chloride ions, decreasing the level of activity of the metal's corrosion process.

Figure 2. Variation over time of Corrosion Potential of the galvanized steel for the two concrete types.

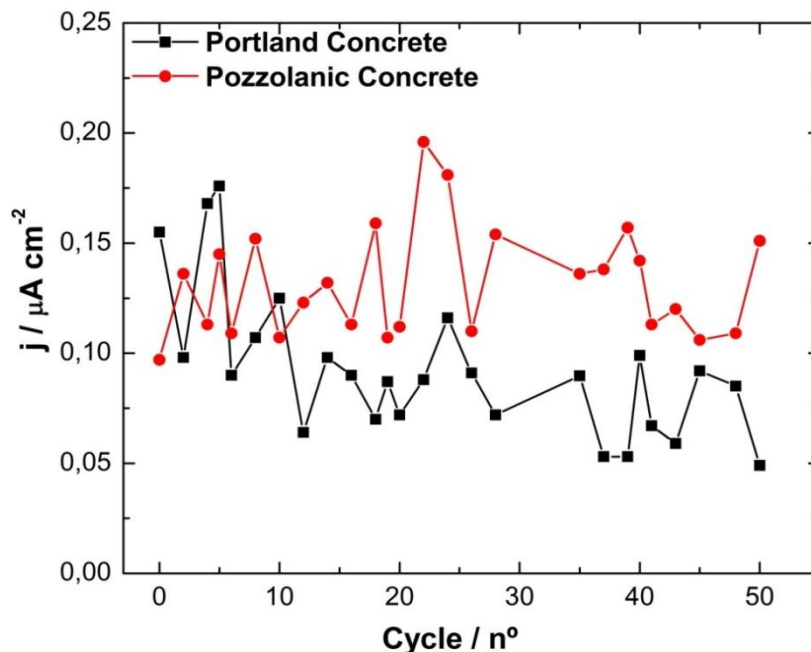
Figure 3 shows the variation in the average corrosion current of the galvanized steel for the two types of concrete. Similar behavioral trends can be seen, though the current measured on the galvanized steel in the Portland concrete is slightly lower. Nevertheless, in both cases the galvanized steel bars remain in a passive state, which is in agreement with the values obtained for corrosion potential.

Figure 3. Variation over time in Corrosion Current of the galvanized steel in the two concrete types.

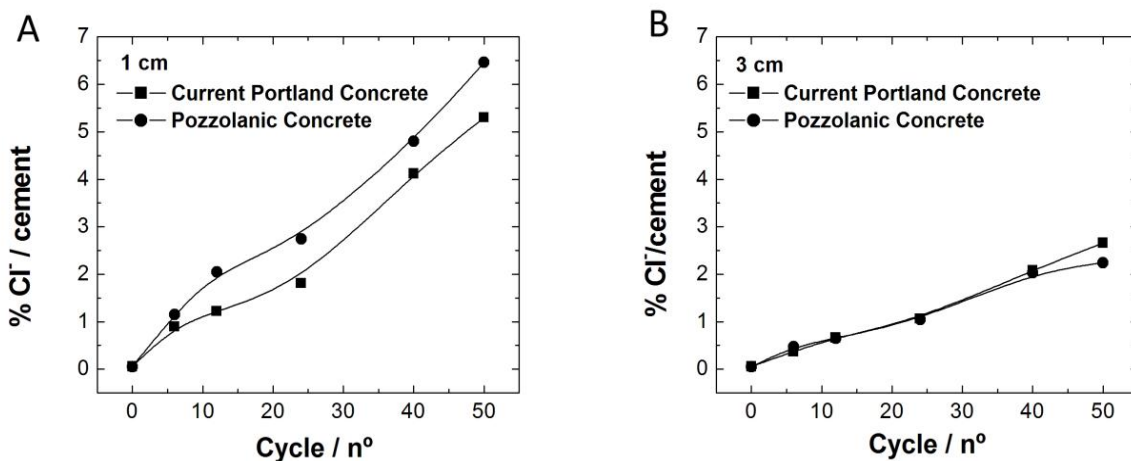
Figure 4. Comparison of free chloride ion concentration in the two concrete types. (A) 1 cm and (B) 3 cm.

The measurements of chloride ion concentration taken at different cycles and different depths (Figure 4A) show that there is higher chloride ion concentration in the Pozzolanic concrete at a depth of 1 cm (the depth furthest from the steel rebar), while at 3 cm (Figure 4B) where the galvanized steel bar is located, the free chloride ion concentration is similar for the two concrete types. The chloride ion diffusion coefficient (D_0) in the Pozzolanic concrete is $1.1 \times 10^{-7} \text{ m}^2 \text{ s}^{-1}$ and in the Standard Portland concrete it is $2.0 \times 10^{-8} \text{ m}^2 \text{ s}^{-1}$. Therefore, the chlorides diffuse more rapidly in the Pozzolanic concrete even though it has lower porosity, as the Portland concrete contains C_3A which retains chlorides, as

shown by the measurements of combined chloride content at a depth of 1 cm in the Portland concrete (1.10%) and in the Pozzolanic concrete (0.80%) and at 3 cm: 1.16% and 0.83%, respectively.

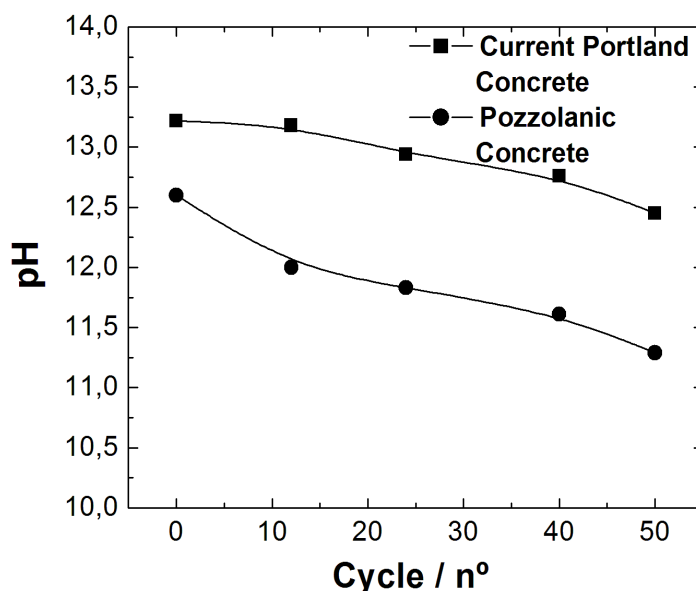
Figure 5 shows the different pH measurements obtained at different cycles on the zinc-concrete interface, for the two concrete types. The Ordinary Portland concrete maintains pH within the range of best stability for zinc corrosion products, between 13.3 and 12.5, while for the Pozzolanic concrete, pH varies between 12.5 and 11.2, a range in which the zinc is stable but the zinc corrosion products, such as calcium hydroxy-zincate [1, 7, 21, 25, 27] and simonkoleite [36] present decreased protective capacity, as they are more porous and more permeable to the entry of aggressive ions like the chloride ion.

Figure 5. pH at a depth of 3 cm at cycles 0, 12, 24, 40 and 50.

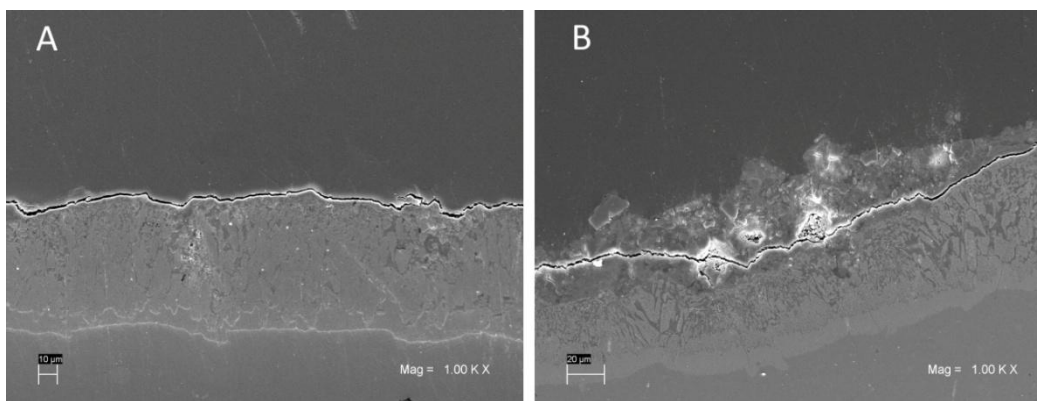
The galvanized steel bars initially have a zinc coating with a thickness of approximately 80 μm , and after removing the specimens from the wet chamber the formation of a fine layer of corrosion products mainly composed of calcium hydroxy-zincate ($\text{Ca}(\text{Zn}(\text{OH})_3)_2 \times \text{H}_2\text{O}$) and zinc oxide (ZnO , zincite) was observed (Figure 6). The corrosion products formed on the galvanized steel embedded in the Ordinary Portland concrete were distributed homogeneously over the Zn layer (Figure 7), while for the rebar embedded in the Pozzolanic concrete, the layer of corrosion product shows irregular thickness along its length (Figure 7B). These observations are in line with the data obtained for the chloride diffusion coefficients, which suggest that the chloride entry rate is not the same for both concrete types, though the final chloride content levels on the interface are similar.

Figure 6. Cross-section micrographs of the galvanized steel obtained by SEM (A) before being embedded in the concrete (B) after removing the reinforced concrete from the wet chamber (1000x) [26].

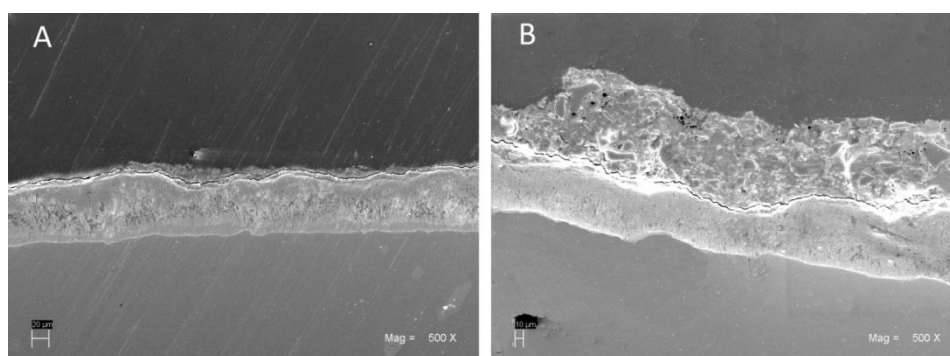
The EDAX analysis of the corrosion products mainly shows the presence of chlorine in the corrosion products in the pozzolanic concrete, while the Portland concrete mainly shows the presence of calcium, zinc and oxygen, corroborating the presence of zincite (ZnO).

Figure 7. Cross-section micrographs of the galvanized steel bars after 50 cycles embedded in (A) Ordinary Portland concrete, and (B) Pozzolanic concrete. (500x)

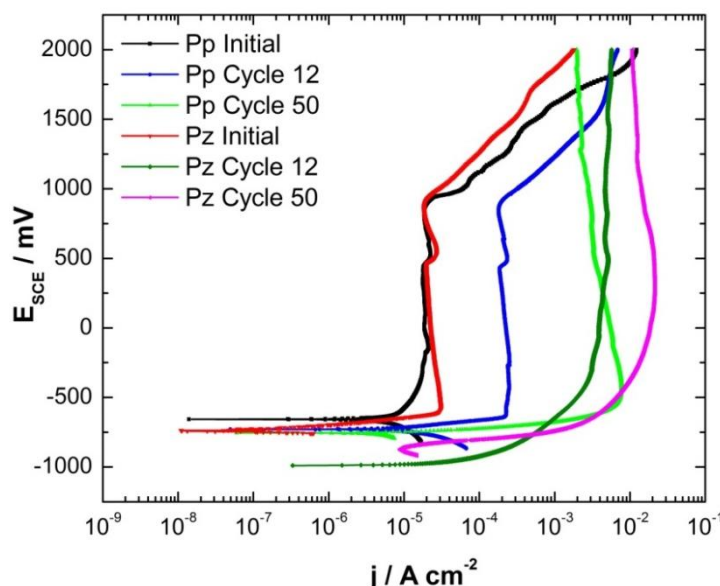
Another method of evaluating the behavior of galvanized steel in the different concretes is to prepare anodic polarization curves in the presence of oxygen for the galvanized rebars in solutions from powdered pieces obtained from the concretes at different cycles of semi-immersion and drying (Fig. 8).

The anodic curve of the galvanized sample for the two solutions prepared from powder from the concretes before emersion in the solution containing chloride ions shows an area of anodic dissolution, with a maximum current of approximately $2.0 \times 10^{-5} \text{ A cm}^{-2}$ and a potential of around -690 mV_{sce}, an area of passivity and an area of picking with a picking potential of around 900 mV_{sce}. However, at cycle 12 of the experiment the curve of the galvanized steel in the Portland concrete

solution (Pp) maintains its shape but shifts to higher currents in one period and decreases its corrosion potential by around 60 mV_{SCE}, unlike the behavior in the Pozzolanic concrete solutions (Pz), where the current increases to $4.0 \times 10^{-3} \text{ A cm}^{-2}$ and the potential decreases to -980 mV_{SCE} due to the presence of chloride. At cycle 50, due to the higher chloride content, the galvanized steel presents less passive behavior for both concrete types, reaching higher current by around $10^{-2} \text{ A cm}^{-2}$. The behavior of the galvanized steel in both situations also corresponds to the difference in pH of the concrete types and the stability of the corrosion products formed under these conditions. The results of polarization curves corroborate those obtained in the other experiments of this study, like corrosion potential, corrosion current and morphology of the galvanized steel.

Figure 8. Polarization curves for galvanized steel rebars embedded in (A) Standard Portland concrete and (B) Pozzolanic concrete
